SECTION 14 INCIDENT REPORT (*Waste Management and Pollution Control Act*)

Date and Time of Notification:	Tuesday 6 th April 2021, 16:00 hrs
Person / Company:	Power and Water Corporation (PWC)
Incident:	Discharge of sewage from sewerage network, Sewage Pumping Station

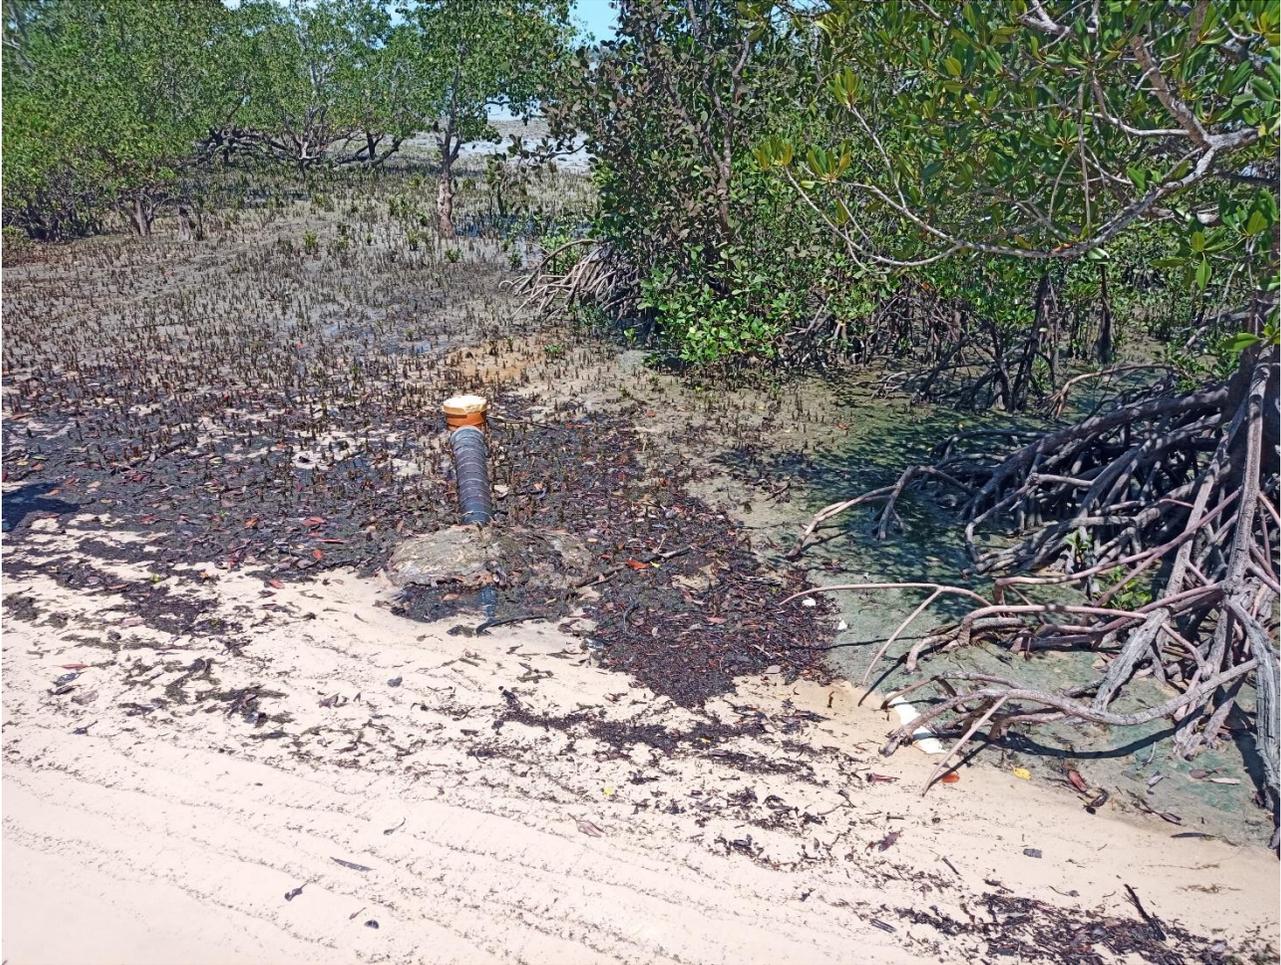
Appendix B – Location Photograph – Discharge point into Apsley Strait

File photo, taken 21st October 2020
