SECTION 14 INCIDENT REPORT (*Waste Management and Pollution Control Act*)

Date and Time of Notification:	Thursday 12 th January 2023, 09:00hrs
Person / Company:	Power and Water Corporation
Incident:	Discharge of sewage from sewerage network (Wastewater treatment Plant)

Coolalinga Wastewater Treatment Plant

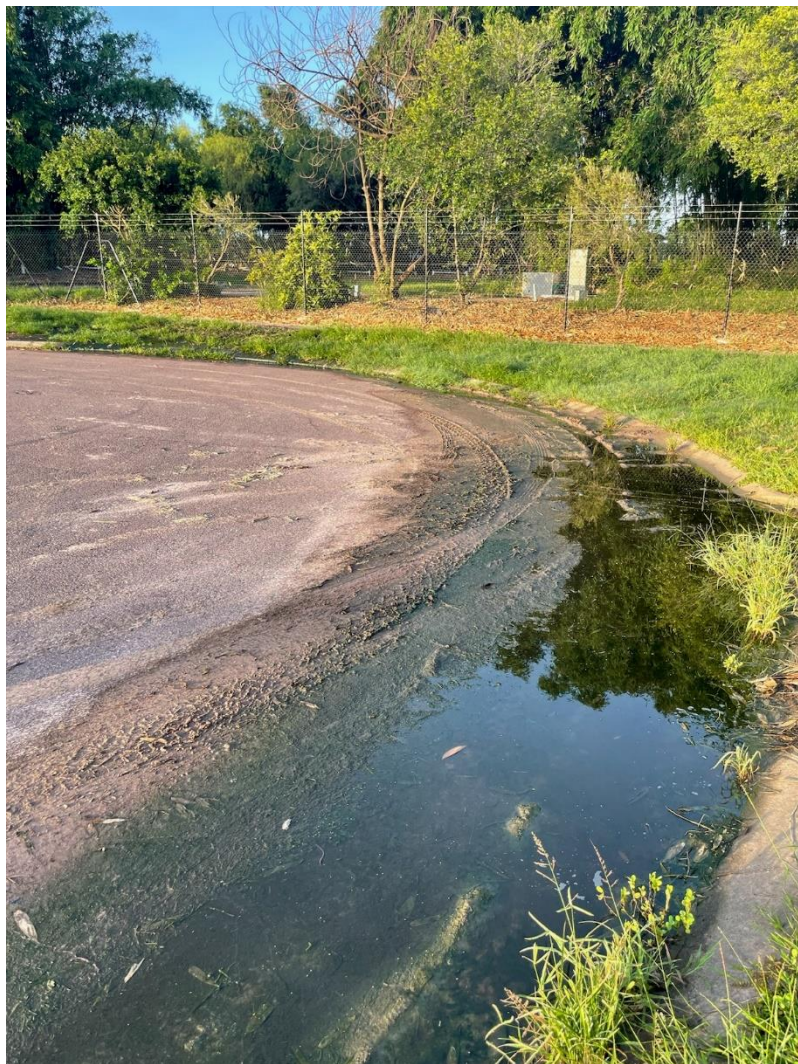
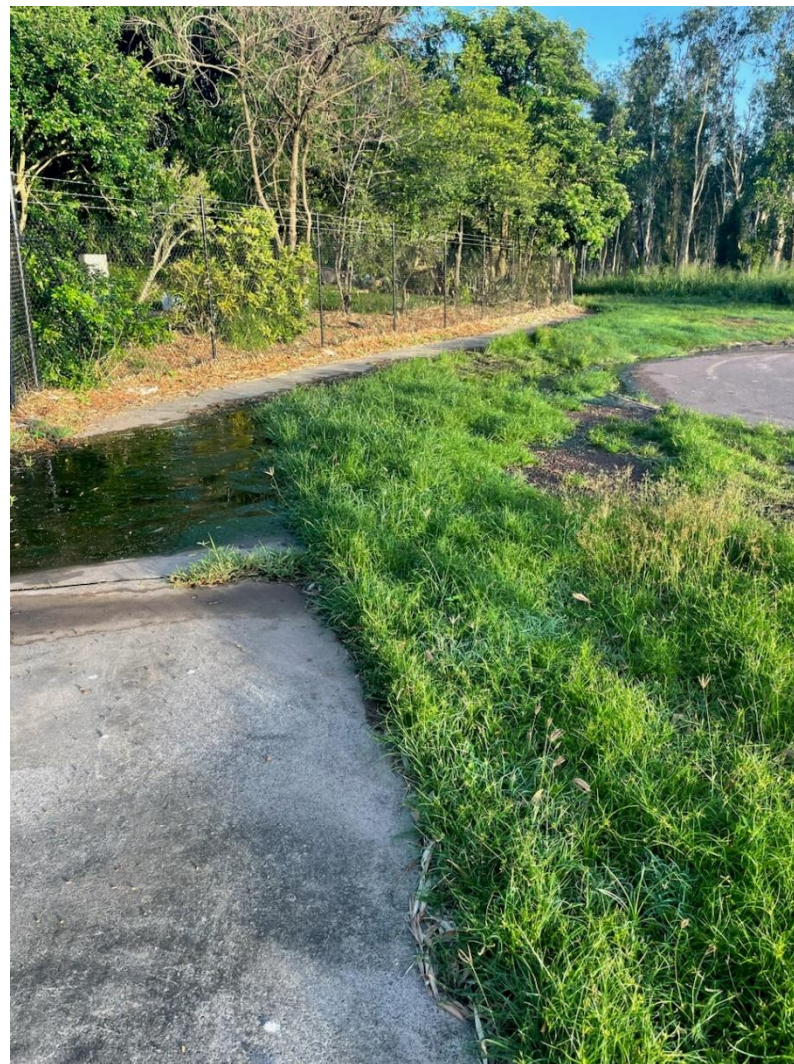
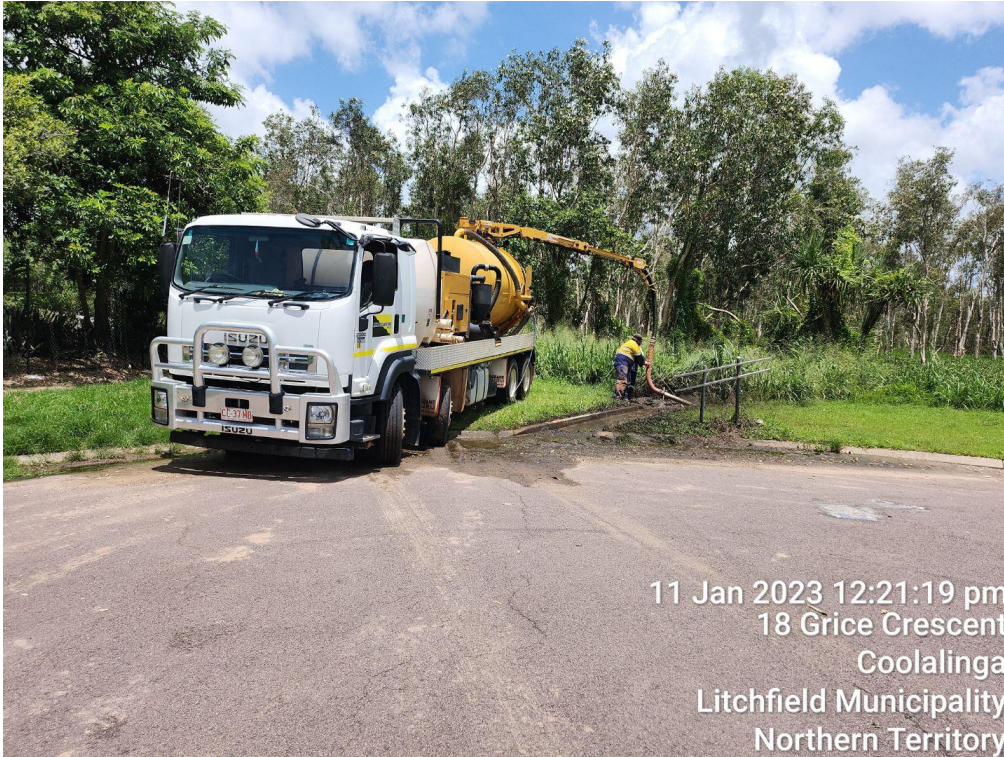
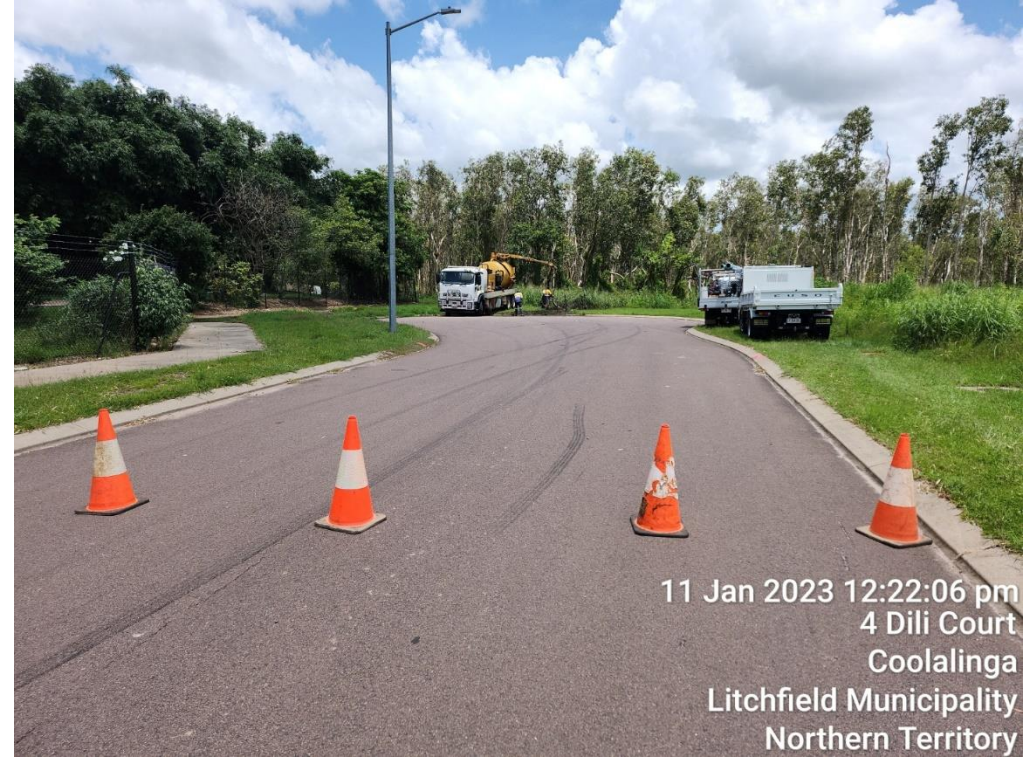
Appendix B – Photographs of the spill site

<p>(a) the incident causing or threatening to cause pollution</p>	<p><i>i. Description of the waste that was discharged.</i></p> <p>Partially treated sewage</p> <p><i>ii. Indicative wastewater quality for the discharge.</i></p> <p>The sewage has been partially treated and more than likely diluted by the 84.4mm of rain that fell in the month of January 2023 (Noonamah airstrip ID 014314). It is currently not possible to provide wastewater quality data, however samples have been taken 11/01/2023 and results can be made available upon receipt from the laboratory.</p> <p><i>iii. Volume of the waste that was discharged.</i></p> <p>The volume of waste discharged is unknown. No telemetric monitoring occurs at the site of discharge.</p>
<p>(b) the place where the incident occurred</p>	<p><i>i. Description of the PWC asset from which the discharge occurred.</i></p> <p>The wastewater evapotranspiration beds at the Coolalinga wastewater treatment plant.</p> <p><i>ii. GPS coordinates of the discharge point from the PWC asset, and the final coordinates of the final discharge point.</i></p> <p><i>Approximate locations are as follows;</i></p> <p>Discharge Point: 131.0396091E, -12.5170772S (evapotranspiration beds) Final Discharge Point: 131.0398339E, -12.5169451S (bushland)</p> <p><i>iii. Indicate any locations nearby to the discharge point where public can gain ready-access, such as public open spaces through which the discharge moves.</i></p> <p>Public access was possible to this spill location, however it is being cleaned up as per the Power and Water Sewage Spills/Overflow Response Work Instruction. There are no gross pollutants (paper) present, as the wastewater has gone through the treatment plant. It should be noted that the treatment plant itself is a fully fenced area,</p>

<p>however the overflow area external of the permanent fence will have temporary fencing and signage erected 11/01/2023 prevent any further access by the public.</p>
<p>(c) the date and time of the incident</p>	<p><i>i. The time and date of commencement and cessation of the discharge.</i></p> <p>The commencement time of the overflow is unknown. The overflow was observed at approximately 07:00hrs by Power and Water staff on 11/01/2023, and the spill was controlled by the afternoon of 11/01/2023.</p> <p><i>ii. How PWC were notified, or became aware of the discharge.</i></p> <p>This overflow was discovered by Power and Water staff conducting regular maintenance inspections. Power and Water's Environmental Services was made aware of the incident at 10:13hrs, 11/01/2023.</p> <p><i>iii. The process by which the discharge occurred.</i></p> <p>The cause of the overflow was due to saturated evapotranspiration beds. These beds were unable to cope with the increased volumes going through the plant as a result of increased inflow volumes caused by recent high rainfall volumes (84.4mm fell so far in the month of January 2023 at the nearest BOM weather recording station – Noonamah airstrip ID014314).</p> <p><i>iv. The reason why the discharge occurred.</i></p> <p>As per (c) iii. Wastewater tank volumes are insufficient for extended high rainfall periods. This site was taken on by Power and Water due to the previous private operator undergoing bankruptcy. The plant is poorly designed and Power and Water are managing the site while looking into long term options for improvement.</p> <p>The preferred long-term solution from an operational perspective is to install a sewage pumping station at the Coolalinga wastewater treatment plant and a rising main to the nearest existing sewage pumping station at Radford Road, Zuccoli. This is a lengthy process (approx. 5 years) to acquire the necessary land to install this rising main. In the interim Power and Water is operating this wastewater treatment plant as best as possible given the limited resources, options and within budget allocations.</p>

<p>(d) how the pollution has occurred, is occurring or may occur</p>	<p>As per (c) iii & (c) iv.</p>
<p>(e) the attempts made to prevent, reduce, control, rectify or clean up the pollution or resultant environmental harm caused or threatening to be caused by the incident</p>	<p><i>i. Confirmation signage and fencing has been erected, as appropriate.</i></p> <p>The treatment plant itself is a fully fenced area, The overflow area external of the permanent fence will have temporary fencing and signage erected 11/01/2023.</p> <p><i>ii. Decontamination of the site as appropriate.</i></p> <p>Clean up consistent with Sewage Spills/Overflow Response Work Instruction as appropriate to the location, and to minimise risk to the Environment. Pooling effluent is being removed via vacuum trucks and the area will be disinfected and thoroughly cleaned.</p>
