SECTION 14 INCIDENT REPORT (*Waste Management and Pollution Control Act*)

Date and Time of Notification:	Tuesday 1 st February 2023, 14:15hrs
Person / Company:	Power and Water Corporation (PWC)
Incident:	Discharge of sewage from sewerage network (manhole)

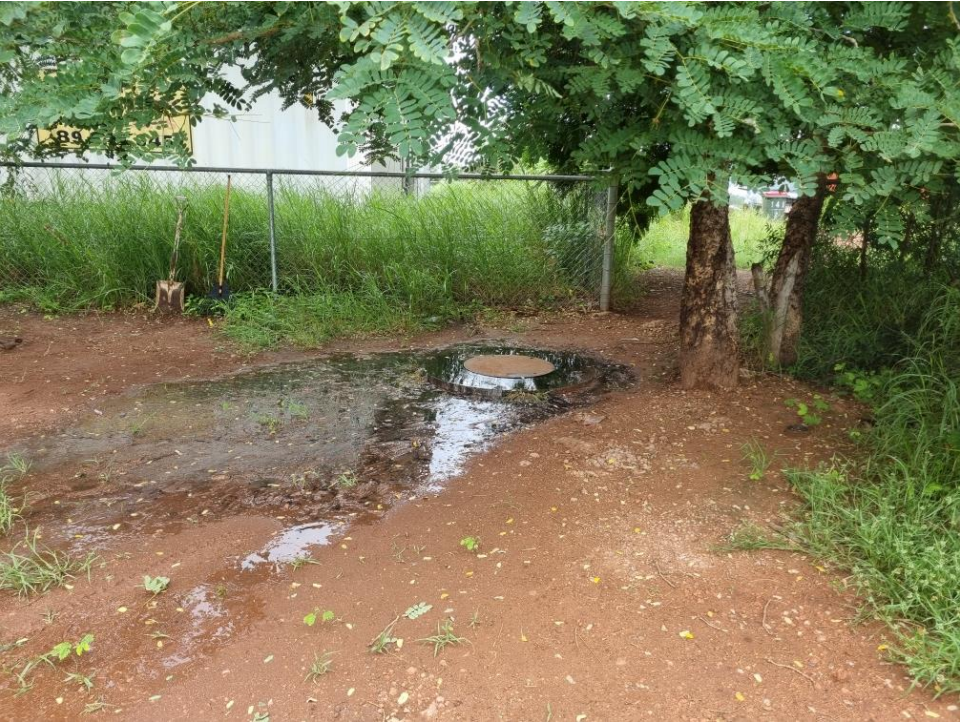
Figure 1. Spill coming from access chamber 4/7.

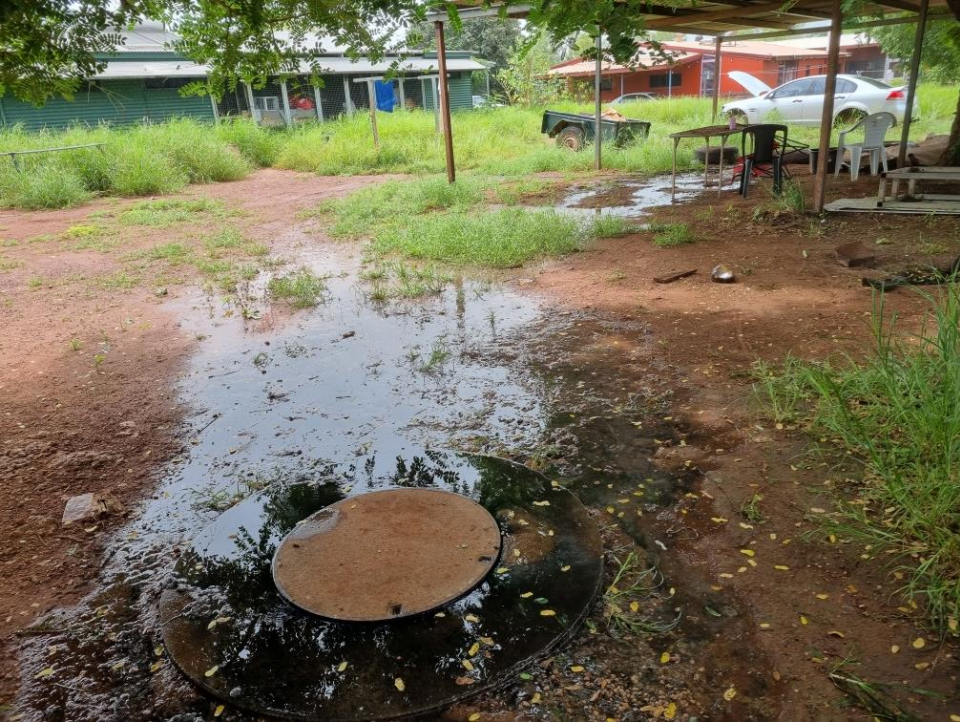
Figure 2. Spill coming from access chamber 4/7.
