## SECTION 14 INCIDENT REPORT (Waste Management and Pollution Control Act)

Date and Time of Notification:	Wednesday 16 <sup>th</sup> August 2023, 12:00hrs
Person / Company:	Power and Water Corporation
Incident:	Discharge of sewage from sewerage network

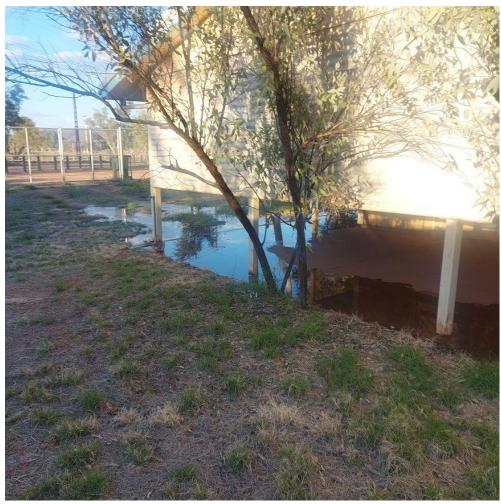
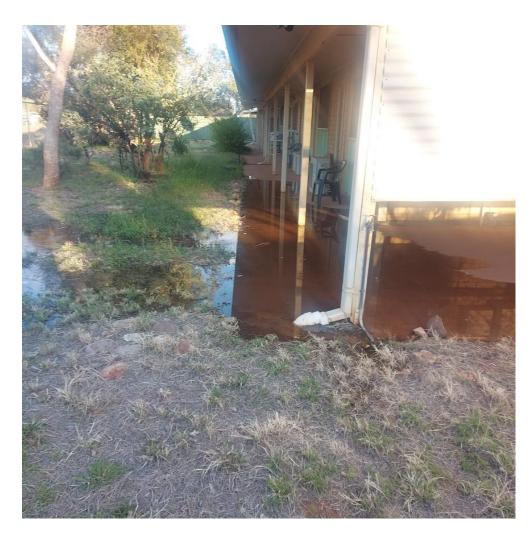
The discharge occurred from an overflow relief gully (ORG), which is not a Power and Water asset. The cause was from a blocked sewer main which is the Power and Water owned asset.

It is believed that shirts or rags were the foreign material that caused a blockage of the sewer main approximately 100 meters downstream of the units, which then caused sewage to build up within the sewer line and eventually overflow from the units ORG.						
	iv. The reason why the discharge occurred.						
	As per (c) iii, Sewerage network infrastructure has been designed to overflow with the best public health and environmental outcomes possible. Design focuses on not overflowing directly inside houses; rather discharge is designed to occur in a controlled manner at locations which can be accessed for infrastructure repair and clean up and with minimal public health or environmental impacts.

Figures 1 & 2 – Site of the overflow. Source: Hermannsburg USCW.

(d) how the pollution has occurred, is occurring or may occur	As per (c) iii & (c) iv.						
(e) the attempts made to	i. Confirmation signage and fencing has been erected, as appropriate.						
prevent, reduce, control, rectify or clean up the pollution or resultant environmental harm caused or threatening to be caused by the incident	Additional fencing was not required in this instance as the property is already surrounded by a 1.8 meter high chain mesh fence. A warning sign with pictograms will be erected today to warn other member of the community.						
	ii. Decontamination of the site as appropriate.						
	Clean up consistent with Sewage Spills/Overflow Response Work Instruction as appropriate to the location, and to minimise risk to the Environment. Blockage was cleared and upon resolution of the blockage, the site was left in a clean state, free from any gross pollutants and the surrounding surface was cleaned and disinfected.
