SECTION 14 INCIDENT REPORT (Waste Management and Pollution Control Act)

Date and Time of Notification:	Friday 22 nd March 2024, 16:00hrs
Person / Company:	Power and Water Corporation
Incident:	Discharge of sewage effluent from the Yarralin sewage pumping station

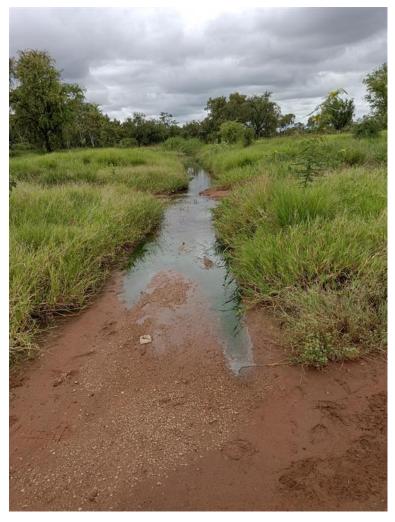
i. Description of the waste that was discharged. Raw, partially diluted sewage effluent
Raw partially diluted sewage effluent
rtaw, partially diluted sewage efficient
ii. Indicative wastewater quality for the discharge.
No representative or recent wastewater quality results are available, because this community's facility does not have a waste discharge licence, hence wastewater quality monitoring does not occur on a regular basis.
iii. Volume of the waste that was discharged.
The volume of wastewater discharged is unknown, no telemetric monitoring occurs in this location.

Appendix B – Location Photograph – showing extent of discharge

Access by the public to the spill is possible. A flight to Yarralin is scheduled to land tomorrow to deliver temporary fencing to prevent the possibility of pedestrian access.

(d) how the pollution has occurred, is occurring or may occur	As per (c) iii & (c) iv.
(e) the attempts made to	i. Confirmation signage and fencing has been erected, as appropriate.
prevent, reduce, control, rectify or clean up the pollution or resultant environmental harm caused or threatening to be caused	Barricading will be erected once it arrives at the community, which is scheduled to occur tomorrow via a chartered flight. This will prevent or reduce the possibility of the public making contact with the spill.
by the incident	ii. Decontamination of the site as appropriate.
	Clean up consistent with Sewage Spills/Overflow Response Work Instruction as appropriate to the location, and to minimise risk to the Environment. Site will be inspected for any wastewater gross pollutant and cleaned up if found.
