**SECTION 14 INCIDENT REPORT (*Waste Management and Pollution Control Act*)**

<b>Date and Time of Notification:</b>	17/11/25 10.00am
<b>Person / Company:</b>	IOR Pty Ltd
<b>Incident:</b>	Diesel Spill to Ground

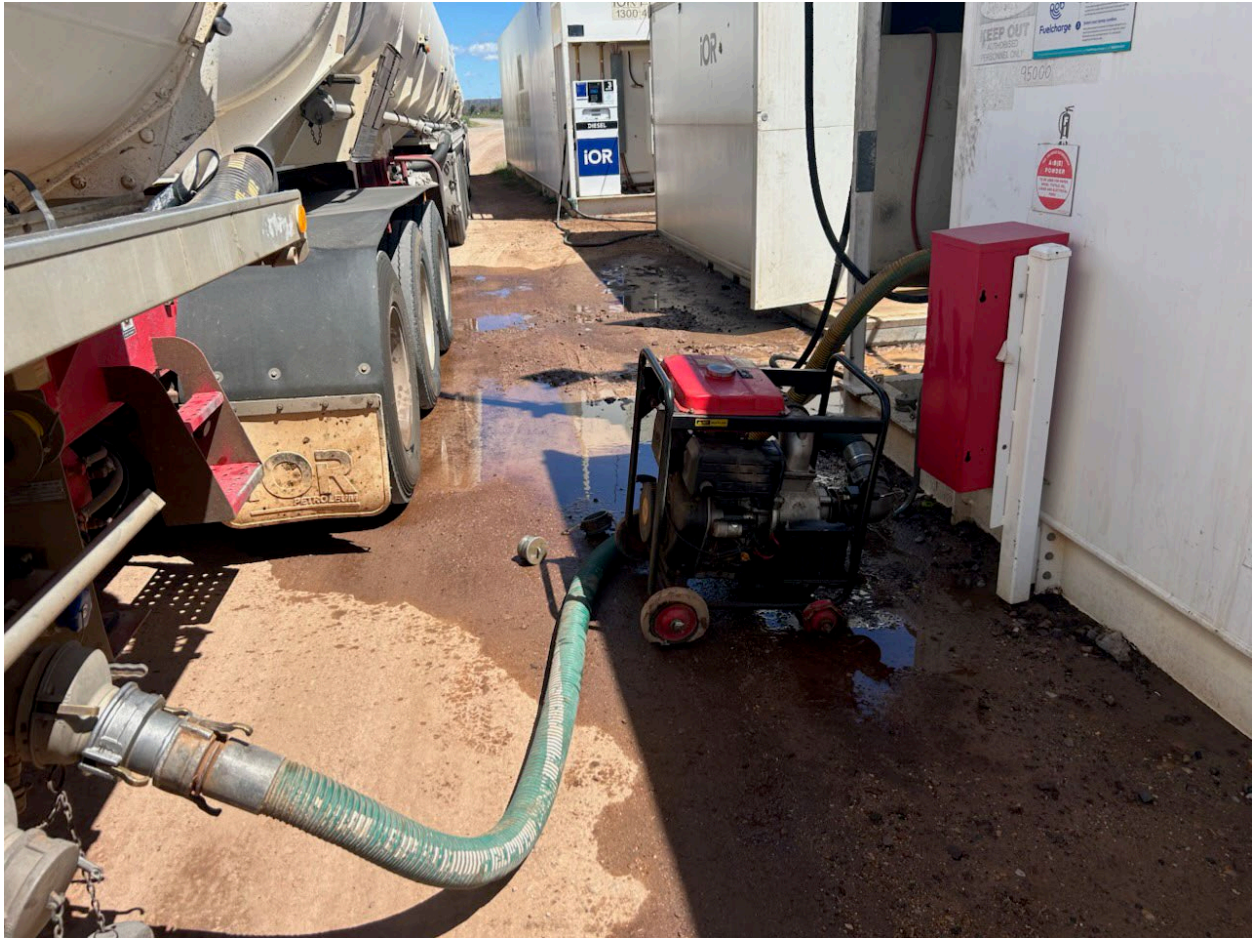
<b>(a) the incident causing or threatening to cause pollution</b>	<b>Soil Contamination – Diesel Spill Approximately 1000 L</b>
<b>(b) the place where the incident occurred</b>	<b>IOR Diesel Stop, Stuart Hwy &amp;, Bohning Rd, Alice Springs NT 0870  -23.835129, 133.835937</b>
<b>(c) the date and time of the incident</b>	<b>10.45am 16/11/25</b>
<b>(d) how the pollution has occurred, is occurring or may occur</b>	<b>During unloading of diesel from truck into the network tank onsite, the pump required a jump start to operate. As the driver was packing up after the jump-start procedure, a hose became disconnected, resulting in a spill and product loss to ground.</b>
<b>(e) the attempts made to prevent, reduce, control, rectify or clean up the pollution or resultant environmental harm caused or threatening to be caused by the incident</b>	<b>Pump turned off, valve closed - IOR Manager and ISS notified - working with a local spill response contractor to assist with immediate clean up, rectification completed and soil removed.  Confirmed all contamination was contained and soil removed by licenced contractor. This has been stockpiled on large containment tarps onsite for hydrocarbon testing, then confirmation of disposal &amp; records to follow.</b>

Picture above: site at time of spill on 16/11/25

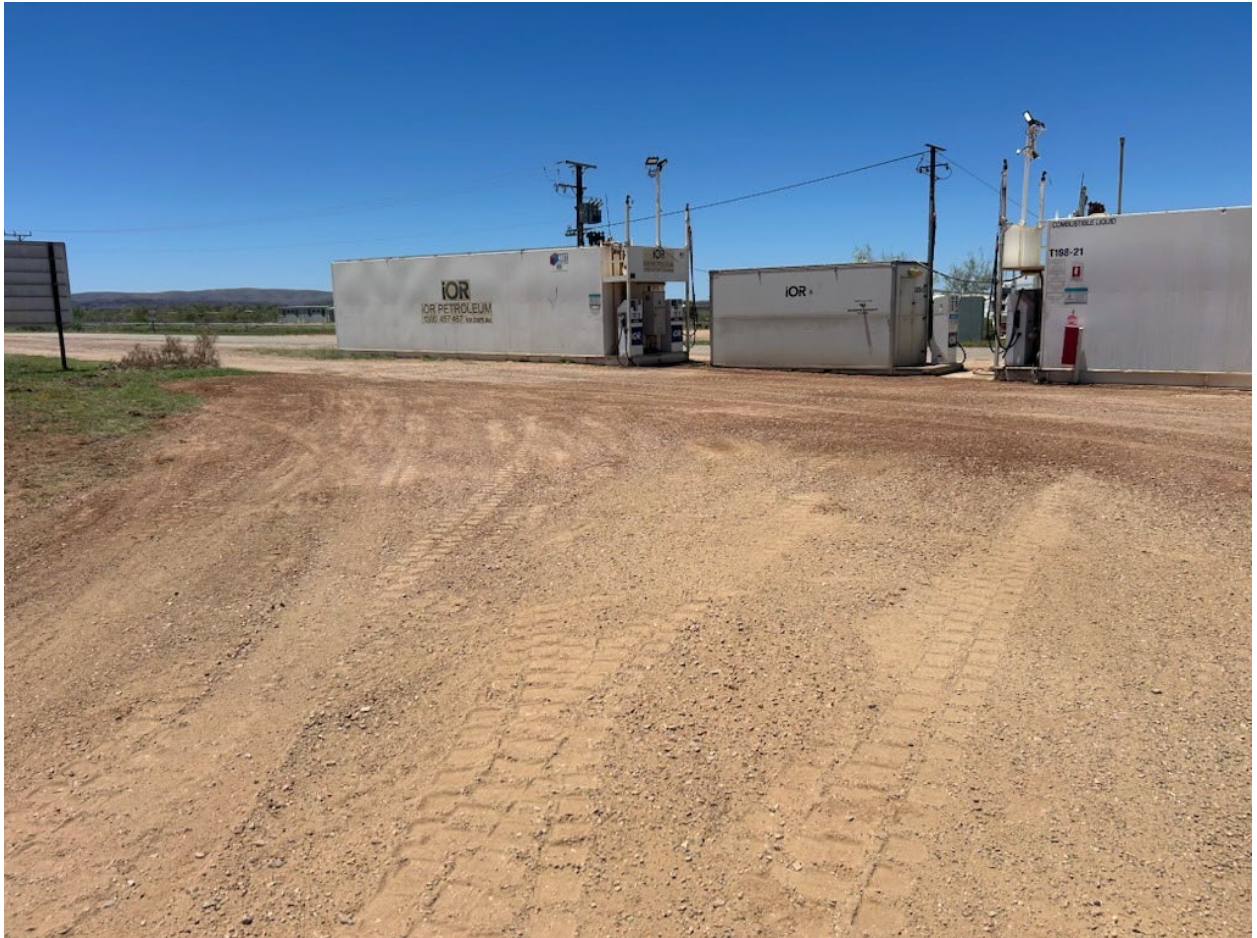
Picture above: Site on 17/11/25 after soil remediation
