## SECTION 14 INCIDENT REPORT (*Waste Management and Pollution Control Act*)

| <b>Incident:</b> | Discharge of highly diluted sewage effluent at Gregory Street, Parap |

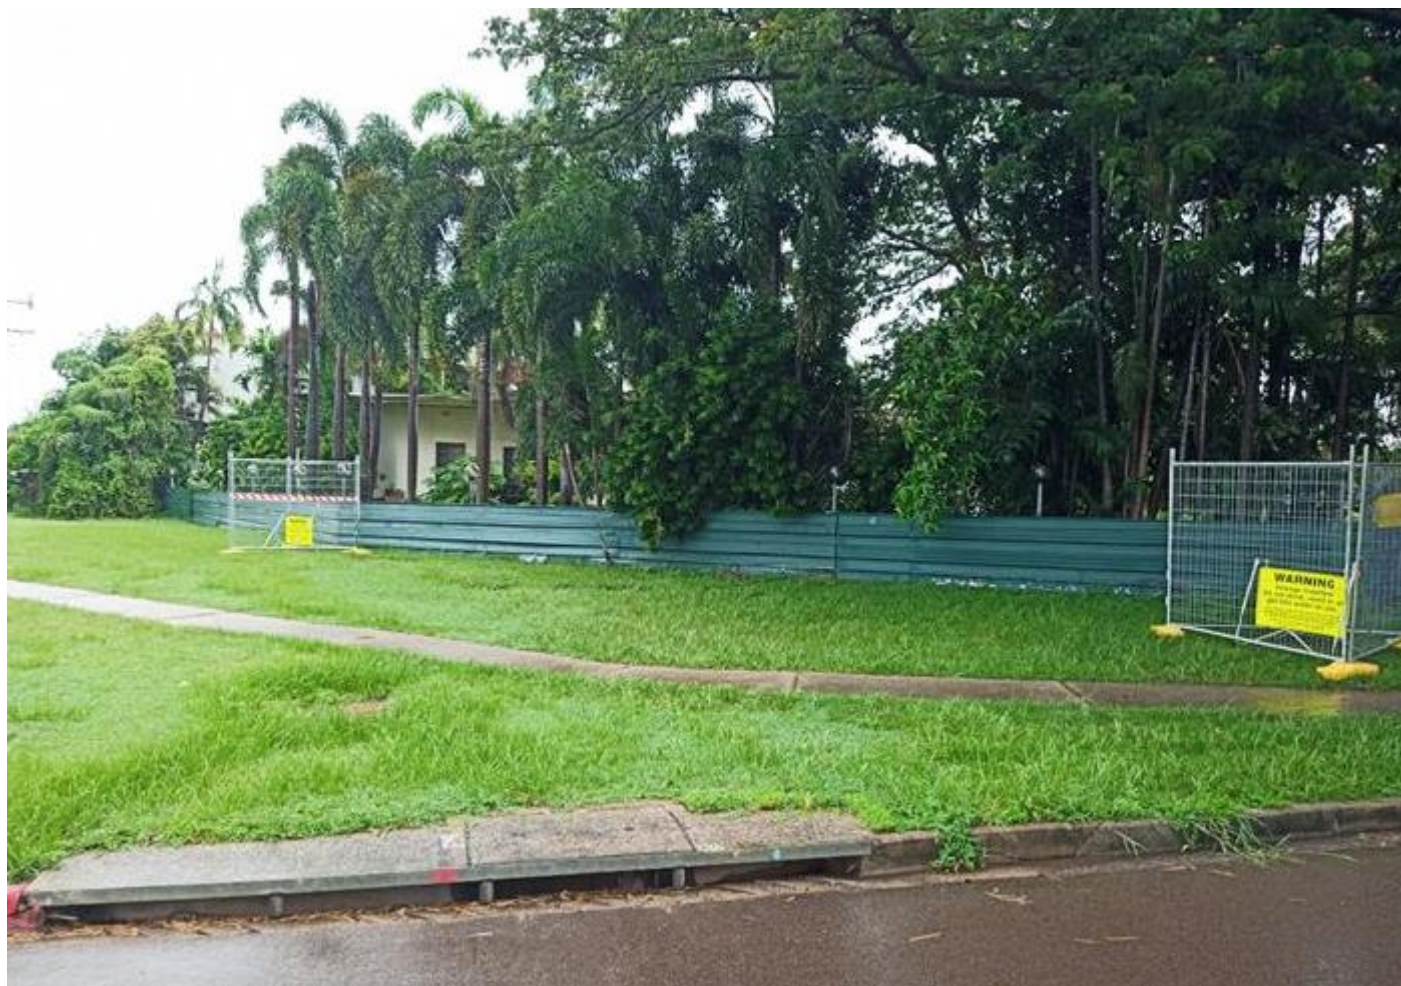
| | <p>1. Two access chambers on cnr Gregory St/East Point Rd:<br/>Discharge Point: -12.4320022 S, 130.8378083 E<br/>and -12.4321384 S, 130.8379457 E<br/>Final Discharge Point: 12.4316500 S, 130.8362400 E</p> <p><i>iii. Indicate any locations nearby to the discharge point where public can gain ready-access, such as public open spaces through which the discharge moves.</i></p> <p>Public access was possible to the overflow relief point discharge location, although due to the wet weather conditions at the time, the likelihood of people visiting these areas was low. Overflow of the diluted sewage ends up in Vestys Lagoon which is part of a public recreation area.</p> |

*Indicative photo of the fenced access chambers on the corner of Gregory Street and East Point Road. Historical photo from 2021.*
