SECTION 14 INCIDENT REPORT (*Waste Management and Pollution Control Act*)

Date and Time of Notification:	Friday 1 st November 2019, 14:31pm
Person / Company:	Power and Water Corporation (PWC)
Incident:	Discharge of raw sewage from sewerage network (Manhole)

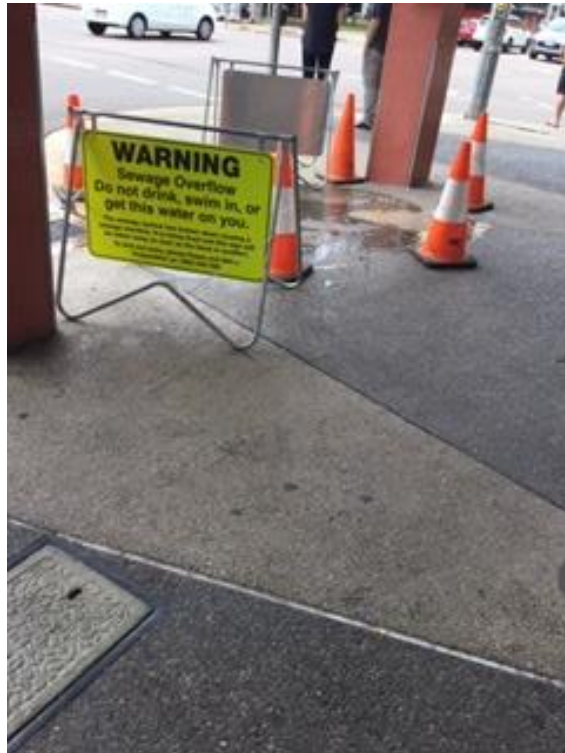
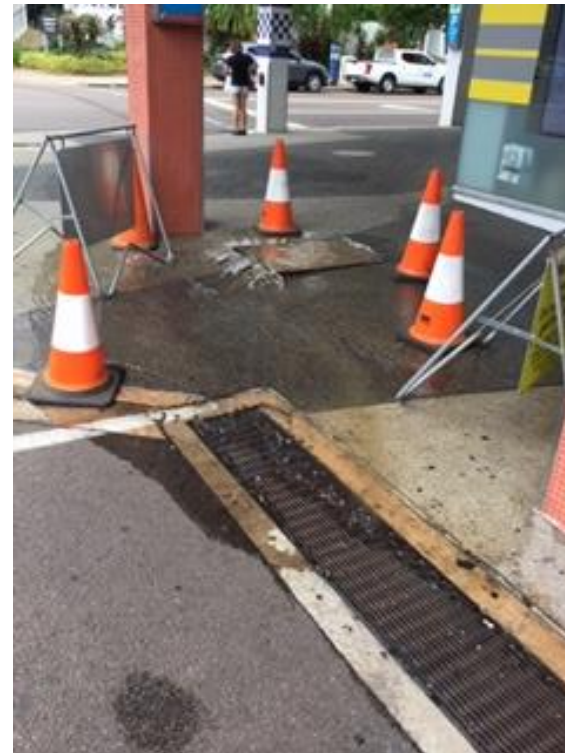
Pre-Clean-up:

(d) how the pollution has occurred, is occurring or may occur	As per (c) iii & (c) iv.
(e) the attempts made to	The blockage was cleared and the overflow was stopped. Clean up

<p>prevent, reduce, control, rectify or clean up the pollution or resultant environmental harm caused or threatening to be caused by the incident</p>	<p>undertaken as per Sewage Spills/Overflow Response Work Instruction.</p> <p><i>i. Confirmation signage and fencing has been erected, as appropriate.</i></p> <p>Upon PWC crew attending the overflow the site was cordoned off with wickets hats which were supervised by PWC staff to prevent access by the public. Upon resolution of the blockage the area was cleaned comprehensively to ensure the area was safe for the public to access immediately. Due to the location temporary fencing was not appropriate. Therefore cleaning undertaken was performed to ensure access by the public immediately after resolution of the blockage was safe.</p> <p><i>ii. Decontamination of the site as appropriate.</i></p> <p>Clean up consistent with Sewage Spills/Overflow Response Work Instruction as appropriate to the location, and to minimise risk to the environment. Vacuum truck was used to remove the wastewater from the manhole, followed by cleaning of the surrounding surface.</p>

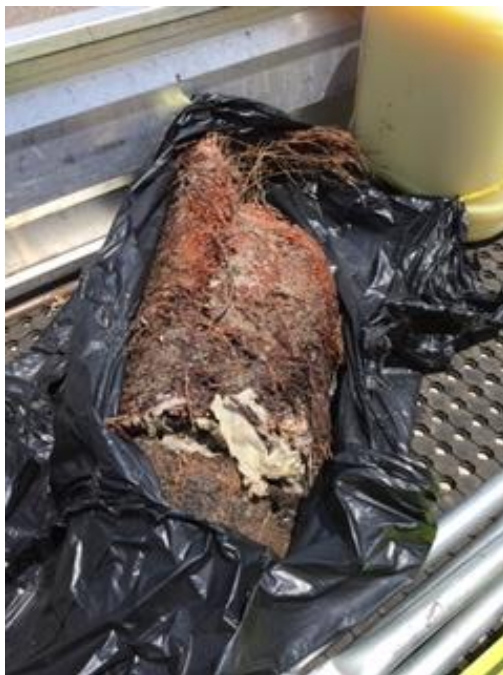
Tree Root Removed
