SECTION 14 INCIDENT REPORT (*Waste Management and Pollution Control Act*)

Date and Time of Notification:	7 February 2020 16:30 Initial notification (phone) – 6 February 2020 11:00
Person / Company:	McArthur River Mining Pty Ltd
Incident:	Spillage of bulk zinc-lead concentrate dust from the rear trailer of a road train on the Carpentaria Highway.

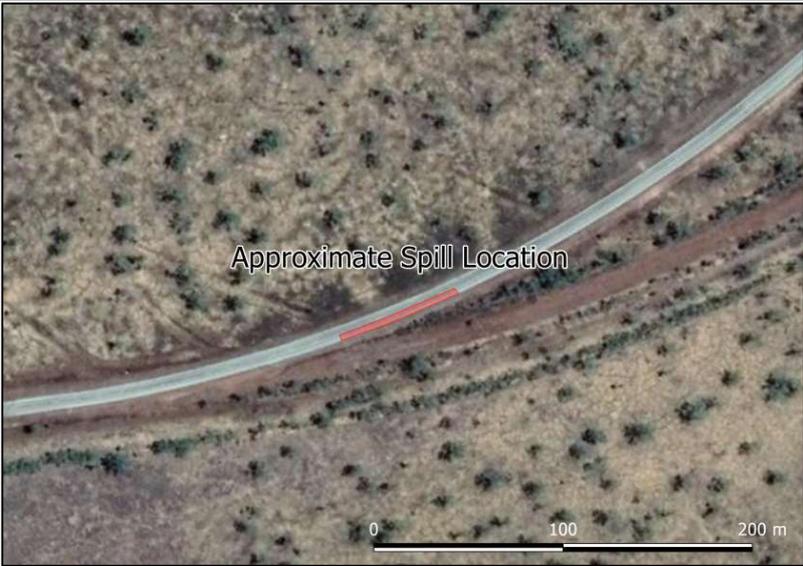
(b) the place where the incident occurred	<p>The spill occurred at two locations on the Carpentaria Highway in close proximity, between the McArthur River Mine (the Mine) and the Bing Bong Loading Facility (Figure 1). These locations have been combined as one spill area of approximately 240 square metres for the purposes of the investigation and post-spill remediation (see Figure 2).</p> <div data-bbox="596 1171 1353 1697" data-label="Image"> </div> <p style="text-align: center;"><i>Figure 1 – Approximate Spill Location</i></p>

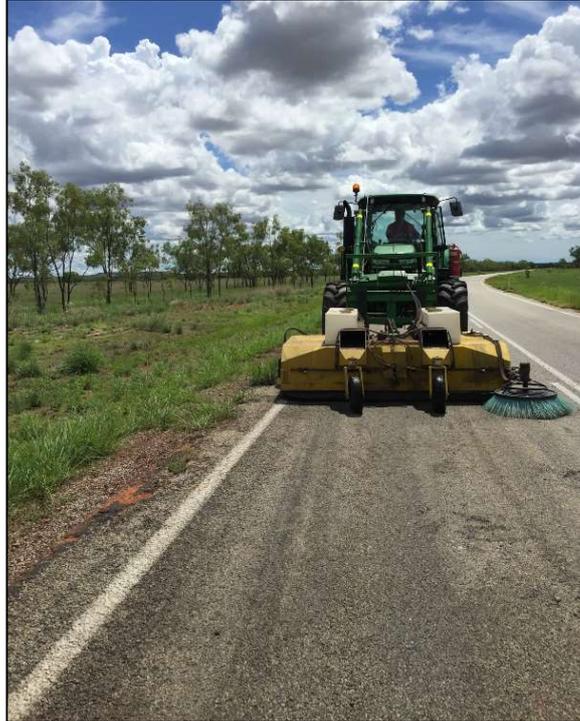
(a) the incident causing or threatening to cause pollution	Approximately 20 kg of bulk zinc-lead concentrate from the rear trailer of a road train was released on the Carpentaria Highway over an area of 240 square metres (65 metres length by 3.7 metres width).

Figure 3 – Concentrate spill site during the clean-up.

<p>(e) the attempts made to prevent, reduce, control, rectify or clean up the pollution or resultant environmental harm caused or threatening to be caused by the incident</p>	<p>At 17:30 on 5 February 2020, McArthur River Mining (MRM) received communication from a local community member that a potential zinc-lead concentrate spill had occurred. Immediately after receiving the communication the length of the road was inspected by MRM staff to identify any signs of potential spillage.</p> <p>At 18:00, a road sweeper was deployed to clean-up the spill material from the road and roadside.</p> <p>At 20:30, rainfall was experienced in the region. At this time, the initial clean-up had been completed and majority of concentrate removed from the road.</p> <p>At 06:00 on 6 February 2020, inspection and clean-up works resumed. This included the use of the road sweeper to remove any residual material for transport back to the Mine. MRM Emergency Response Team provided traffic control for the duration of the clean-up works.</p> <p>MRM Environment staff re-inspected the length of the road to determine any sensitive receptors or surface water areas, collecting GPS locations and helping direct the clean-up activities as required.</p> <p>Validation Assessment</p> <p>MRM have undertaken validation sampling of the potentially impacted areas in accordance with Schedule B2 of the National Environment Protection (Assessment of Site Contamination) Measure 1999 (NEPM, 1999). Once received, the laboratory results will determine whether the post-spill remediation was successful and will include control and impact samples for soil on the roadside and surface water for the runoff drain adjacent to the road.</p> <p>The following samples are proposed to be collected and analysed (Figure 5):</p> <ul style="list-style-type: none"> • Five soil samples comprised of the following: <ul style="list-style-type: none"> ○ Three impact sites (SS1 to SS3); ○ Two control sites (CS1 and CS2); and • Three surface water and soil samples (WS1 to WS3) within the roadside runoff drain to determine whether this area has been impacted by any runoff from the incident area. <p>All samples will be analysed for relevant contaminants of potential concern (i.e. zinc and lead) and results will be compared against relevant NEPM (1999) guidelines to confirm whether remediation works have been successful and if further remediation is required. Impact site samples will also be compared with control samples to inform the effectiveness of clean-up.</p>

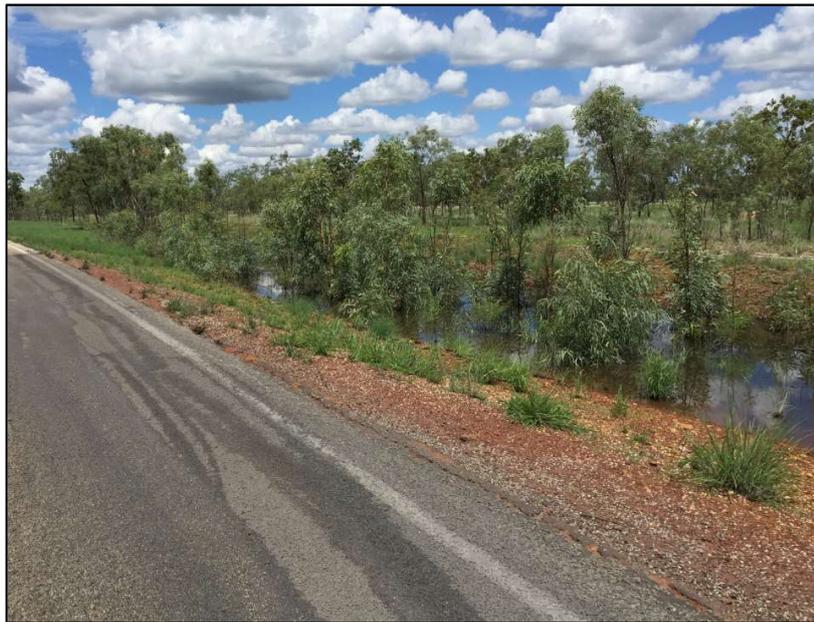
Figure 4 – Roadside runoff drain.

The potential for environmental impact is considered to be low due to the small volume of zinc-lead concentrate released and the immediate remedial response, as outlined further below.

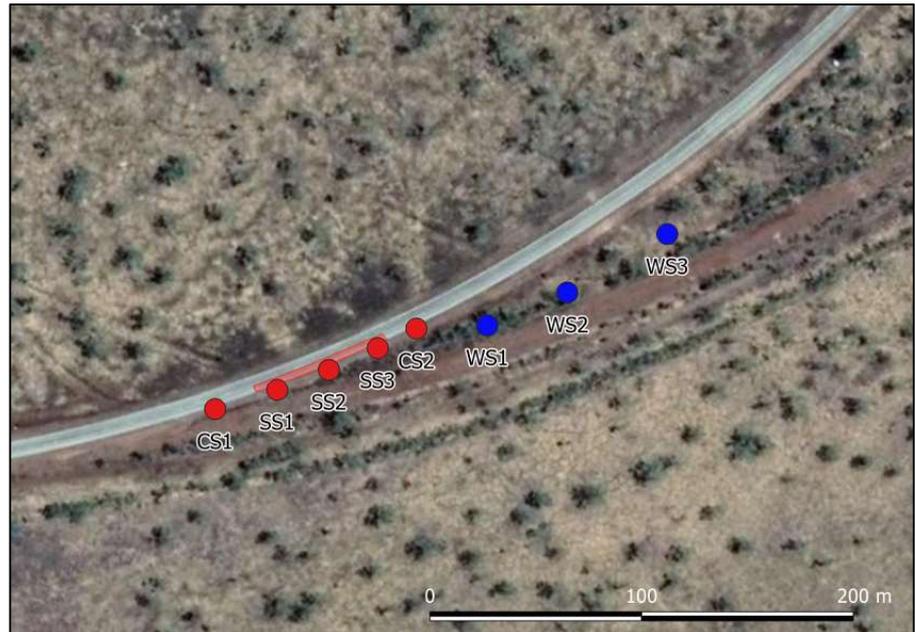
Figure 5 – Proposed sample locations.

MRM are in contact with members of the local community to determine if they witnessed the incident. Although no additional locations could be identified on the highway from multiple visual surveys, a conservative approach will be followed by MRM and any additional areas identified by community members will be added to the validation sampling program. Sampling for these additional areas will be carried out in accordance with Schedule B2 of NEPM (1999), and remediation will be completed if required.
