**SECTION 14 INCIDENT REPORT (*Waste Management and Pollution Control Act*)**

<b>Date and Time of Notification:</b>	Friday 15 <sup>th</sup> January 2021, 10:50hrs V2.0 17/01/21 V3.0 20/01/21
<b>Person / Company:</b>	Power and Water Corporation ( <b>PWC</b> )
<b>Incident:</b>	Discharge of highly diluted sewage from sewerage network due to wet weather

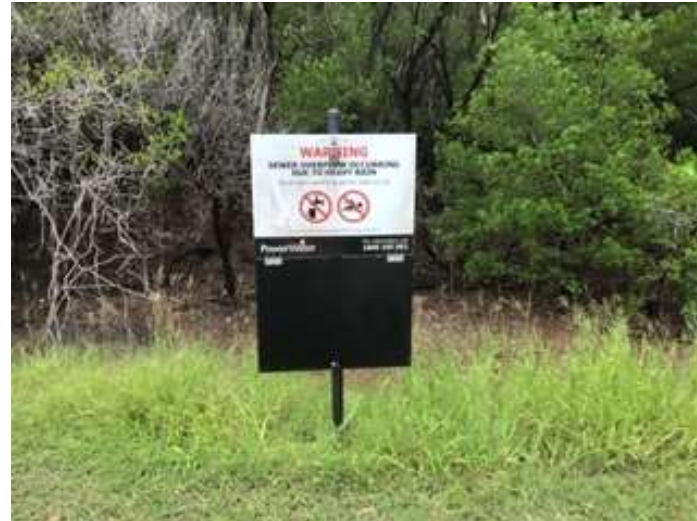
Corner of Trower Road and Rapid Creek Road, Rapid Creek - Sewer overflow relief point – Photo – Warning Sign

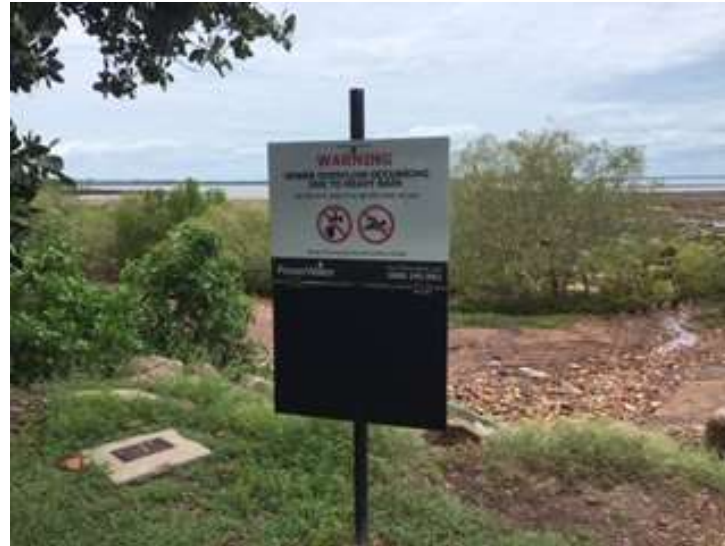
194 Casuarina Drive, Nightcliff (Aralia St, Jetty End) – Photo Warning Sign

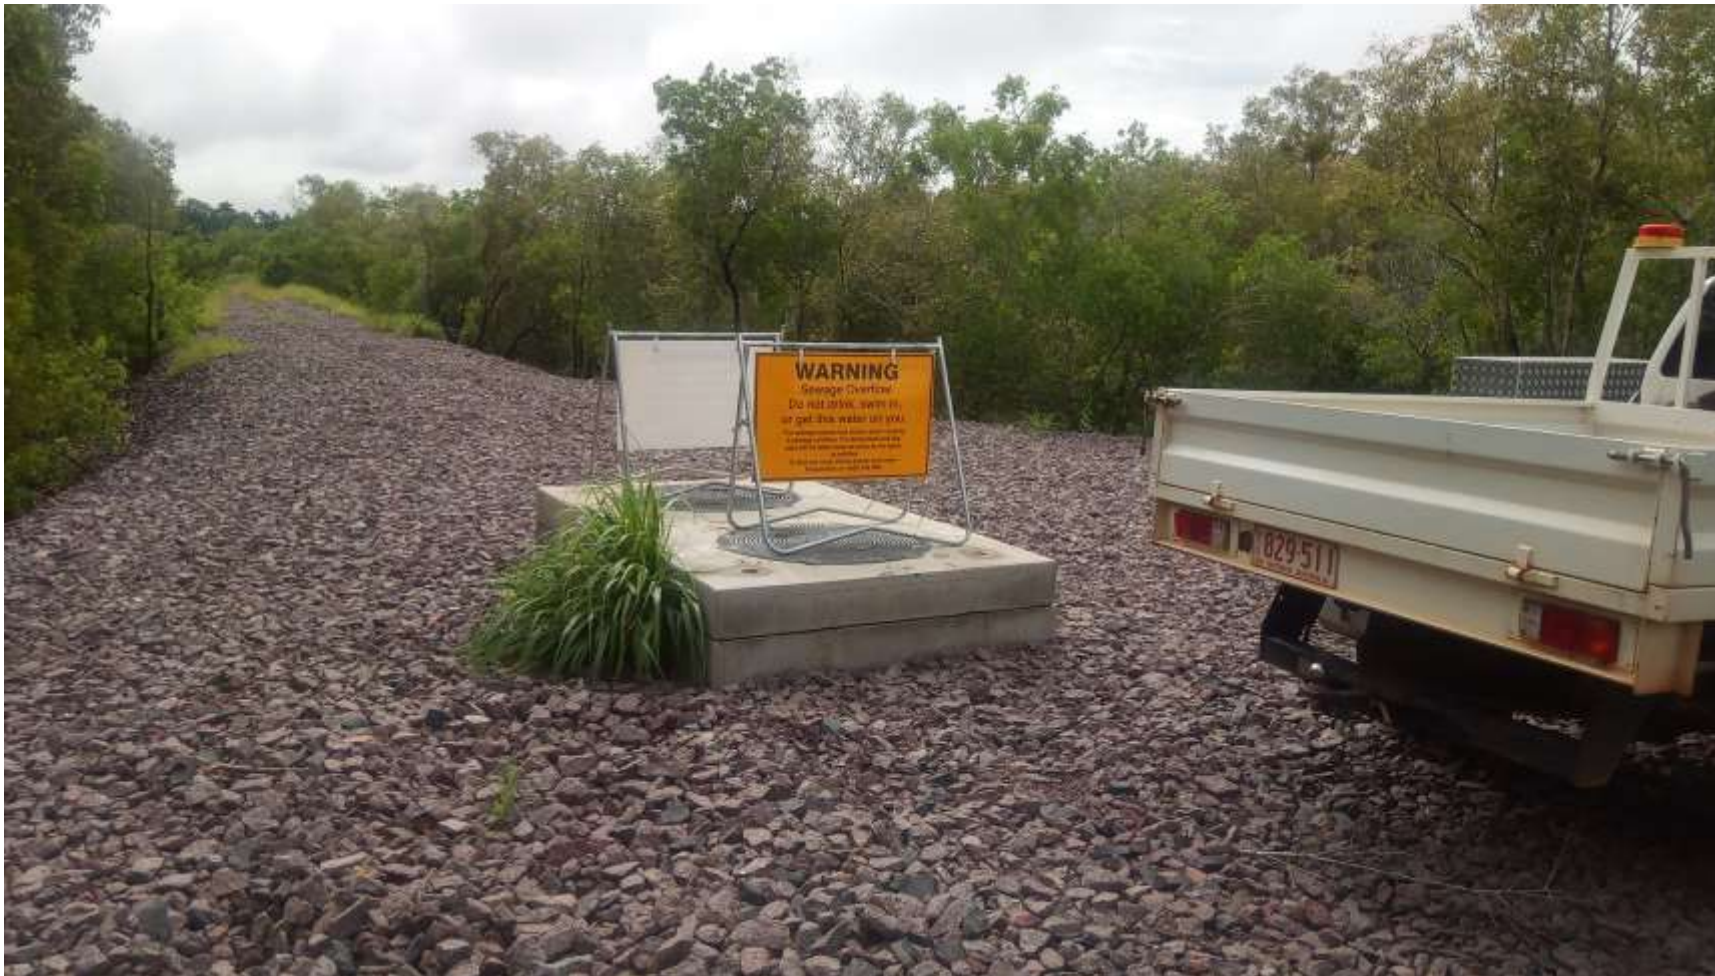
Lakeside Drive and Rapid Creek Road SPS Photo – Warning Signs

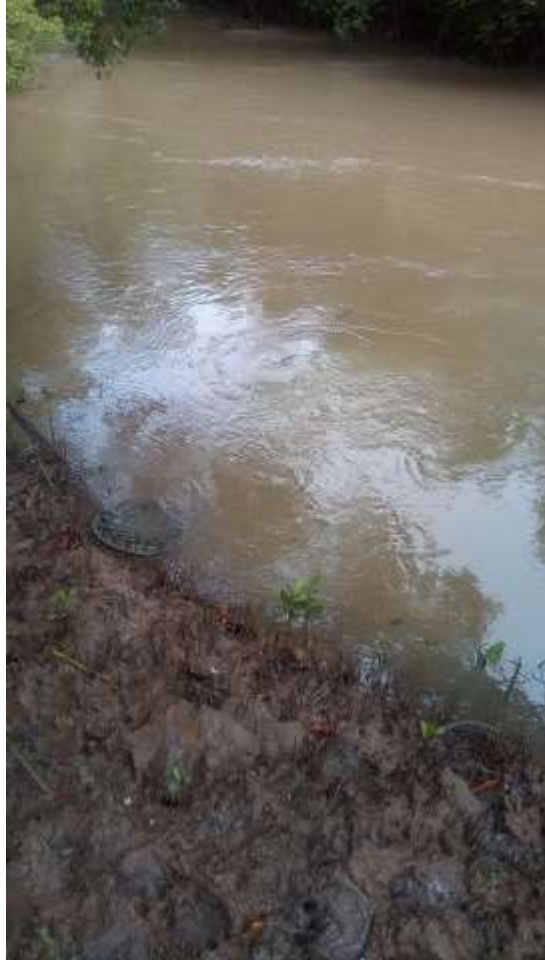
Lakeside Drive and Rapid Creek Road SPS Photo – Discharge Point within swollen creek
