## SECTION 14 INCIDENT REPORT (*Waste Management and Pollution Control Act*)

<b>Date and Time of Notification:</b>	Tuesday 16 <sup>th</sup> February 2021, 12:48hrs
<b>Person / Company:</b>	Power and Water Corporation ( <b>PWC</b> )
<b>Incident:</b>	Discharge of raw sewage from sewerage network (no gross pollutants)

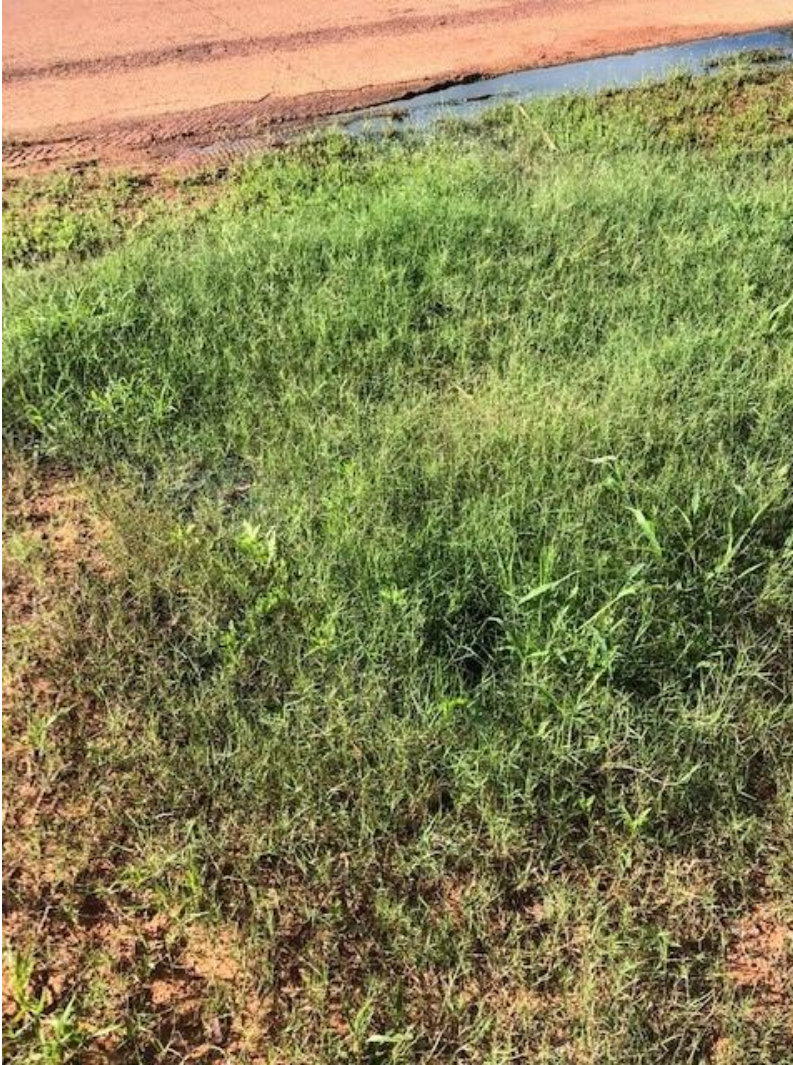
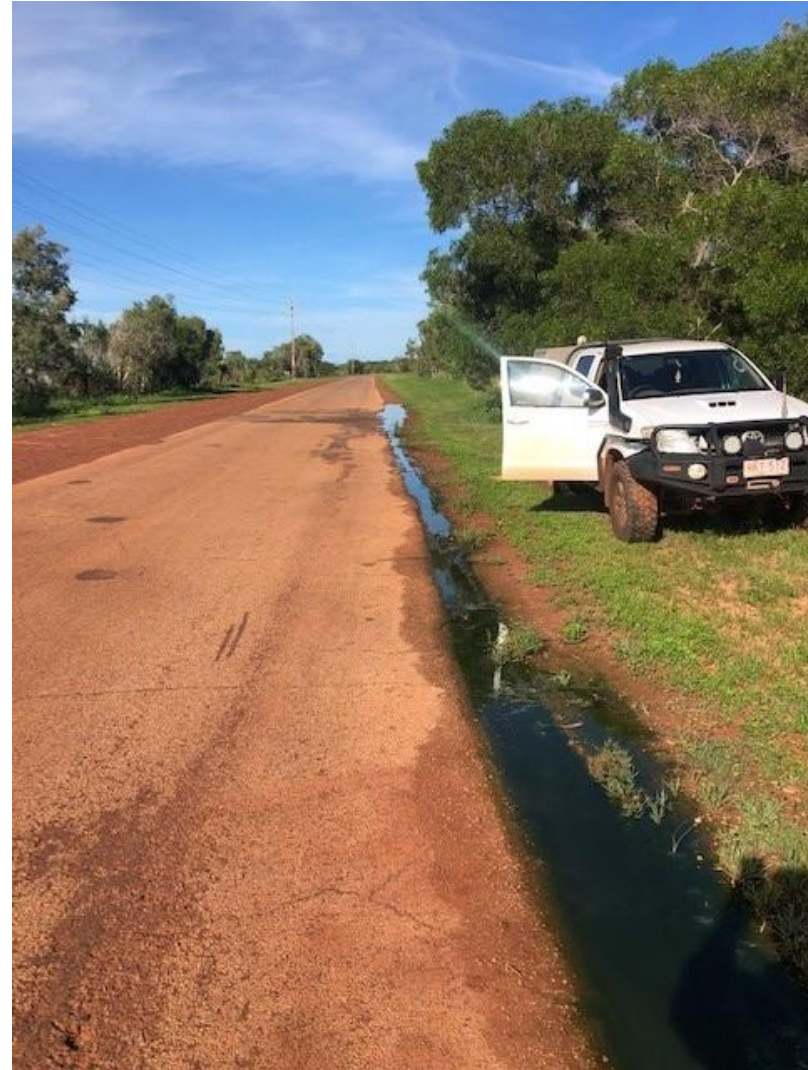
Appendix B – Photographs of the discharge location

<p><b>(a) the incident causing or threatening to cause pollution</b></p>	<p><i>i. Description of the waste that was discharged.</i></p> <p>Raw sewage (no gross pollutants)</p> <p><i>ii. Indicative wastewater quality for the discharge.</i></p> <p>There is currently no wastewater quality data available for raw sewage from the Numbulwar community; a sample will however be taken on the 17<sup>th</sup> February, as part of the routine monitoring program. Results can be provided once received from the laboratory. Rainfall leading up to the overflow was 1.4mm for the previous 2 days (BOM Weather Stn: 014518 – Groote Eylandt Airport), therefore raw sewage has spilt as a result of the broken sewer rising main.</p> <p><i>iii. Volume of the waste that was discharged.</i></p> <p>The volume of waste discharged is unknown. No telemetric monitoring occurs at the site of discharge. The area affected by the spill covered an area of approximately 20 square meters and pooled on the side of the road, it did not travel to any drainage lines.</p>

<p><b>(b) the place where the incident occurred</b></p>	<p><i>i. Description of the PWC asset from which the discharge occurred.</i></p> <p>150mm diameter PVC sewer rising main that runs between sewage pumping station #1 and the Numbulwar waste stabilisation ponds.</p> <p><i>ii. GPS coordinates of the discharge point from the PWC asset, and the final coordinates of the final discharge point.</i></p> <p>Approximate Discharge Point:        135.7373798E, 14.2811214S          Approximate final discharge point:    135.7372351E, 14.2811872S</p> <p><i>iii. Indicate any locations nearby to the discharge point where public can gain ready-access, such as public open spaces through which the discharge moves.</i></p> <p>The discharge occurred adjacent to the community access road, which the public has access to, however signage has been erected, to warn members of the community of the spill.</p>

<p><b>(c) the date and time of the incident</b></p>	<p><i>i. The time and date of commencement and cessation of the discharge.</i> The commencement time of the spill is unknown. The spill was first observed around 08:00hrs on the 16<sup>th</sup> February 2021 by the Essential Services Operator (ESO). The spill was stopped by temporarily turning off the sewage pumping station, excavating around the spill site and repairing the broken pipe. This work was completed around 12:30hrs 16/02/2021.</p> <p><i>ii. How PWC were notified, or became aware of the discharge.</i> The Essential Services Operator (ESO) noticed the spill on the side of the road on the morning of the 16<sup>th</sup> February 2021 and then notified the PWC Coordinator.</p> <p><i>iii. The process by which the discharge occurred.</i> The sewer rising main has deteriorated over time since installation, and under the pressure of the sewage pumping station, the pipe gave way.</p> <p><i>iv. The reason why the discharge occurred.</i> As per (c) iii. The age of the infrastructure has caused the PVC pipework to become brittle, and with the additional pressure of the sewage pumping station #1, has caused the pipework to fail.</p>

<p><b>(d) how the pollution has occurred, is occurring or may occur</b></p>	<p>As per (c) iii &amp; (c) iv.</p>
<p><b>(e) the attempts made to prevent, reduce, control, rectify or clean up the pollution or resultant environmental harm caused or threatening to be caused by the incident</b></p>	<p><i>i. Confirmation signage and fencing has been erected, as appropriate.</i> Warning signage consisted of two “men at work” signs and safety bollards, which were erected shortly after noticing the spill. No other, more suitable signage was available at the time.</p> <p><i>ii. Decontamination of the site as appropriate.</i> Clean up undertaken to minimise risk to public health and the environment. Area was inspected for gross pollutants of which none were observed. The area has had chlorine applied to the spill.</p>
<p><b>(f) the identity of the person notifying the NT EPA</b></p>	<p>PWC Environmental Team on behalf of Water Services</p>
