SECTION 14 INCIDENT REPORT (*Waste Management and Pollution Control Act*)

Date and Time of Notification:	Monday 29 th March 2021, approx. 16:00pm
Person / Company:	Power and Water Corporation (PWC)
Incident:	Discharge of raw sewage from sewerage network (Sewer Pumping Station (SPS))

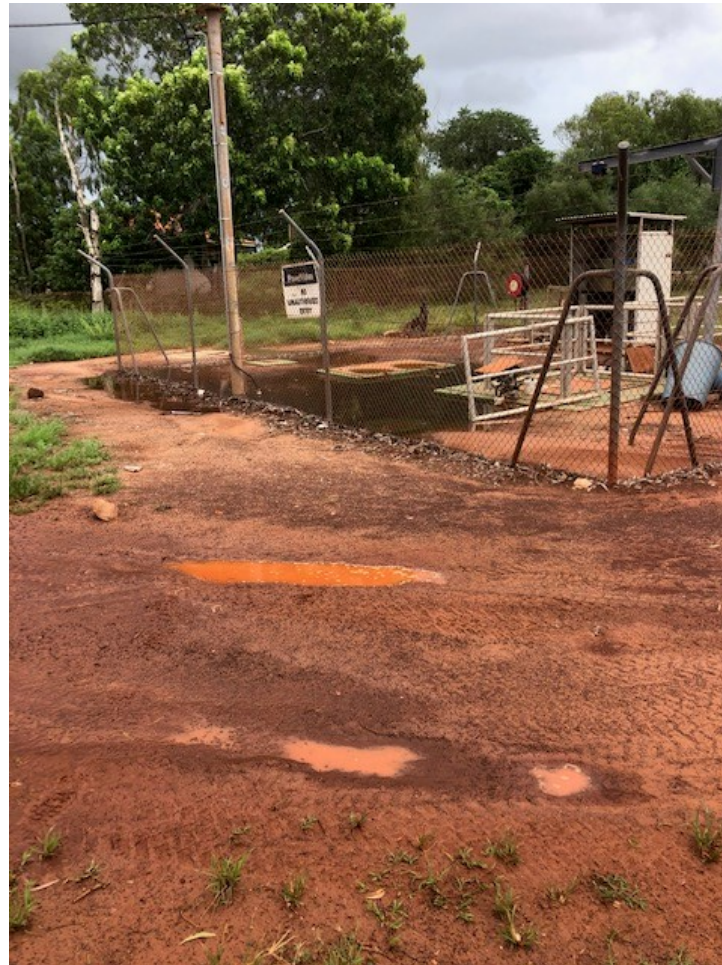
Photo 1 – Prior to Clean-up

<p>occurred this morning (29/03/21) and there is no metered data available for the SPS to determine an exact volume of the overflow.</p> <p>The overflow was resolved shortly (approx. 12:00pm) after attendance to the site by external contractor engaged by PWC.</p> <p>Discharge of raw sewage occurred to land within the SPS compound with some sewage exiting the compound and sitting along the fence-line.</p>

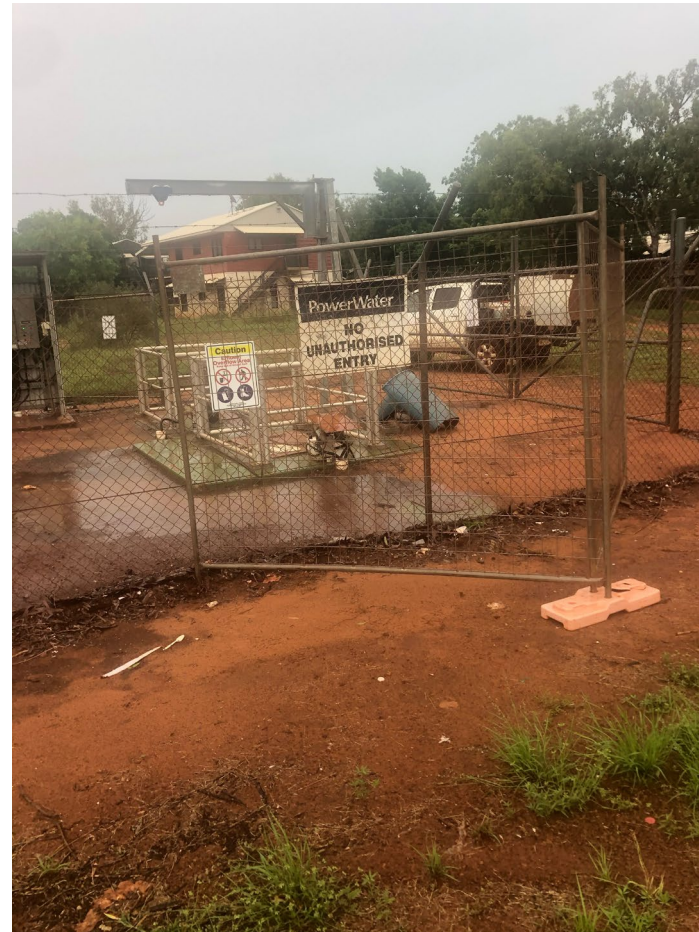
Photo 2 – Post Clean-up

Note: Report that sewage had dried up by 12:00pm upon re-instatment of the SPS. Water present in photo was from recent rain and is not sewage.

(d) how the pollution has occurred, is occurring or may occur	As per (c) iii & (c) iv.
(e) the attempts made to prevent, reduce, control, rectify or clean up the pollution or resultant environmental harm caused or threatening to be caused by the incident	<p><i>i. Confirmation signage and fencing has been erected, as appropriate.</i></p> <p>Upon completion of clean-up of the area, fencing and signage has been installed to prevent access by the public.</p> <p><i>ii. Decontamination of the site as appropriate.</i></p> <p>Clean up undertaken to minimise risk to public health and the environment. Area was inspected for gross pollutants of which none were observed. The area has had chlorine applied to the spill area.</p>
