SECTION 14 INCIDENT REPORT (*Waste Management and Pollution Control Act*)

Date and Time of Notification:	Wednesday 9 th June 2021, 12:45 hrs
Person / Company:	Power and Water Corporation (PWC)
Incident:	Discharge of raw sewage from sewerage network, (sewer manhole cover to roadside stormwater drain)

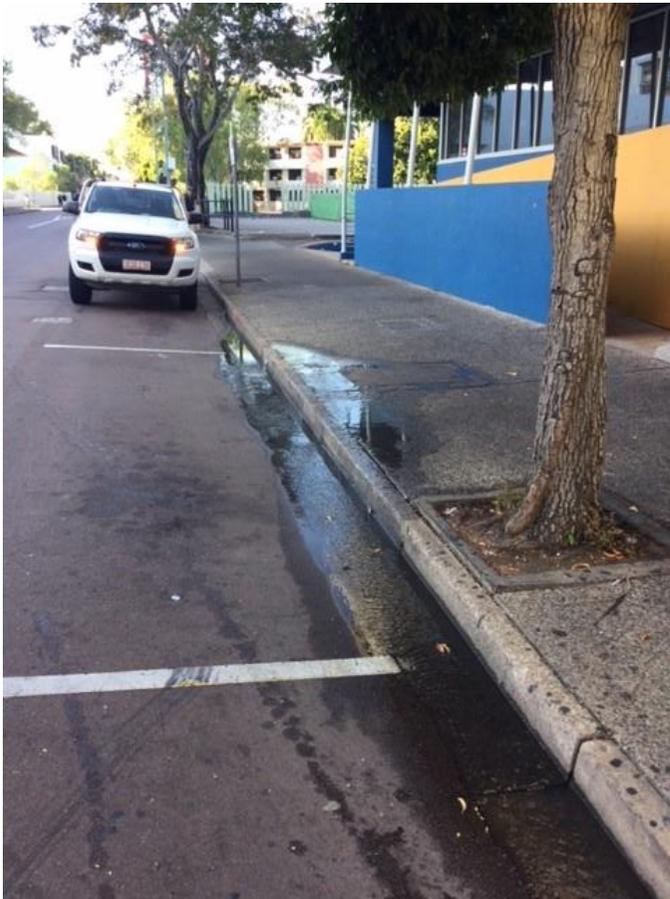
Discharge point – Pre-clean up

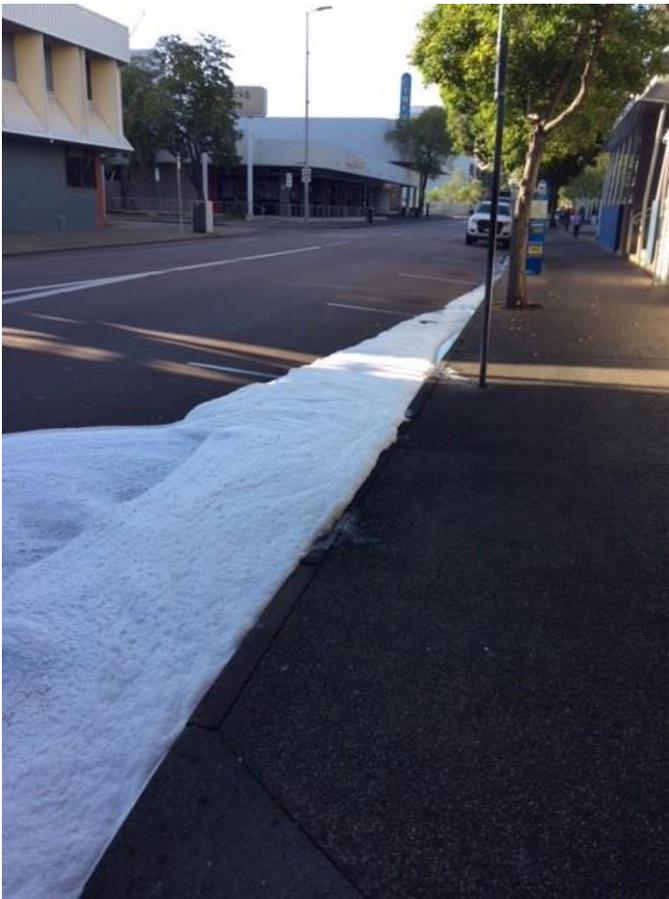
During clean up and disinfection process

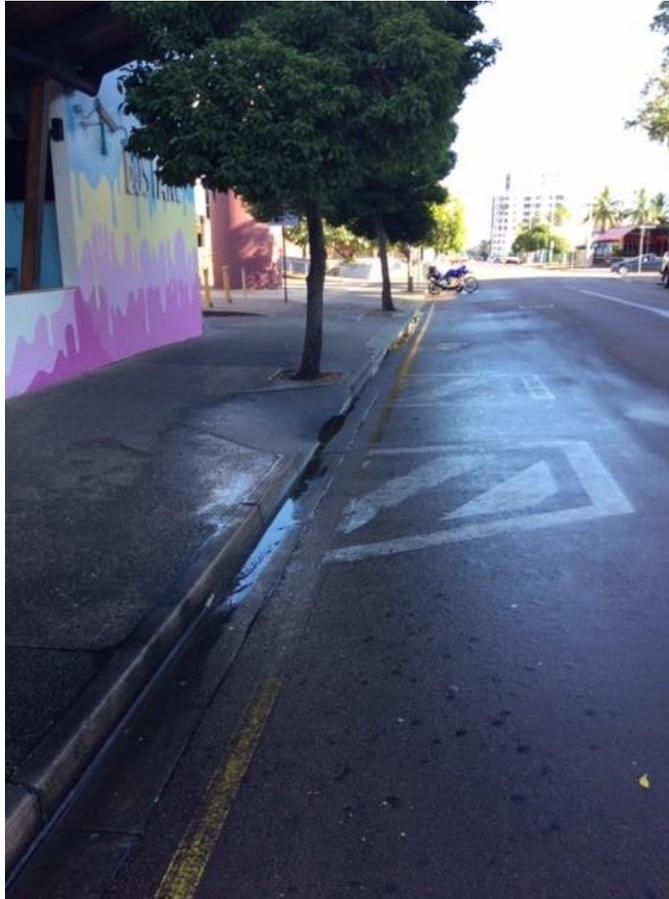
Post clean up
