SECTION 14 INCIDENT REPORT (Waste Management and Pollution Control Act)

Date and Time of Notification:	Thursday 11 th November 2021, 14:36hrs
Person / Company:	Power and Water Corporation (PWC)
Incident:	Discharge of fully treated effluent from Alice Springs Ponds to Ilparpa Swamp

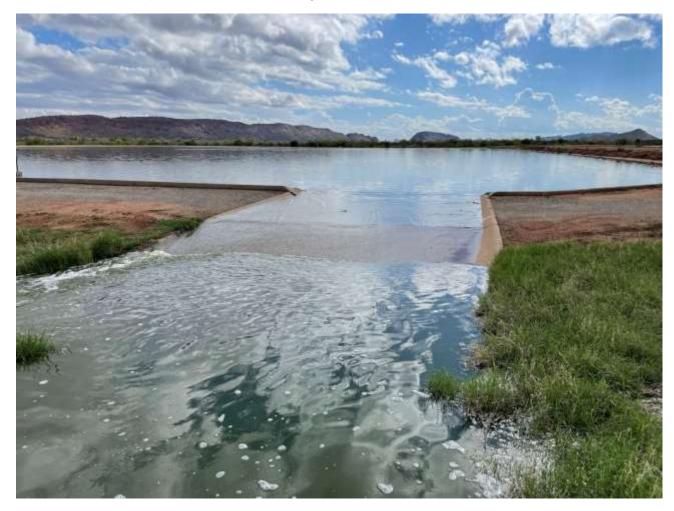
(b) the place where the incident occurred	 i. Description of the PWC asset from which the discharge occurred. Overflow relief point near the outlet of pond C3 (final maturation pond of C set) at the Alice Springs Ponds. 				
	 ii. GPS coordinates of the discharge point from the PWC asset, and the final coordinates of the final discharge point. Photo 1: Discharge Point (Point 1): 133.8321538E, -23.7403845S Photo 2: Final Discharge Point (Point 2): 133.8353127E, -23.7434124S (Stormwater drain) iii. Indicate any locations nearby to the discharge point where public car gain ready-access, such as public open spaces through which the discharge moves. The discharge flow is controlled across PWC land until it then exits at the southern fence line. After which it then flows into the Ilparpa Swamp Access to the waterway is possible, as site is public land. However access to flood water is discouraged by the Northern Territor Government due to drowning risks.

Photo 1: (Point 1 as per Section (b)): Discharge from Pond C3 Taken 16:04hr 10/11/2021

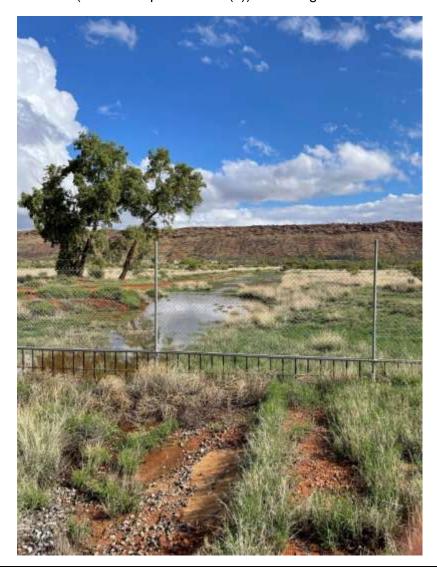
Photo 2: (Point 2 as per Section (b)): Discharge Point to Environment. Taken 16:10hr 10/11/2021
