SECTION 14 INCIDENT REPORT (*Waste Management and Pollution Control Act*)

Date and Time of Notification:	Sunday 15 th January 2023, 14:35hrs
Person / Company:	Power and Water Corporation (PWC)
Incident:	Discharge of sewage from sewerage network (gas trap manhole cover)

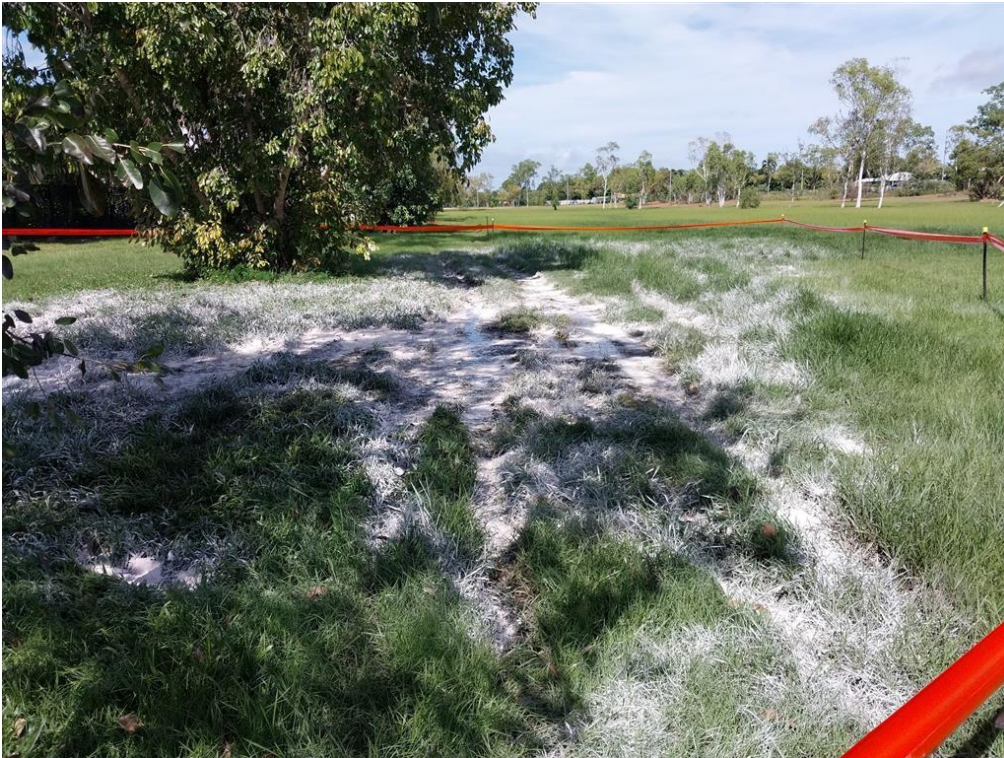
Appendix B – Photographs of the spill area, showing the applied lime, temporary bunting and erected signage.

Figure 1. Photograph of the spill site, taken 15/01/2023.

(d) how the pollution has occurred, is occurring or may occur	As per (c) iii & (c) iv.
(e) the attempts made to prevent, reduce, control, rectify or clean up the pollution or resultant environmental harm caused or threatening to be caused by the incident	<p><i>i. Confirmation signage and fencing has been erected, as appropriate.</i></p> <p>Fencing and signage has been erected around the entire spill area as per the Power and Water Sewage Spills/Overflow Response Work Instruction, refer to photographs in appendix B.</p> <p><i>ii. Decontamination of the site as appropriate.</i></p> <p>Clean up consistent with the Power and Water Sewage Spills/Overflow Response Work Instruction as appropriate to the location, and to minimise risk to the environment. Blockage was cleared and upon resolution of the blockage, the site was left in a clean state, free from any gross pollutants, this was followed by the application of lime to the spill affected area and the entire area was fenced and warning signage was erected.</p>

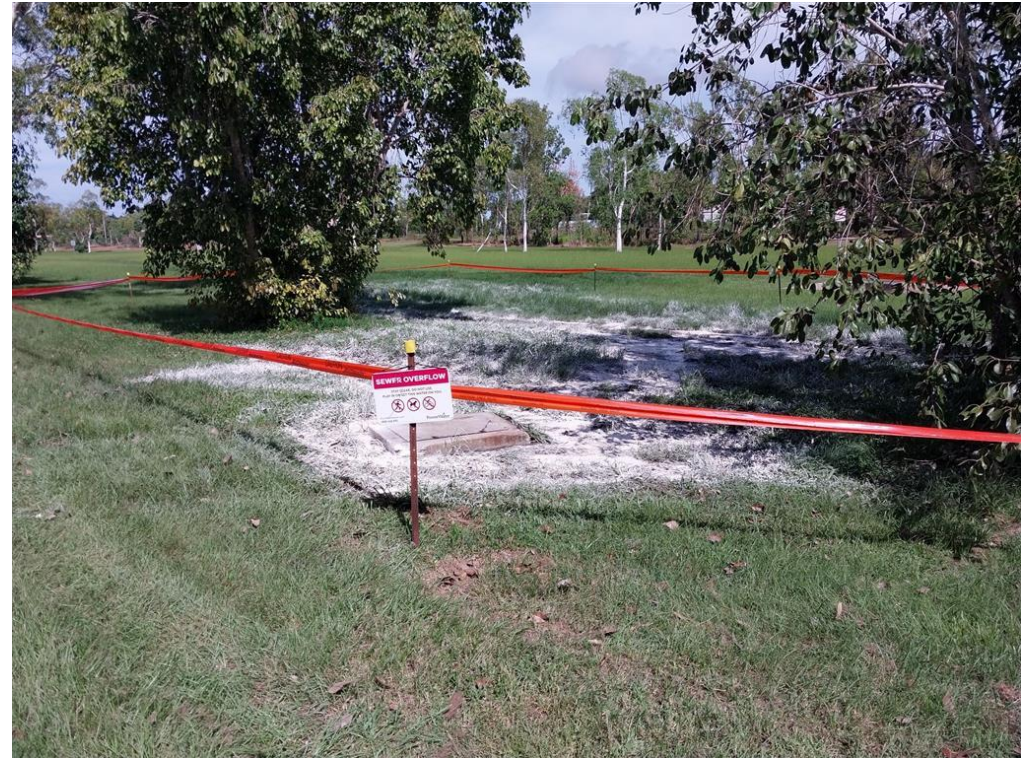
Figure 2. Photograph of the spill site, taken 15/01/2023.
