## INDEPENDENT MONITOR'S AUDIT OF THE MCARTHUR RIVER MINE FOR THE 2010 OPERATIONAL PERIOD

**ENVIRONMENTAL EARTH SCIENCES VIC**  
REPORT TO THE MINISTER FOR PRIMARY INDUSTRY FISHERIES AND  
RESOURCES  
OCTOBER 2011  
VERSION 1

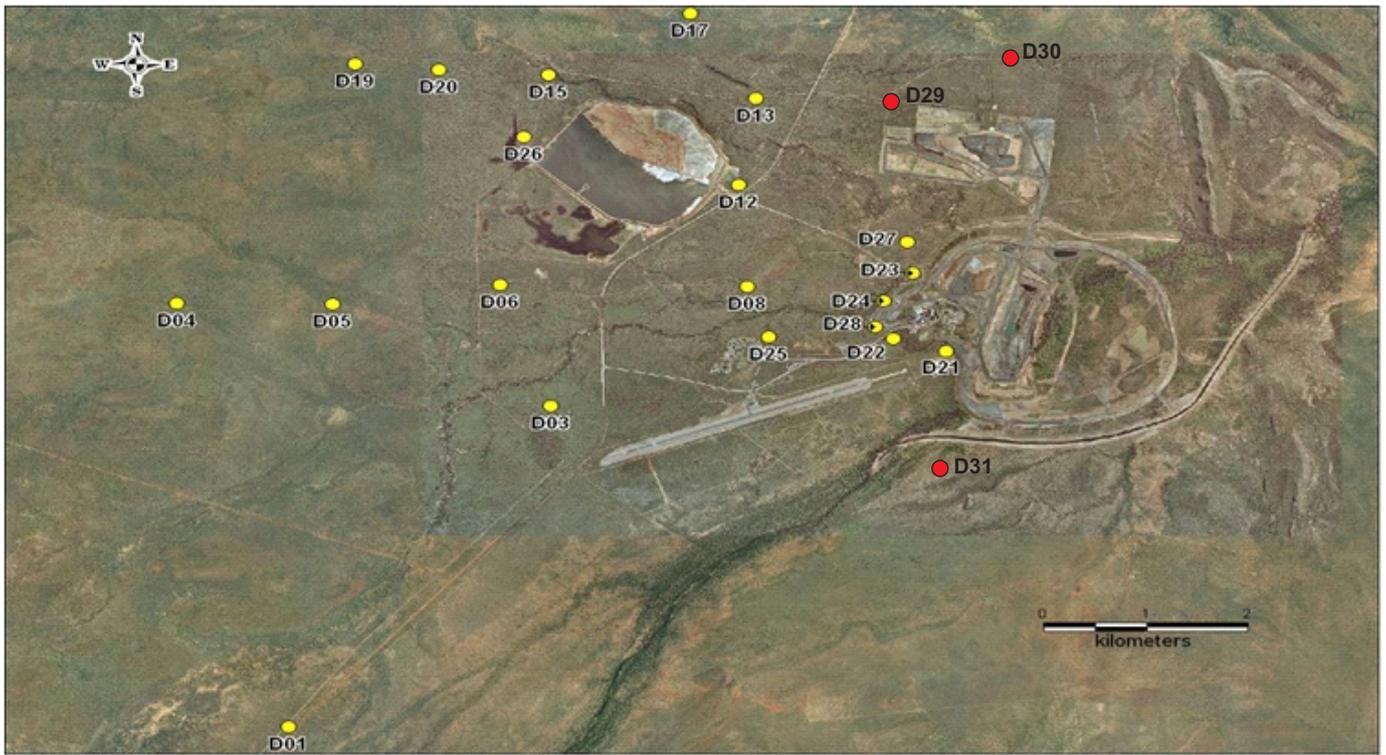
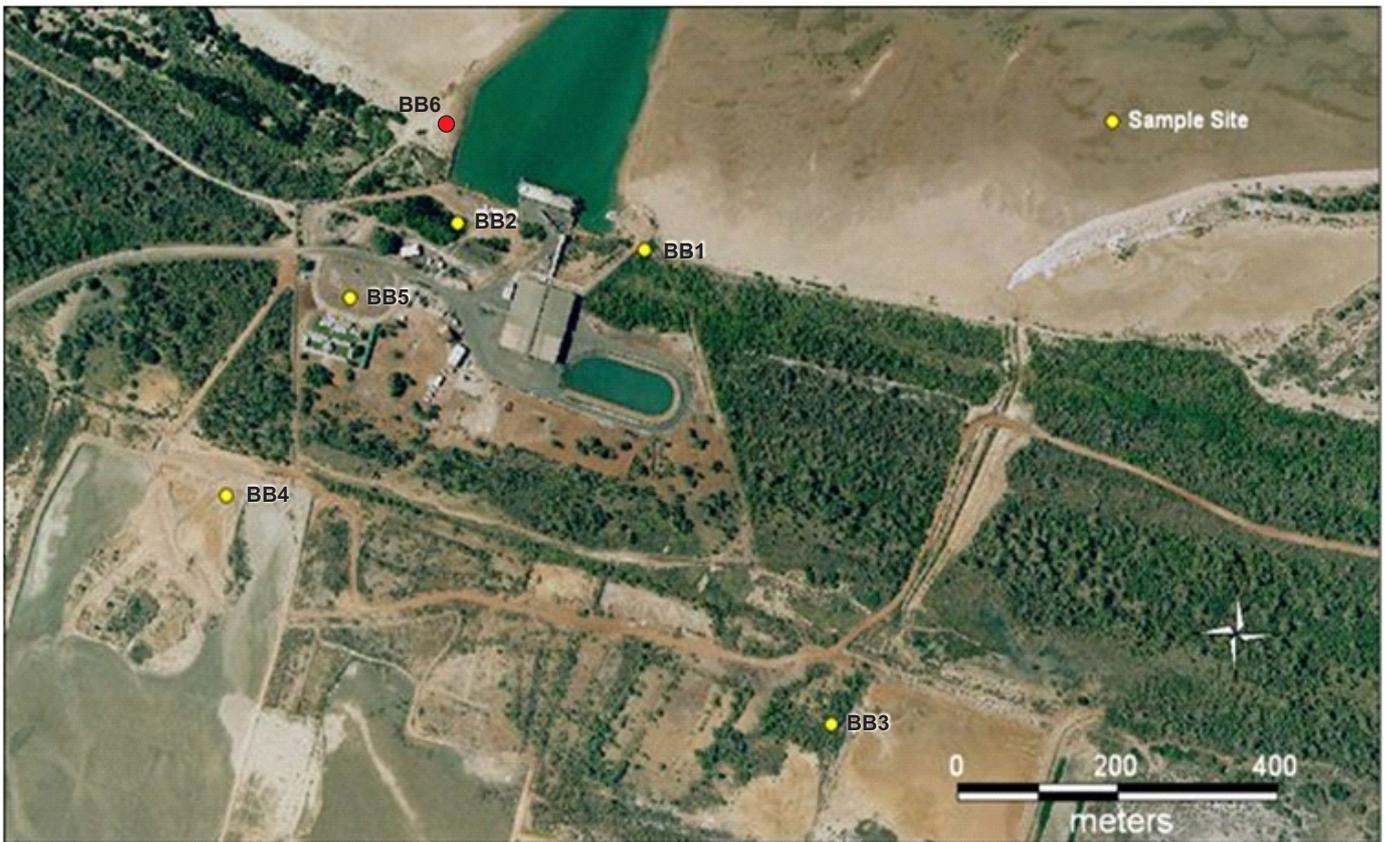
The additional dust gauge (BB6), which is located on the mud flats (Figure 5), up-wind of the Bing Bong Facility was sighted during the site inspection. It is acknowledged that this gauge was added by MRM in response to a recommendation by the Independent Monitor in the previous audit report.

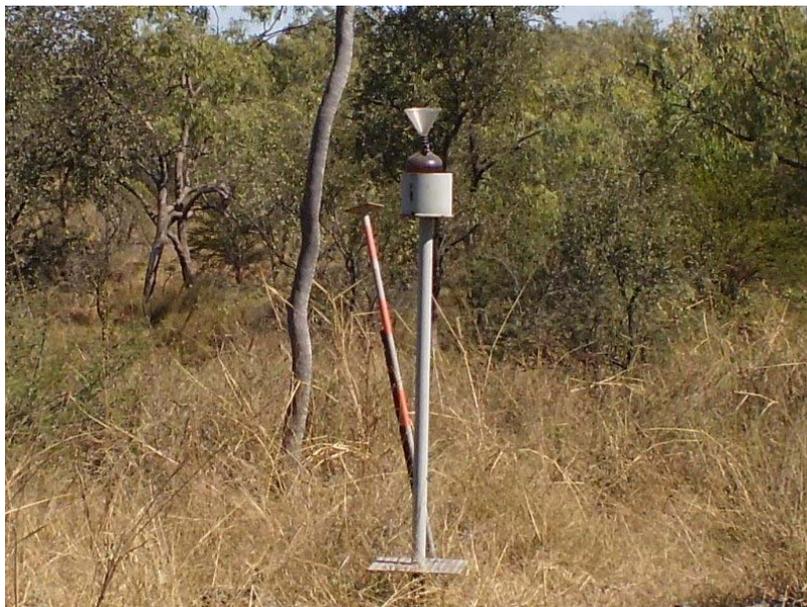
**Plate 6** Depositional dust monitoring location. Source: Independent Monitor.

According to the Environmental Monitoring Manual 2010, the dust monitoring program comprises fifteen depositional gauges located at the mine site (for example, see Plate 6) and six located at the Bing Bong Port loading facility. It is acknowledged that MRM has increased the number of locations in response to the Independent Monitor comments from the last audit as follows:

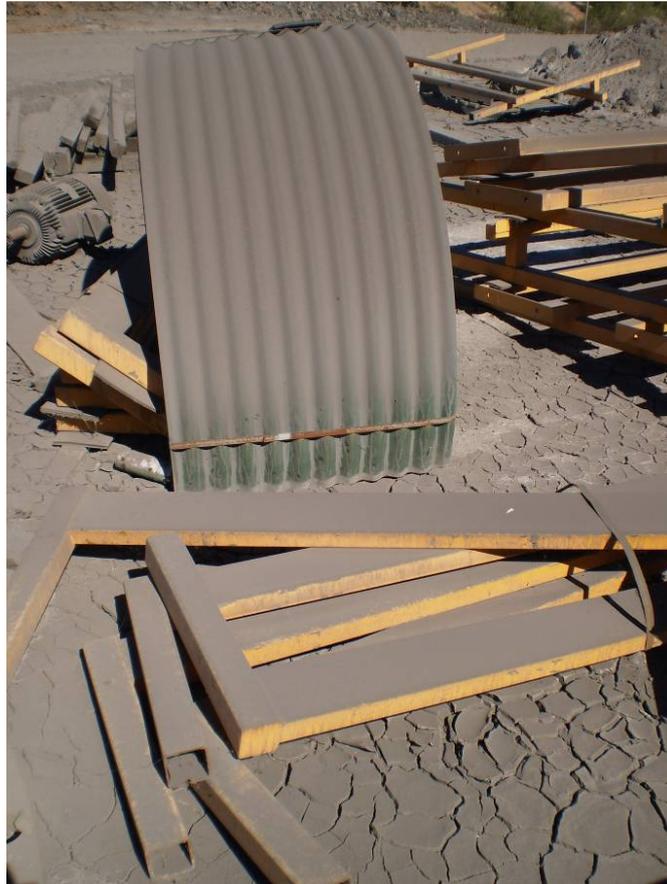
**Plate 7** Likely concentrate dust accumulating on objects in the PACRIM yard

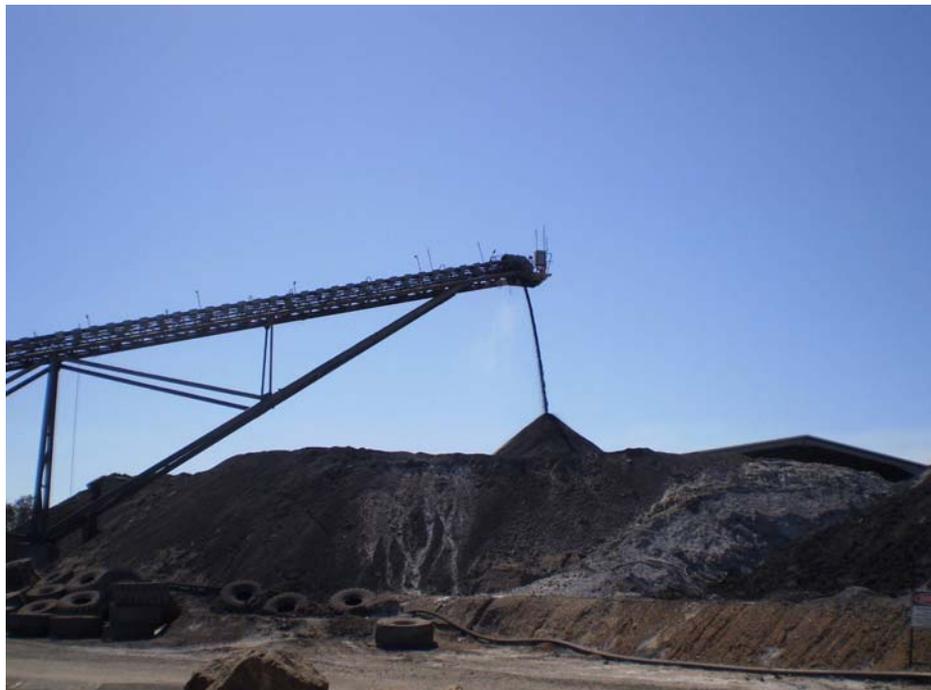
However, MRM staff did advise that an additional hood had been placed on the plant to try to limit dust, and that sprays were working throughout the plant to suppress dust. The IM also observed that a spray at the top end of the PACRIM conveyor line is now used constantly rather than intermittently (Plate 8).

**Plate 8** Sprays located at the top of the conveyor are now used more often.

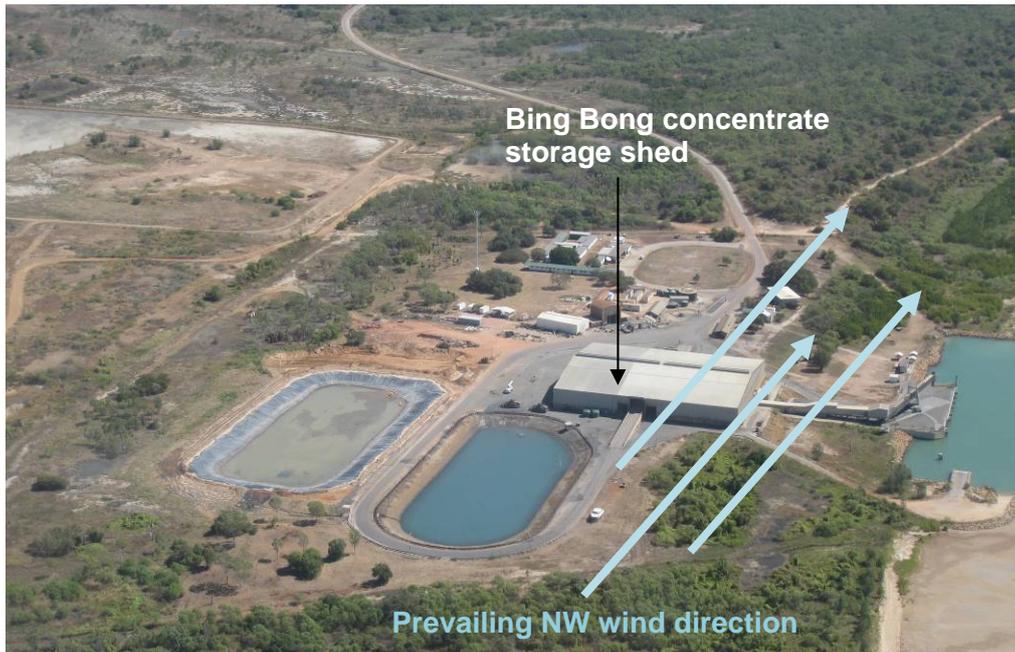
- although monitoring location BB1 at Bing Bong Port recorded dust lead concentrations of up to  $600\,000 \text{ mg/kg}$  (or 60%), the TIM at this location has decreased since the last monitoring period; this finding highlights the fact that, although total dust collected at this site may have decreased, the dust that was collected is contaminated with a high proportion of lead, which is likely to have originated from concentrate stored at Bing Bong Port (see Plate 9).

**Plate 9** Aerial photograph showing the position of the Bing Bong concentrate storage shed in relation to the prevailing North West wind direction. Photo: Independent Monitor 2011.

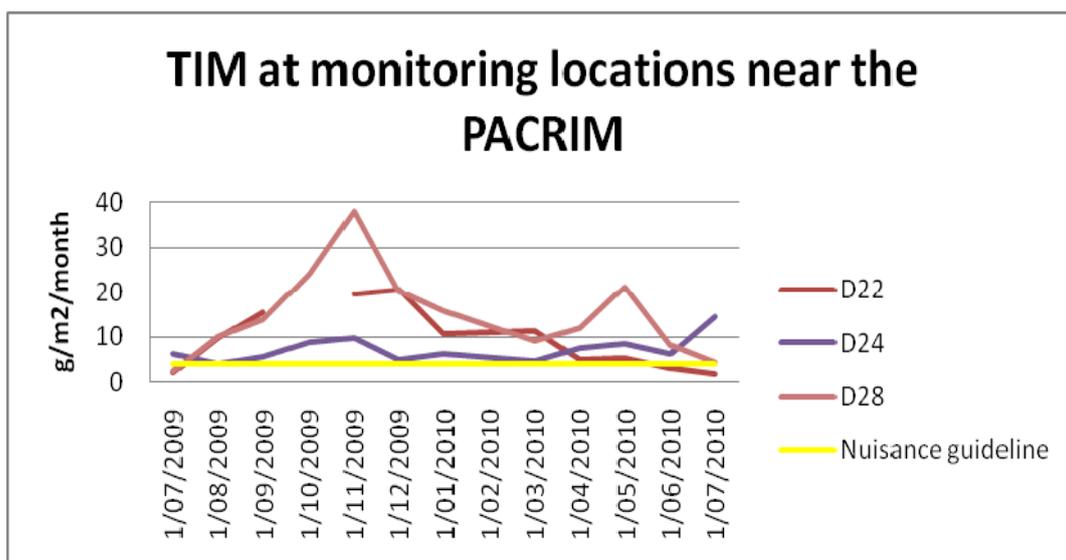
**Chart 1** TIM at monitoring locations near the PACRIM.

As can be seen in Charts 1 to 3, high dust levels (TIM) have been recorded at monitoring locations near the PACRIM: D22, D24 and D28 (see Figure 5 for locations). Elevated lead concentrations have also been recorded at these locations and it is therefore recommended that further mitigation measures should be implemented. In addition, elevated TIM levels may be an issue at monitoring location Bing Bong Port BB3, being the highest concentration over the nuisance level, and mine site D12, D21 and D6, being the highest concentrations at the mine site.

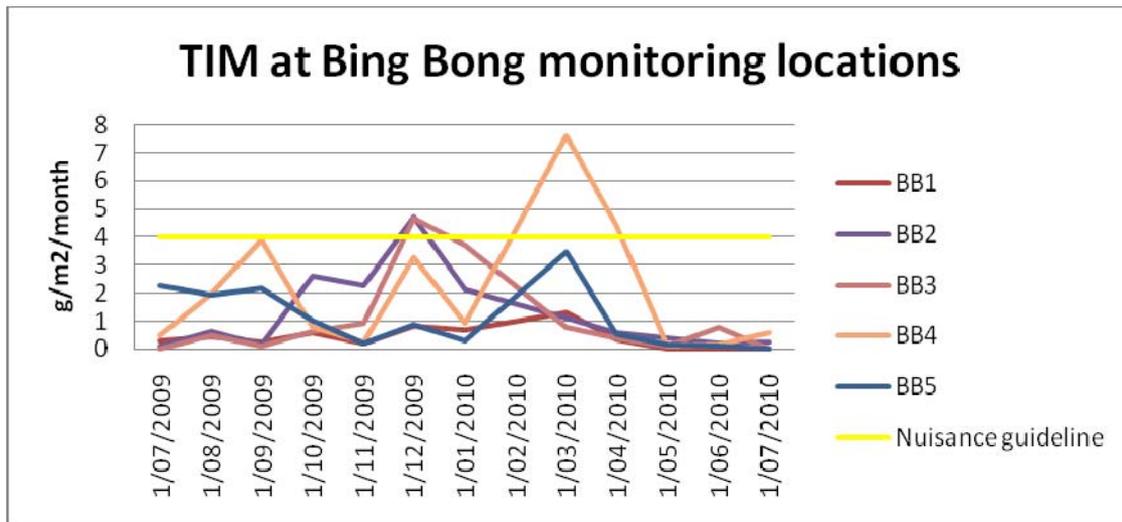
**Chart 2** TIM at Bing Bong monitoring locations.

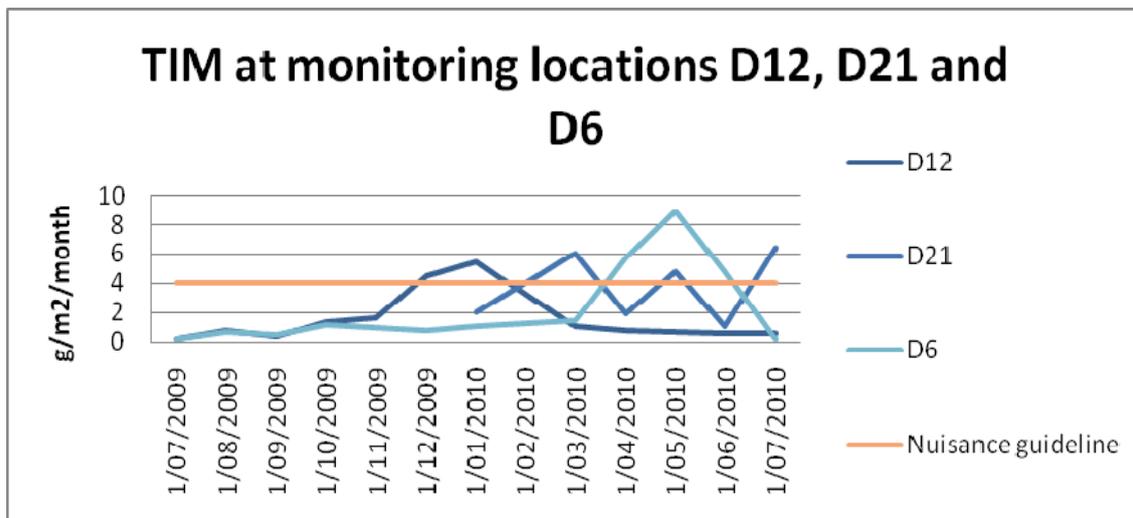
**Chart 3** TIM at Bing Bong monitoring locations D12, D21 and D6.

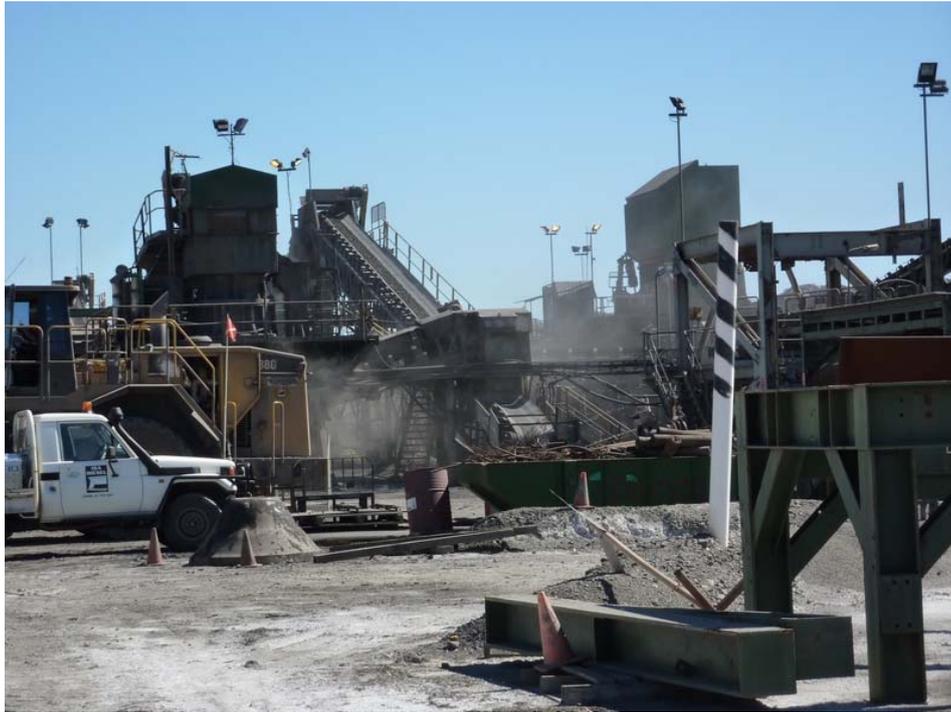
Dust remains as an issue in this audit. At the mine site the main source of contaminated dust is from the operation of the PACRIM crusher plant. During its May 2011 site inspection, the IM observed dust emanating from the PACRIM plant (Plate 10), and noted dust settled on surrounding objects (Plate 7). No significant improvements to dust management from the PACRIM were observed this audit. However, we do note that MRM have advised that limiting dust emissions completely from this plant may not be possible.

**Plate 10** PACRIM area. Note fugitive dust in the centre of the photo. We note that MRM have advised that limiting dust emissions completely from this plant may not be possible. Photo: Independent Monitor 2011.

Further efforts to control fugitive dust emissions are needed, particularly in the PACRIM area, where high TIM and lead concentrations have been recorded. The latter situation is the issue of most concern with regard to the dust monitoring program undertaken by MRM. This is due to the likely considerable contribution that concentrate-laden dust is having on sediment and soil metal enrichment. The IM also makes the following additional recommendations:

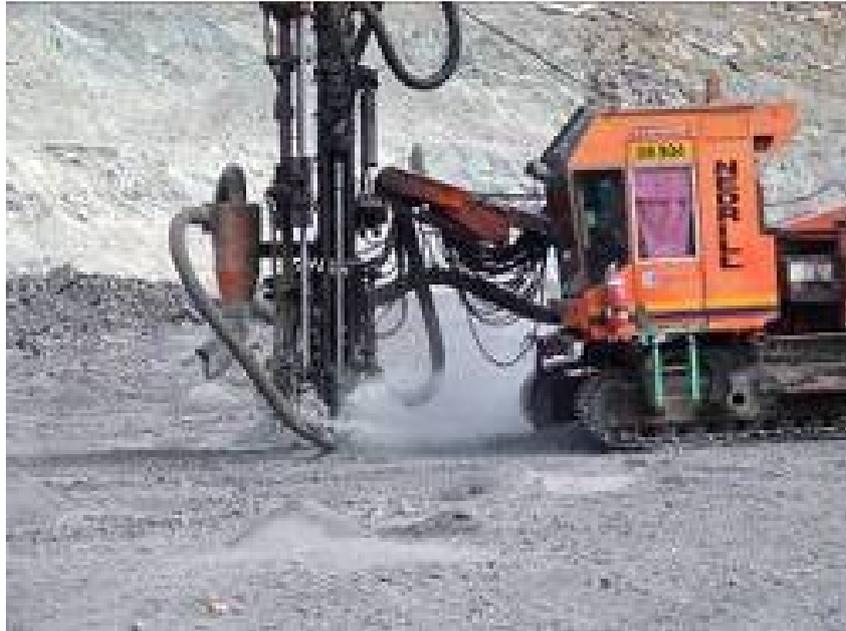
**Plate 11** Dust generated by working drill rig. Photo sourced from Simtars (2010) assessment

- due to lack of training of the operator, the dust suppression system on the working drill rig was not functioning (see Plate 11);
- fine dusts are present below the ejection chute of the mobile crushing plant and within the stockpiles of processed stone;
- concentrates of varying degree of moisture are stored in the shed (Plate 12). As concentrate dries out it increases the risk of fugitive dust emissions from the shed;

- MRM should work towards eliminating the issues identified in the Simtars' assessment by increasing concentrate moisture, reducing concentrate stockpiles, increasing the use of water sprays and water trucks, implementing a spilt concentrate recovery program and more effectively training MRM staff. It is also recommended that a similar assessment be undertaken annually;
