SECTION 14 INCIDENT REPORT (*Waste Management and Pollution Control Act*)

Date and Time of Notification:	Wednesday 16 th October 2019, 15:45hrs
Person / Company:	Power and Water Corporation (PWC)
Incident:	Oil Leak from transformer bund at the Sadadeen Complex, Alice Springs

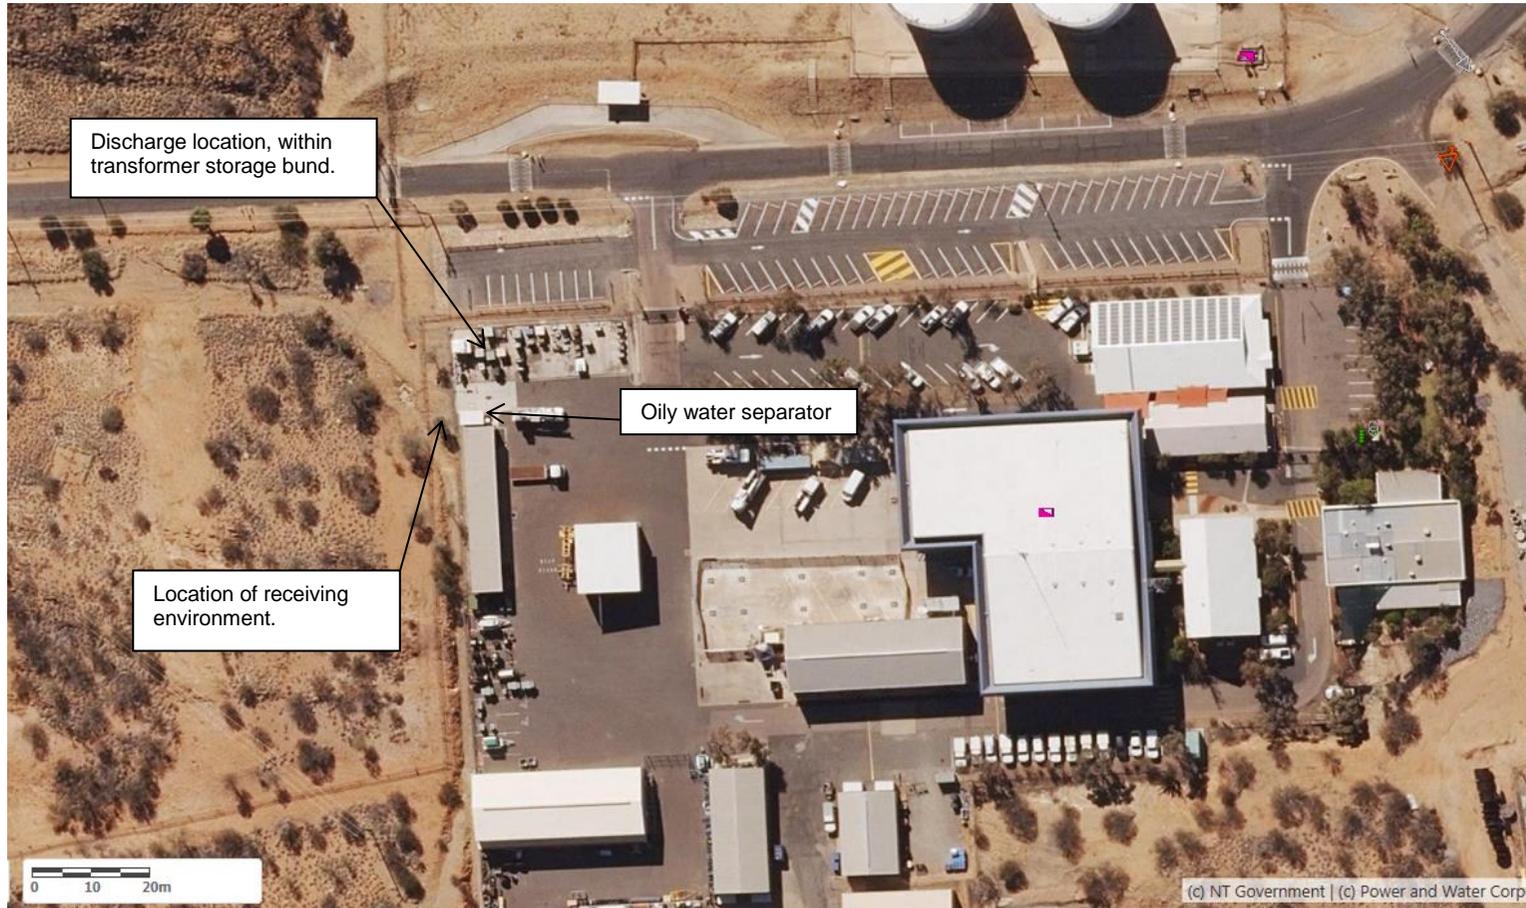
(b) the place where the incident occurred	<p>Sadadeen Valley – Power and Water Office Complex, Berger Court, Alice Springs.</p> <p><i>i. Description of the PWC asset from which the discharge occurred.</i></p> <p>Pole top transformer, with a total oil capacity of 550 litres.</p> <p><i>ii. GPS coordinates of the discharge point from the PWC asset, and the final coordinates of the final discharge point.</i></p> <p>Discharge Point: 133.893778, -23.709085 Final Discharge Point: 133.893724, -23.709197</p> <p><i>iii. Indicate any locations nearby to the discharge point where public can gain ready-access, such as public open spaces through which the discharge moves.</i></p> <p>Access to the public is not possible, PWC personnel only. In addition, the spill area has been taped off with caution tape.</p>

<p>bund noticed the spill.</p> <p><i>iii. The process by which the discharge occurred.</i></p> <p>The transformer in question was stored on a self-bunding pallet that gave way under the weight of the transformer, causing the transformer to fall over and break the low voltage bushings, resulting in the spillage of the entire oil contents, within the transformer storage bund area.</p> <p><i>iv. The reason why the discharge occurred.</i></p> <p>The self-bunding pallet used to store the transformer, although adequately rated for the weight, was not used as per manufactures recommendations, with a load spreader. This is being investigated internally.</p>

(d) how the pollution has occurred, is occurring or may occur	<p>The oily water separator was inundated with too much oil at one time. An investigation into the capability of the OWS is being undertaken.</p>

(e) the attempts made to prevent, reduce, control, rectify or clean up the pollution or resultant environmental harm caused or threatening to be caused by the incident	<p><i>i. Confirmation signage and fencing has been erected, as appropriate.</i></p> <p>There is no public access to the spill location, as such "caution" tape was deemed sufficient to warn of the spill, which has been erected.</p> <p><i>ii. Decontamination of the site as appropriate.</i></p> <p>Remediation of the site will commence in earnest once the PCB concentration of the oil has been determined. Suitable contractor/s will be engaged to conduct this remediation. Validation sampling post remediation will be conducted.</p>
