**SECTION 14 INCIDENT REPORT (*Waste Management and Pollution Control Act*)**

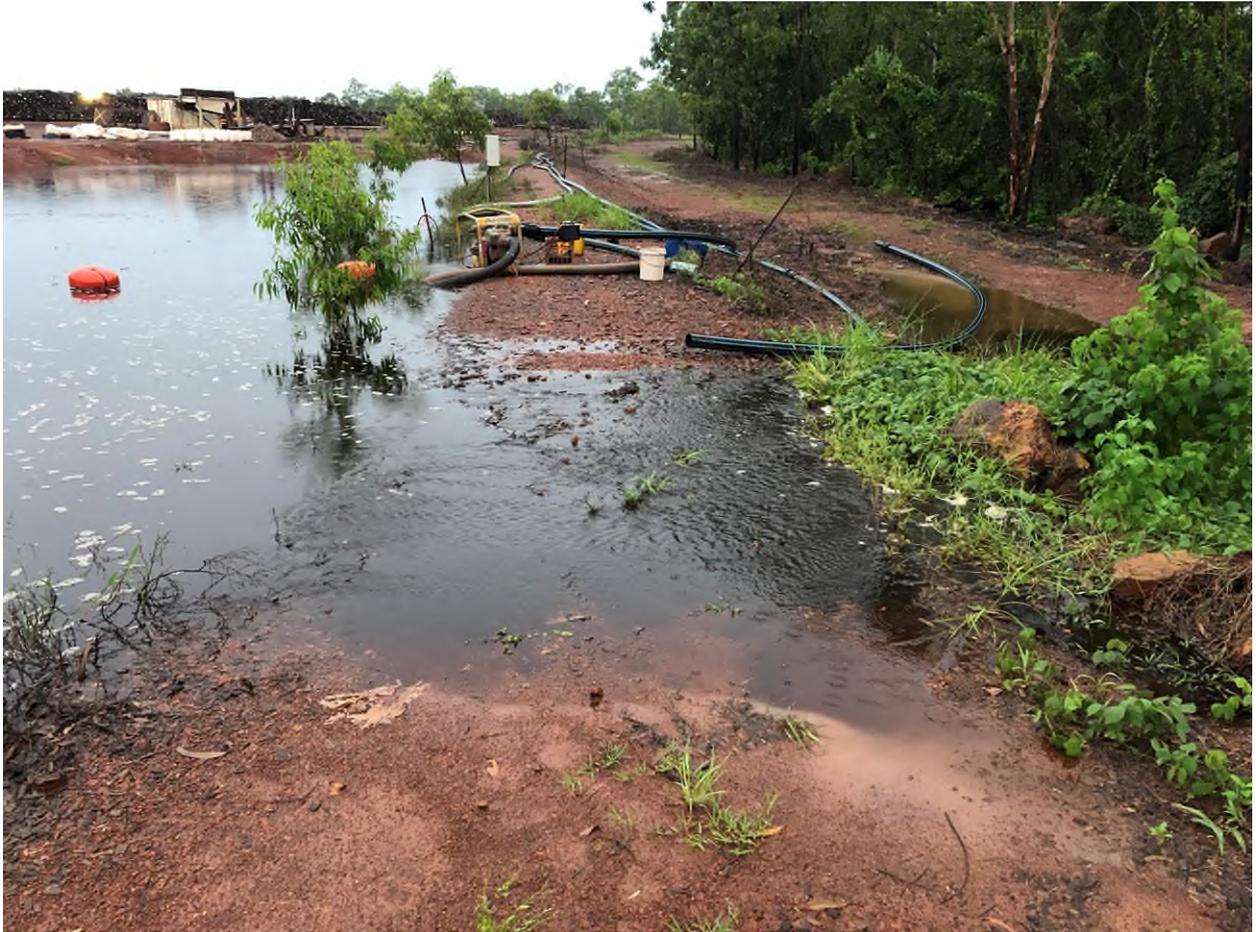
Overflow point at Basin 4 30/1/2021 6:56am.
