SECTION 14 INCIDENT REPORT (*Waste Management and Pollution Control Act*)

Date and Time of Notification:	Friday 12 th March 2021, 13:28hrs
Person / Company:	Power and Water Corporation (PWC)
Incident:	Discharge of raw sewage from sewerage network

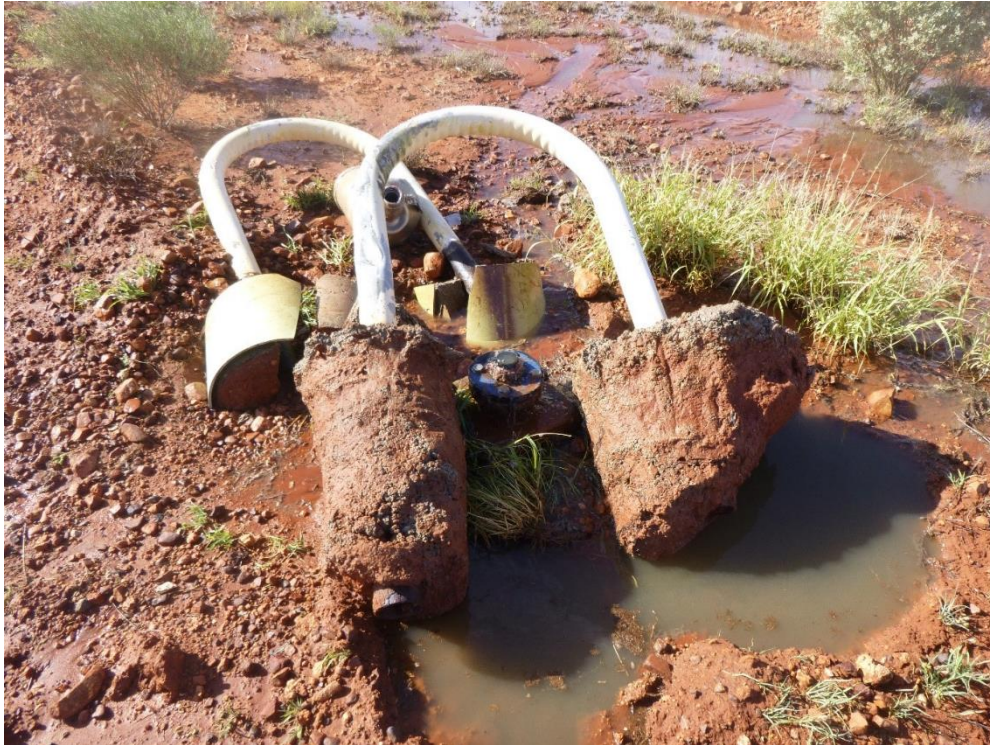
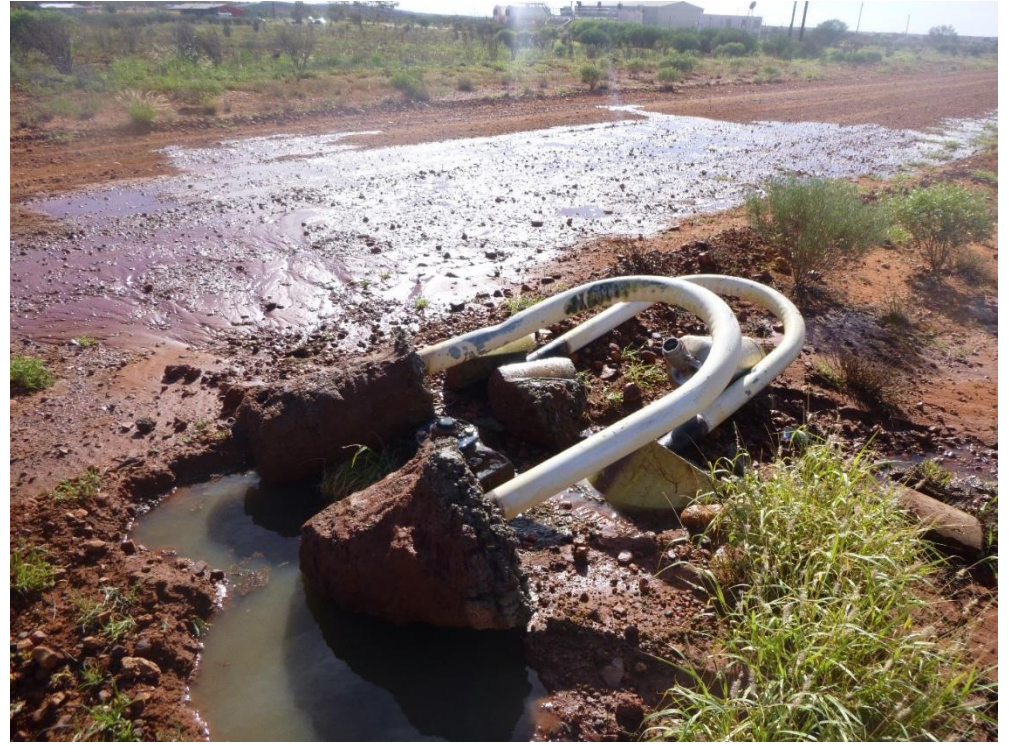
<p>(b) the place where the incident occurred</p>	<p><i>i. Description of the PWC asset from which the discharge occurred.</i></p> <p>A sheared off air valve associated with a 150mm diameter PVC sewer rising main, that runs between sewage pumping station #1 and the Imanpa waste stabilisation ponds.</p> <p><i>ii. GPS coordinates of the discharge point from the PWC asset, and the final coordinates of the final discharge point.</i></p> <p>Approximate Discharge Point: 25.1318807 S, 132.5676419 E Approximate final discharge point: 25.1323000 S, 132.5676900 E</p> <p><i>iii. Indicate any locations nearby to the discharge point where public can gain ready-access, such as public open spaces through which the discharge moves.</i></p> <p>The discharge occurred adjacent to the community's rubbish tip access road, which the public has access to, however it is not expected that</p>

Appendix B – Photographs of the discharge location – On initial discovery of the overflow

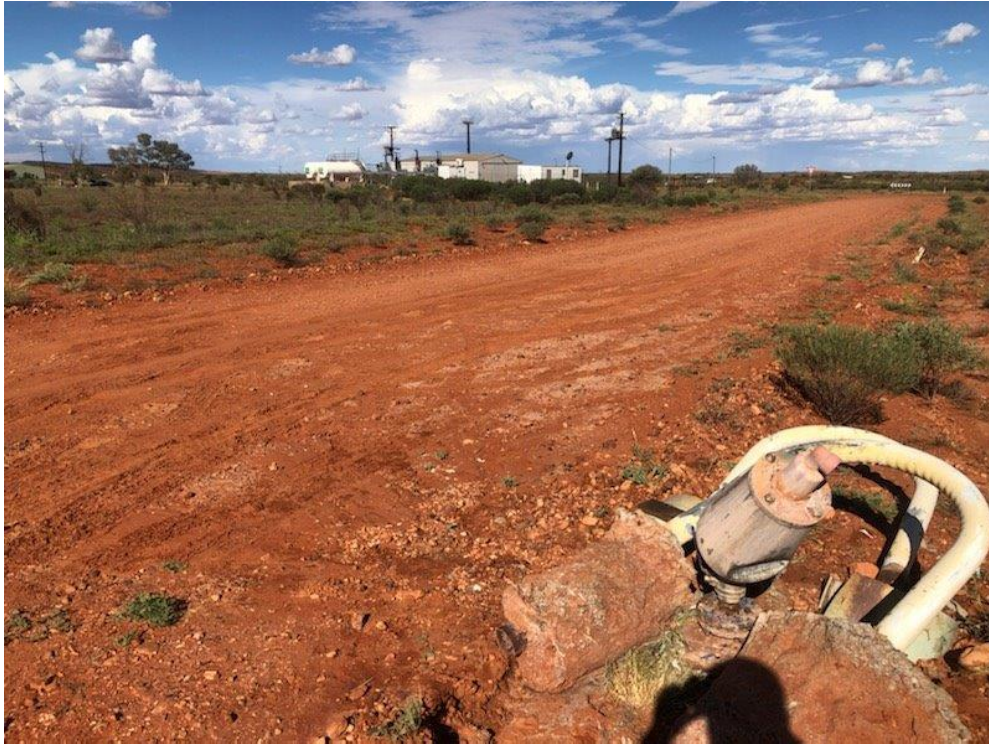
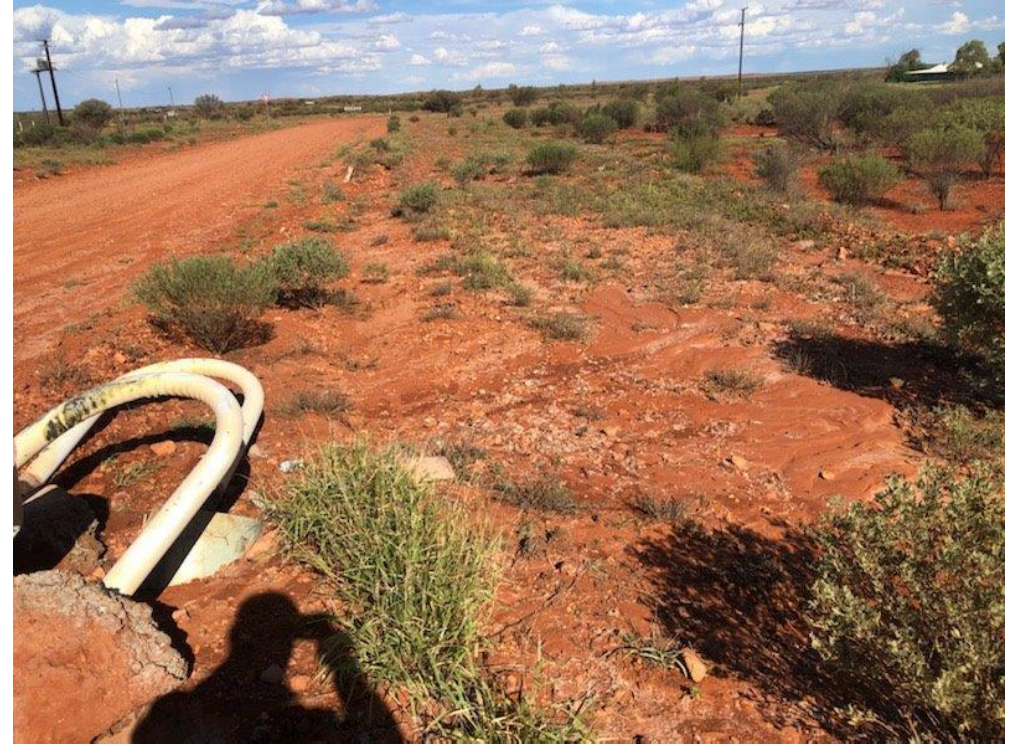
Appendix B – Photographs of the discharge location, post temporary repairs and clean up.

(d) how the pollution has occurred, is occurring or may occur	As per (c) iii & (c) iv.
(e) the attempts made to prevent, reduce, control, rectify or clean up the pollution or resultant environmental harm caused or threatening to be caused by the incident	<p><i>i. Confirmation signage and fencing has been erected, as appropriate.</i> Warning tape was erected around the damaged asset to identify the risk to members of the public. No other, more suitable signage was available at the time.</p> <p><i>ii. Decontamination of the site as appropriate.</i> Clean up undertaken to minimise risk to public health and the environment. The ESO was instructed to collect any gross pollutants, but reported that no gross pollutants were visible in the overflow. The spill had dispersed and evaporated, removing any risk of public contact, before signage could be erected.</p>
