SECTION 14 INCIDENT REPORT (*Waste Management and Pollution Control Act*)

Date and Time of Notification:	Stormwater discharge event reported via the NT EPA Pollution Hotline on 18 th March 2021 at 12:10PM.
Person / Company:	GEMCO Mining Pty Ltd.
Incident:	Stormwater from GEMCO Port Facility entering Milner Bay.

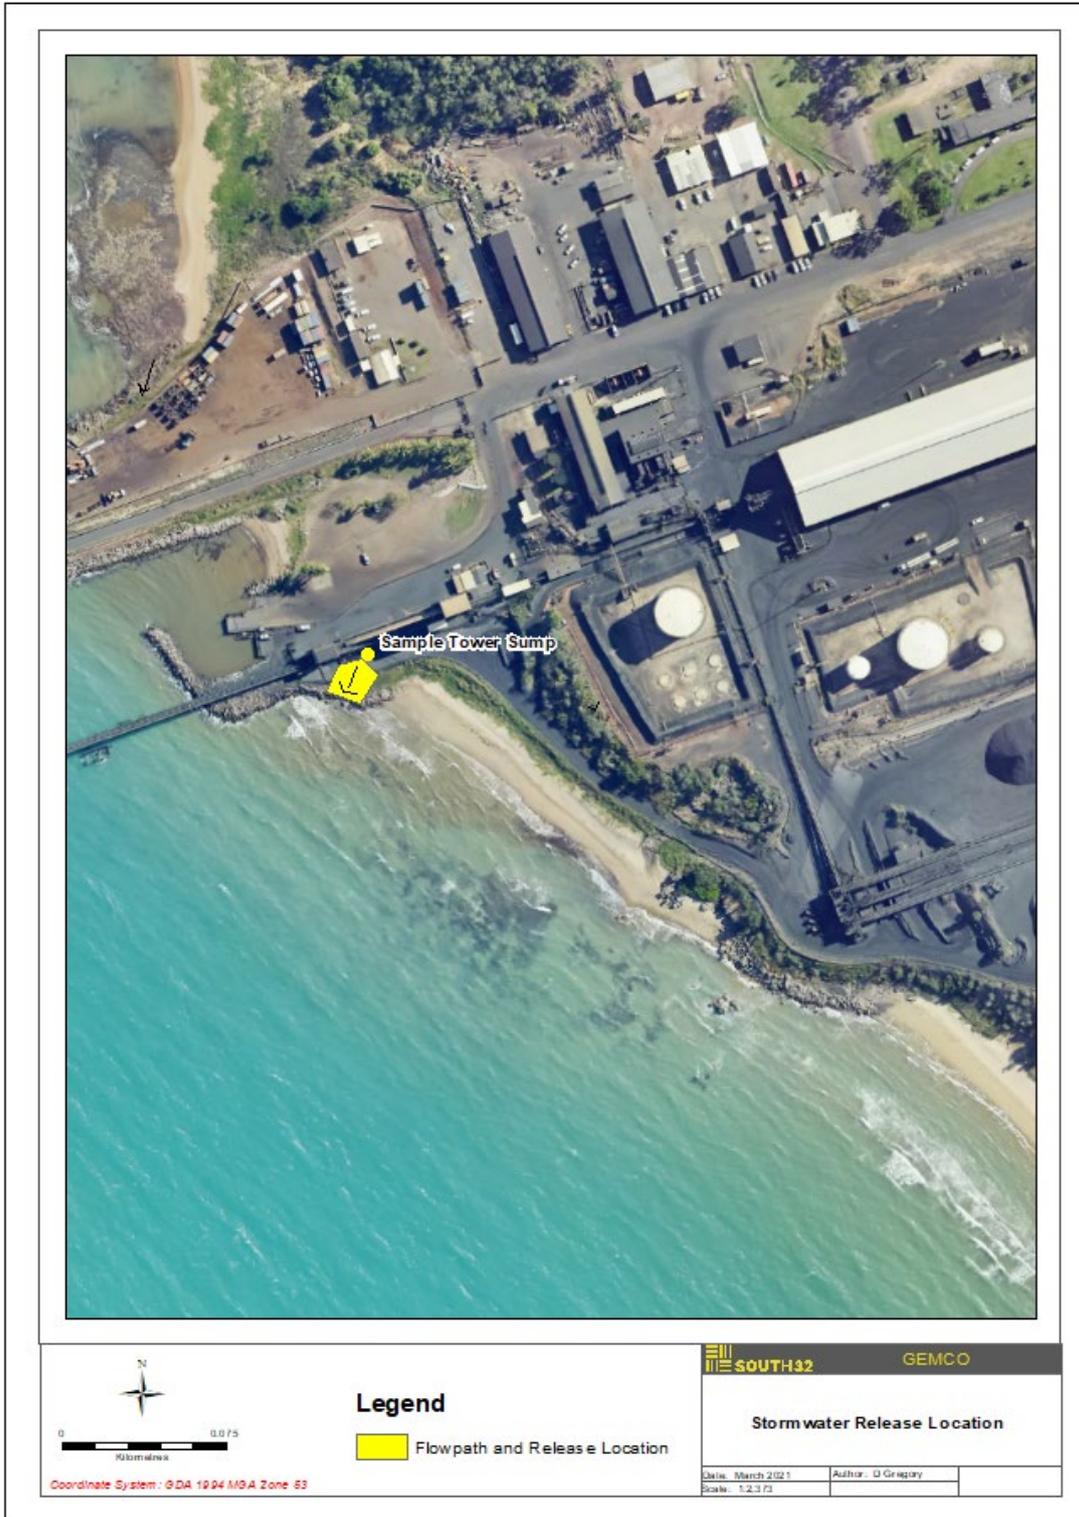
Figure 1: Stormwater discharge location

(a) the incident causing or threatening to cause pollution	Stormwater from GEMCO Port stockpiles entering Milner Bay.
(b) the place where the incident occurred	GEMCO's Port Facility (see Figure 1 below).

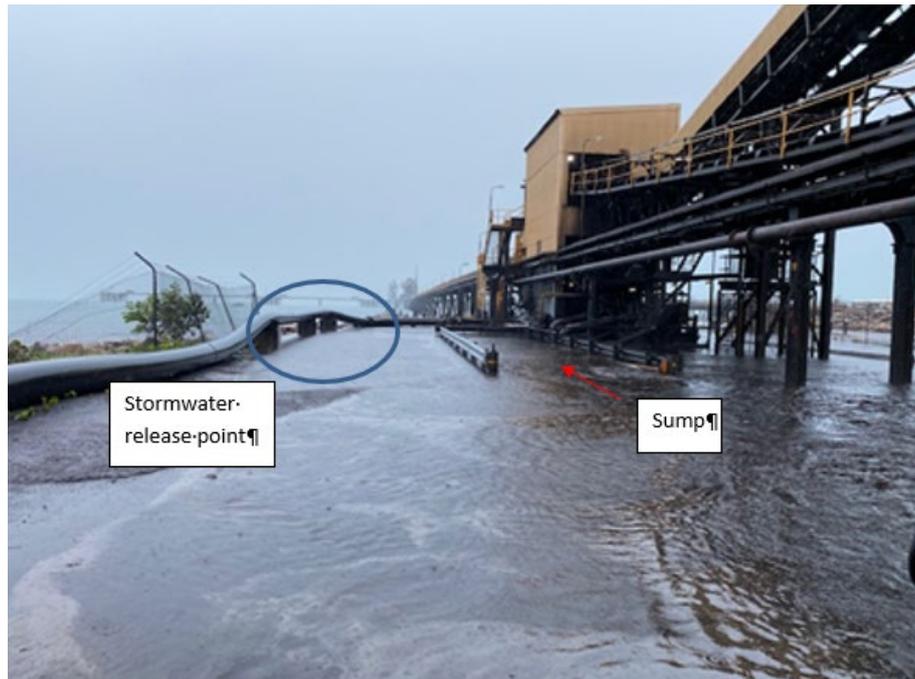
(c) the date and time of the incident	Overflow commenced 18 th March 2021 at approximately 11:00am. Overflow ceased at approximately 11:20am.
(d) how the pollution has occurred, is occurring or may occur	<p><u>18th March 2021</u></p> <p>Stormwater overtopped a sump located at the transfer tower at the GEMCO Port Facility during a rainfall event and resulted in the discharge of stormwater into Milner Bay. The pumps located within the sump were all operating as per their design. Heavy rainfall and associated runoff exceeded the design capacity of the pumps. The substantial rainfall experienced over the past few days has led to extensive runoff from outside of GEMCO's Port area (off lease) to enter our lease, inundating our stormwater controls. GEMCO in co-operation with the ALC Infrastructure section have been working together to address this, specifically some of the impacts of water runoff resulting from their new development at Pole 7. As part of this work we identified that some of the upstream water sources can potentially be diverted prior to entering the Milner Bay stockpile area's or be directed better into the bypass drains. Both GEMCO and the ALC infrastructure team see this work as a priority and have taken a bipartisan approach to implementing the changes quickly. Whilst not ideal the events of the last two days have been instrumental in helping both organisations understand these impacts. As a result, we are optimistic that the measure we intend to put in place will both reduce the mobilisation of sediment and also redirect flows appropriately to minimise downstream impacts.</p>

Figure 2: Looking directly at the Sample Tower and sump during the stormwater release. Photo taken at 11:15 AM, 18/03.

(e) the attempts made to prevent, reduce, control, rectify or clean up the pollution or resultant environmental harm caused or threatening to be caused by the incident	<p>The discharge of stormwater into Milner Bay ceased once the pumps were able to keep up with the flow volumes (~11:20am).</p> <p>Water is no longer discharging off lease. No ongoing environmental impacts are anticipated from this event.</p> <p>Samples have been collected of the Sample Tower sump stormwater to assess the water quality which will be compared to relevant water quality guidelines (i.e. ANG 2018) and will be reported to the NT EPA.</p>
(f) the identity of the person notifying the NT EPA	David Gregory (Environment Specialist)
