SECTION 14 INCIDENT REPORT (*Waste Management and Pollution Control Act*)

Date and Time of Notification:	Initial notification (email) – 23 March 12:50																		
Person / Company:	McArthur River Mining Pty Ltd (MRM)																		
Incident:	Spillage of five kilograms (kg) of zinc concentrate on the Carpentaria Highway road surface. The source of the spill originated from a road train travelling from McArthur River Mine (the Mine) to the Bing Bong Loading Facility (BBLF).																		
(a) the incident causing or threatening to cause pollution	A total of approximately 5 kg of zinc concentrate was released at five locations on the Carpentaria Highway, between the Mine and the BBLF. All concentrate was confined to the sealed bitumen, and the five small spills occurred within an approximate 800 metre (m) length of road.																		
(b) the place where the incident occurred	<p>The Global Positioning System (GPS) points for the five spill locations are listed in Table 1 below and shown in Figure 1.</p> <p style="text-align: center;"><i>Table 1 – GPS Coordinates of all spill locations.</i></p>

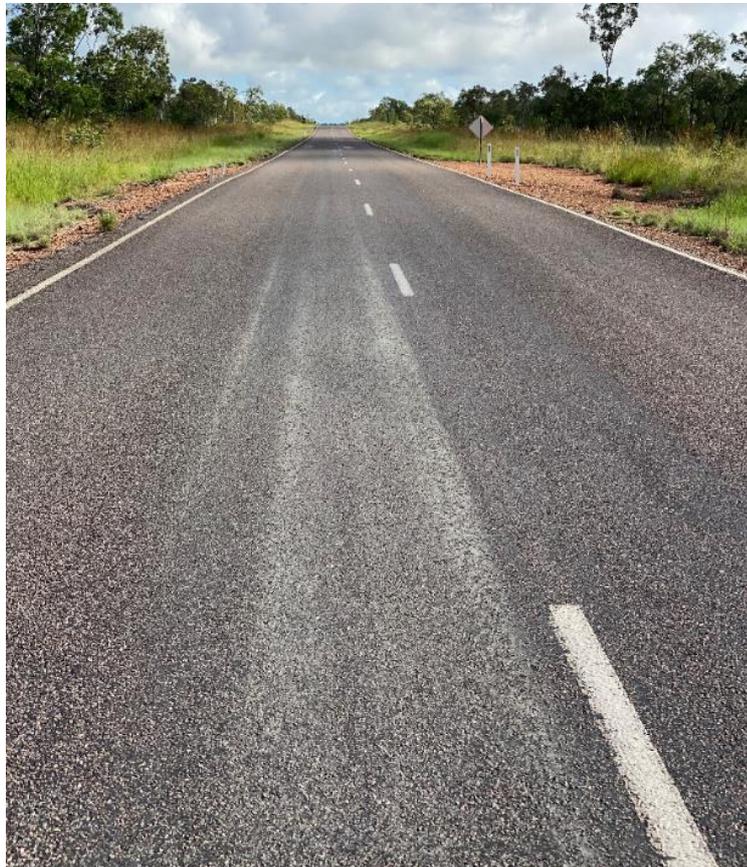
The concentrate was confined to the sealed bitumen for (Figure 2) presenting a low risk of pollution or environmental harm. Based on the inspections, approximately 5 kg of concentrate is estimated to have been spilt in total.

Investigation into specific incident found the contributing factors included the trailer being loaded whilst the trailer was wet causing some of the zinc concentrate to become a slurry, and the uneven road surface causing some of the slurry to be ejected from the trailer.

Figure 2: Concentrate observed on road at Site 4 prior to clean-up efforts.

The investigation for this specific incident concluded that contributing factors included the trailer being loaded whilst the trailer was wet causing the zinc concentrate to slurry, and the uneven road surface. It is a critical requirement for road train operators to follow the loading procedure to prevent similar spills from occurring. The work crew undertook training via a toolbox talk, reiterating the requirement to check load levels and remove any water from the trays prior

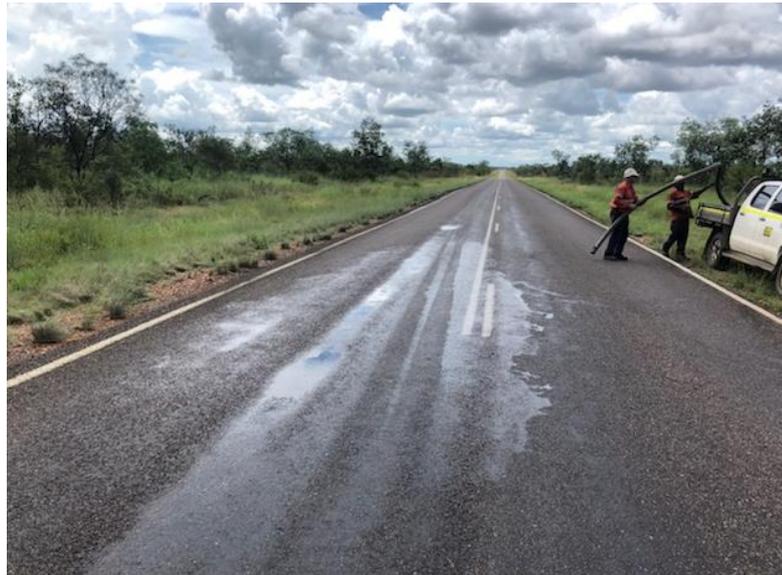
Figure 3: Spill clean-up efforts via pressure cleaner and vacuum truck.

At approximately 12:30 on 23 March 2021, a vacuum truck was deployed to clean-up all of the material on the sealed bitumen (Figure 3 and 4). This involved pressure washing the concentrate and simultaneously using a vacuum truck to collect the residue, which was transported to the BBLF containment ponds.

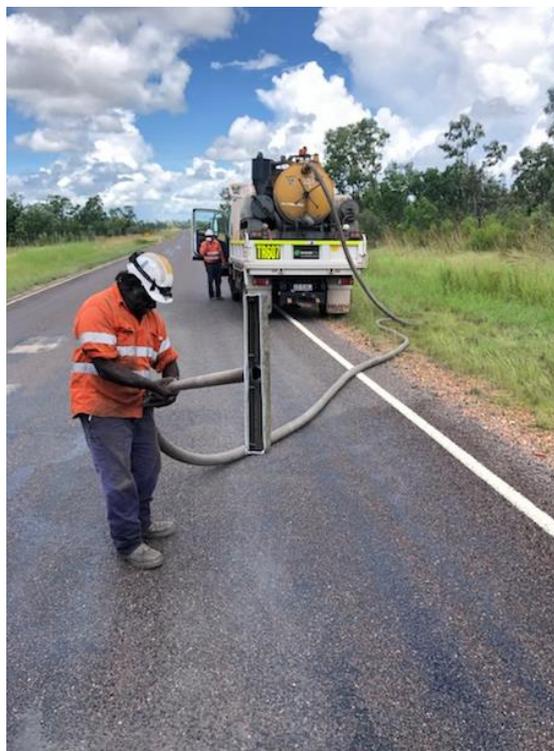
Figure 4: Spill clean-up efforts via pressure cleaner and vacuum truck.

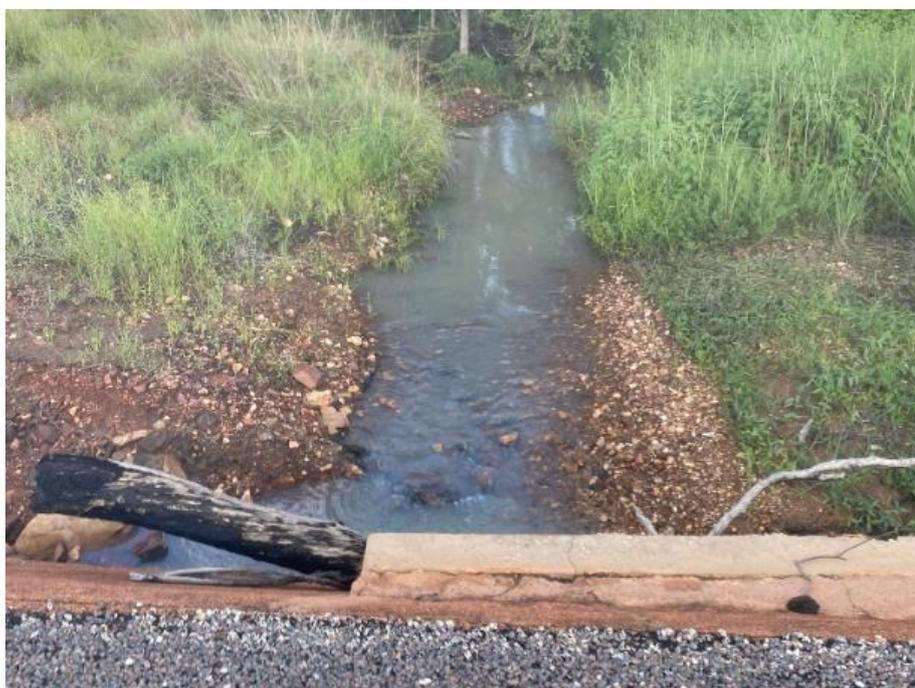
Soil samples were collected at all spill locations to determine whether the soil surrounding the spill site is suitable for the intended land use. Additionally, water samples were collected at a potentially sensitive receptor at Site 3 (i.e. small creek culvert) (Figure 5). Details of the samples are provided below.

Figure 5: Site 3 – small creek culvert.

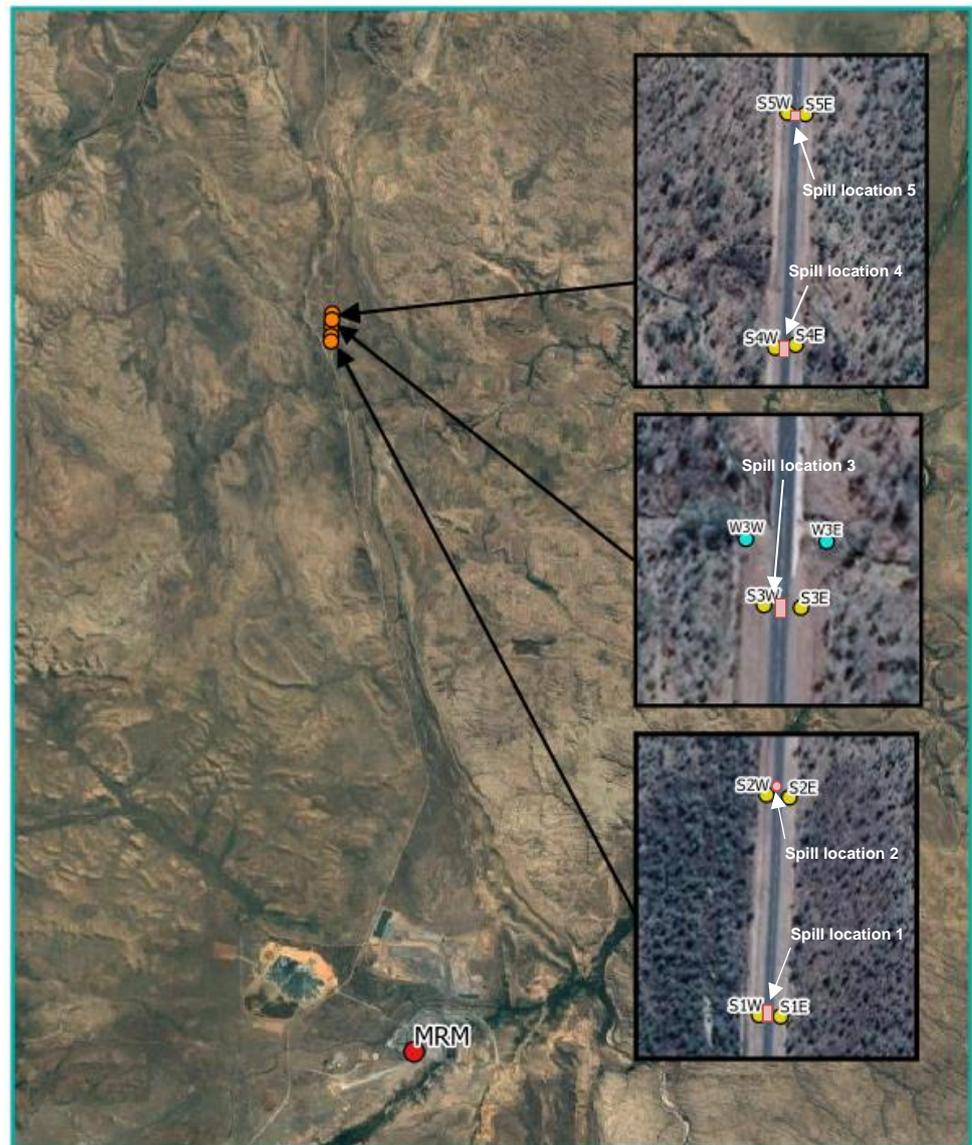
On 24 March 2021, soil samples were collected at the five spill locations (Figure 6) in accordance with *Australian Standard 4482.1-2005: Guide to the investigation and sampling of sites with potentially contaminated soil*.

On 24 March 2021, two water samples were collected at Site 3 (Figure 6) in accordance with *Australian Standard 5667.1-1998: Water quality - Sampling Guidance on the design of sampling programs, sampling techniques and the preservation and handling of samples*.

Figure 6: Sampling locations at the spill locations.
