SECTION 14 INCIDENT REPORT (*Waste Management and Pollution Control Act*)

Date and Time of Notification:	Wednesday 1 st December 2021, 16:00hrs
Person / Company:	Power and Water Corporation (PWC)
Incident:	Discharge of raw sewage from sewerage network (no gross pollutants)

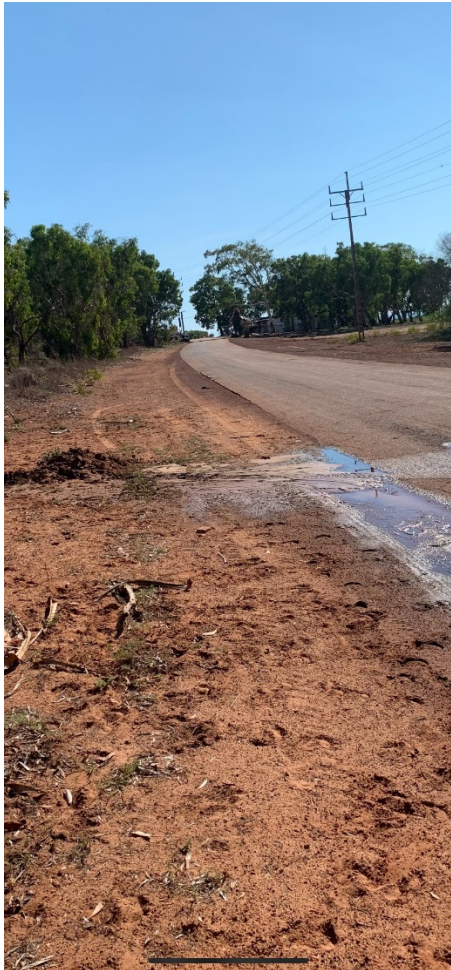
(c) the date and time of the incident	<p><i>i. The time and date of commencement and cessation of the discharge.</i></p> <p>The exact commencement time of the spill is unknown. The spill was first observed around 10:00hrs on the 30th November 2021 by the Essential Services Operator (ESO). The spill was stopped at approximately 10:15hrs by temporarily turning off the sewage pumping station, excavating around the spill site and repairing the broken pipe. This work was completed around 14:00hrs 30/11/2021.</p> <p><i>ii. How PWC were notified, or became aware of the discharge.</i></p> <p>The Essential Services Operator (ESO) noticed the spill on the side of the road on the morning of the 30th November 2021 and then notified the PWC Coordinator.</p> <p><i>iii. The process by which the discharge occurred.</i></p> <p>The sewer rising main is assumed to have deteriorated over time since installation, and under the pressure of the sewage pumping station, the pipe gave way.</p> <p><i>iv. The reason why the discharge occurred.</i></p> <p>As per (c) iii.</p>

Photo 1 – Pre-clean up

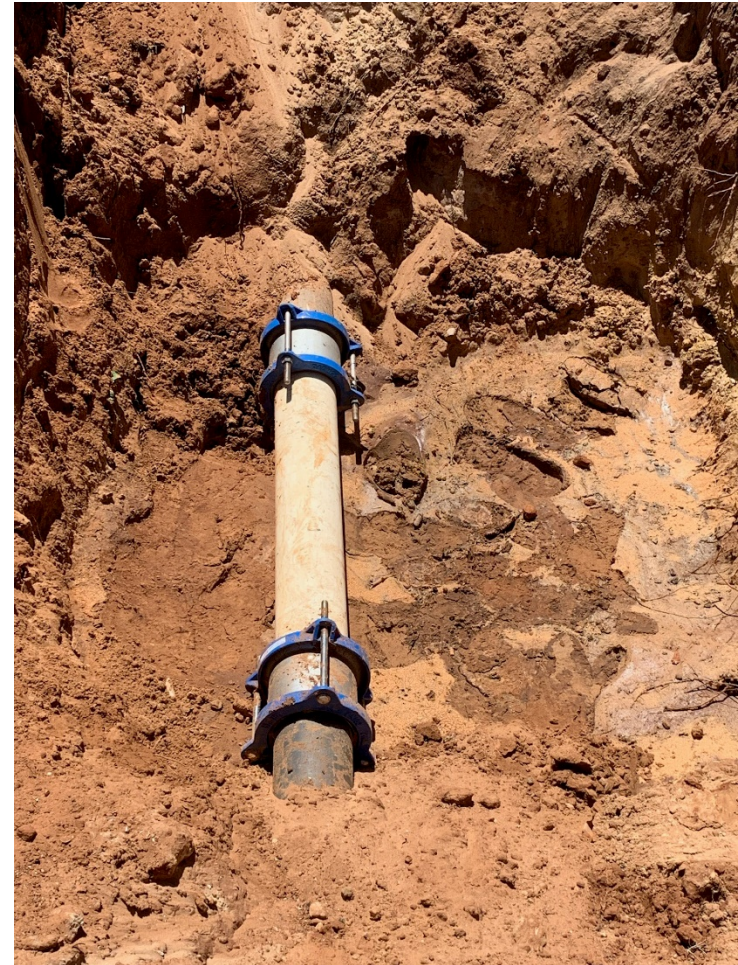
Photo 2 – Repaired main

(d) how the pollution has occurred, is occurring or may occur	As per (c) iii.
(e) the attempts made to prevent, reduce, control, rectify or clean up the pollution or resultant environmental harm caused or threatening to be caused by the incident	<p><i>i. Confirmation signage and fencing has been erected, as appropriate.</i></p> <p>Warning signage has been installed around the site to deter the public from entering the area. Photos attached.</p> <p><i>ii. Decontamination of the site as appropriate.</i></p> <p>Clean up undertaken to minimise risk to public health and the environment. Area was inspected for gross pollutants of which none were observed. The excavation site had clean fill applied to the surface covering the affected area.</p>

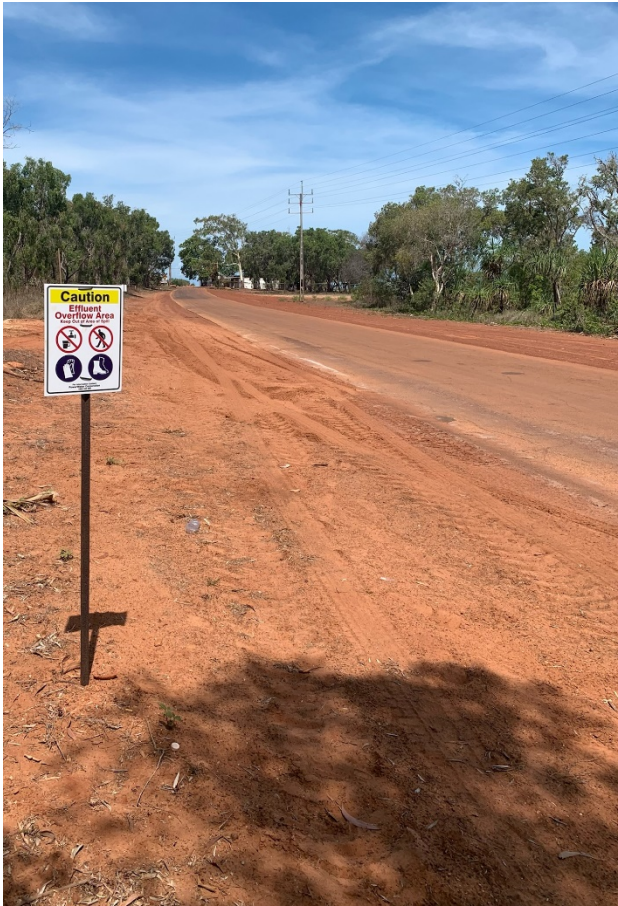
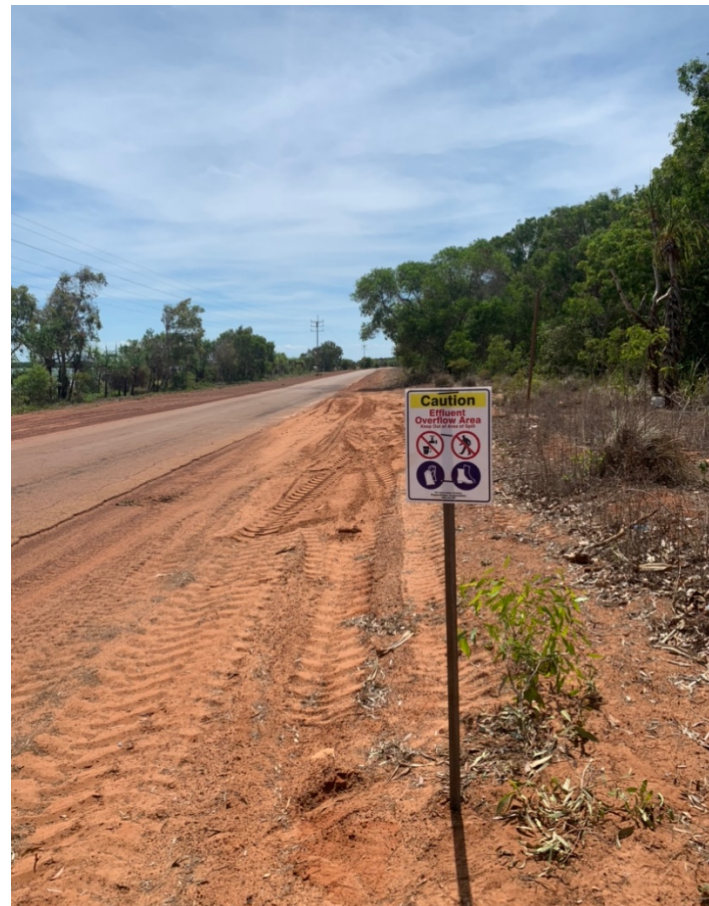
Photo 4 & 5 – Post-clean up / Warning Signage
