SECTION 14 INCIDENT REPORT (*Waste Management and Pollution Control Act*)

Date and Time of Notification:	Initial notification (email) – 17 April 16:28						
Person / Company:	McArthur River Mining Pty Ltd (MRM)						
Incident:	Spillage of zinc concentrate on the Carpentaria Highway. The source of the spill originated from a road train travelling from McArthur River Mine (the Mine) to the Bing Bong Loading Facility (BBLF).						
(a) the incident causing or threatening to cause pollution	A total of approximately 2 kilograms (kg) of bulk concentrate was released at one location on the Carpentaria Highway, between the Mine and the BBLF. All concentrate was confined to the road.						
(b) the place where the incident occurred	<p>The Global Positioning System (GPS) points for the length of the spill is provided in Table 1 below and shown in Figure 1.</p> <p style="text-align: center;"><i>Table 1 – GPS Coordinates of spill end and start.</i></p> <table border="1" style="margin-left: auto; margin-right: auto;"> <thead> <tr> <th>Spill Location</th> <th>Easting*</th> <th>Northing*</th> </tr> </thead> <tbody> <tr> <td>Carpentaria Highway</td> <td>613 396</td> <td>8 182 636</td> </tr> </tbody

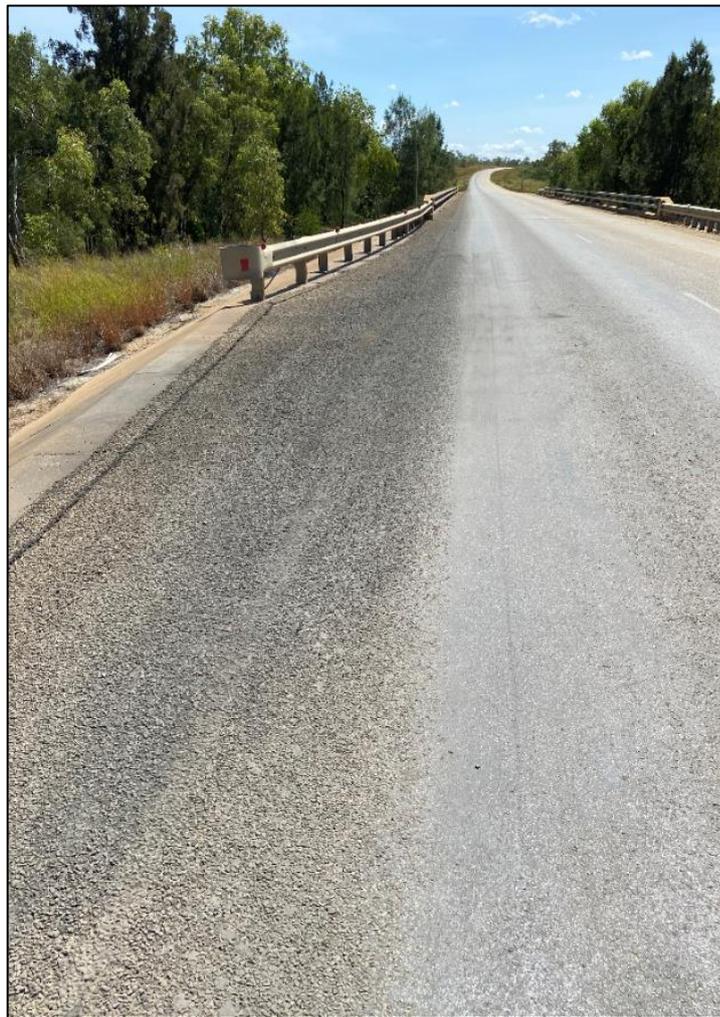
On 17 April 2022 at approximately 11:00, a Transport Contractor Supervisor observed grey material (indicative of bulk concentrate) on the Carpentaria Highway on the north bound approach to the Barney Creek Bridge.

During the inspection, bulk concentrate was observed on the road at the spill location. It was estimated that approximately 2 kilograms (kg) of bulk concentrate had been spilled across one location, totalling approximately 10 metres (m) in length (Figure 2).

The source of the spill was likely from a road train carrying bulk concentrate from the Mine to the BBLF, however the exact time of the spill is unknown.

Figure 2: The Carpentaria Highway north bound approach to the Barney Creek Bridge (spill location).

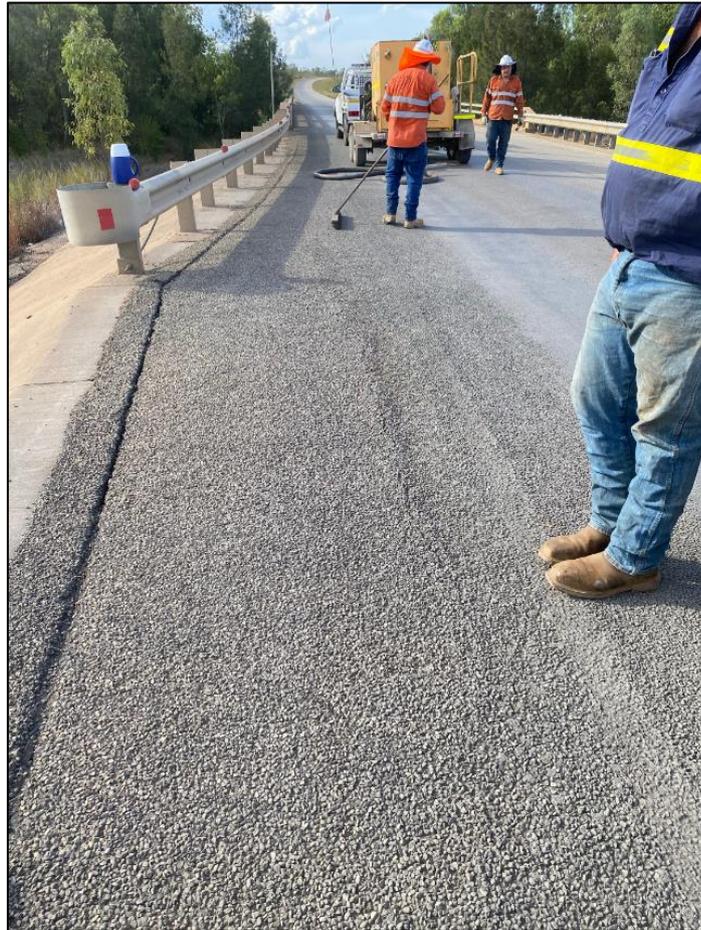
On 17 April 2022 at approximately 14:50, following the completion of the clean-up works, MRM Environment Team personnel inspected the road and did not identify any visible signs of bulk concentrate at the spill location.

Figure 3: Spill location after clean-up works were completed.

On 17 April 2022 at approximately 13:30, a broom and vacuum truck was deployed to clean up all bulk concentrate from the sealed bitumen (Figure 3). This involved sweeping up the majority of the concentrate while simultaneously using a vacuum truck to collect the residue, of which half was transported to the Mine's concentrate loading shed for re-use and the other half was watered down and disposed of in the Mine's contamination bin.

The work crews undertook training via a toolbox talk, reiterating the requirements of the MRM Concentrate Transport Procedure. As per the procedure, the operators must sweep all residue concentrate off trailer guards prior to exiting the concentrate shed, and the inspectors at the gate house must thoroughly check the trailers for concentrate, prior to giving approval to exit.

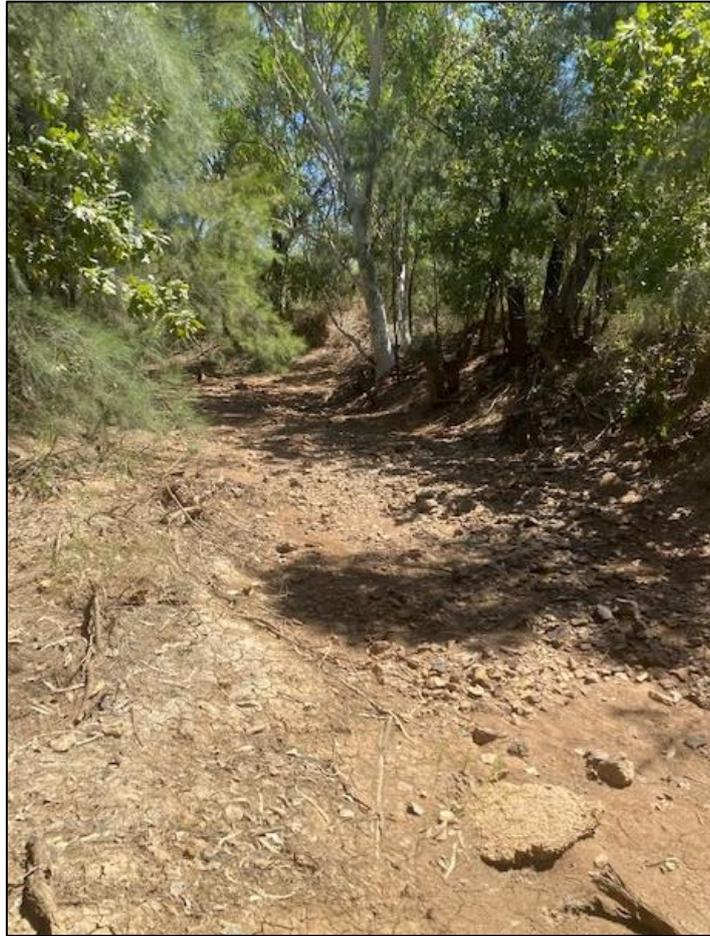
Barney Creek was identified as a potential sensitive receptor, however the spill occurred approximately 40 m from Barney Creek and on close inspection there were no visible signs of concentrate in or surrounding Barney Creek (Figure 4).

The potential for material environmental harm is considered low due to the small volume spilt, the spill being confined to one location on the highway, and the timely remedial response.

Figure 4: Barney Creek, facing north-west. The spill location was approximately 40 metres away from Barney Creek.

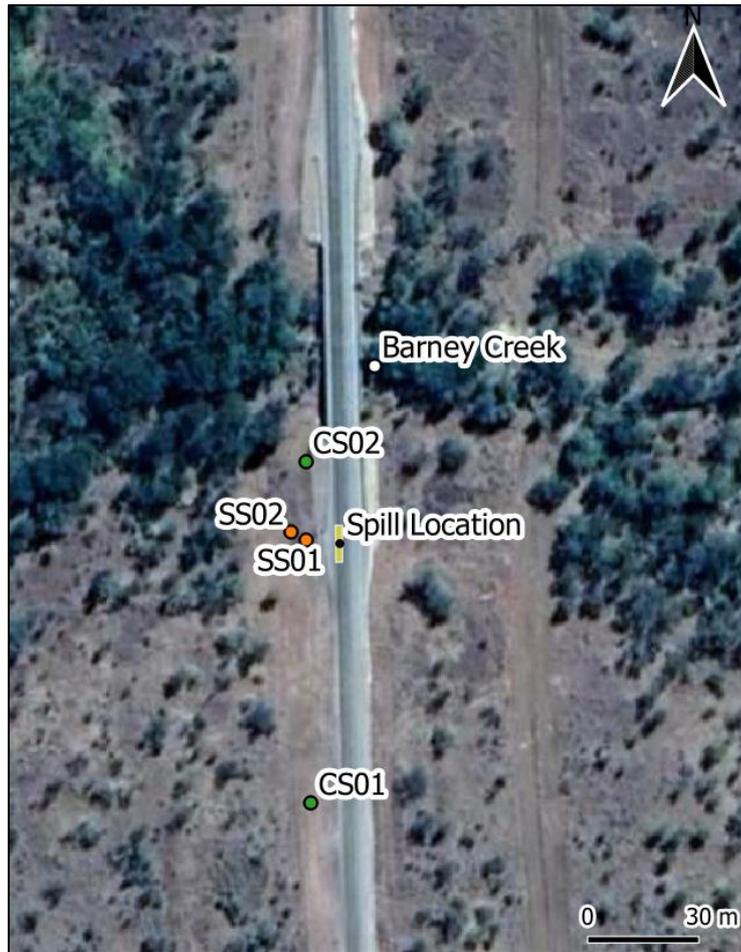
On 17 April 2022, soil samples were collected at four locations within the proximity of the spill location (Figure 5) in accordance with *Australian Standard 4482.1-2005: Guide to the investigation and sampling of sites with potentially contaminated soil*.

Figure 5: Soil sample locations at the spill location.

All soil samples are being analysed for contaminants of concern (i.e., zinc and lead) and results will be compared against the relevant *National Environment Protection (Assessment of Site Contamination) Measure 1999 (NEPM, 1999) Guidelines* to validate remediation was successful. The findings of the soil results will be provided to the NT EPA in due course.
