SECTION 14 INCIDENT REPORT (*Waste Management and Pollution Control Act*)

Date and Time of Notification:	Initial notification was provided by email on 16 August 2023.						
Person / Company:	McArthur River Mining Pty Ltd (MRM)						
Incident:	Spillage of bulk concentrate on the Carpentaria Highway. The concentrate originated from a road train travelling from McArthur River Mine (the Mine) to the Bing Bong Loading Facility (BBLF).						
(a) the incident causing or threatening to cause pollution	A road train travelling from the Mine to the BBLF unknowingly spilled approximately 5 kilograms (kg) of bulk concentrate on the Carpentaria Highway.						
(b) the place where the incident occurred	<p>The incident occurred on the Carpentaria Highway, approximately 650 metres (m) southwest of the BBLF entrance. A reference map is provided in Attachment A.</p> <p>The Global Positioning System (GPS) points for the incident location are provided in Table 1 below.</p> <p><i>Table 1 – GPS co-ordinates of the incident location.</i></p> <table border="1" data-bbox="454 1283 1034 1391"> <thead> <tr> <th>Incident location</th> <th>Easting</th> <th>Northing</th> </tr> </thead> <tbody> <tr> <td>Carpentar

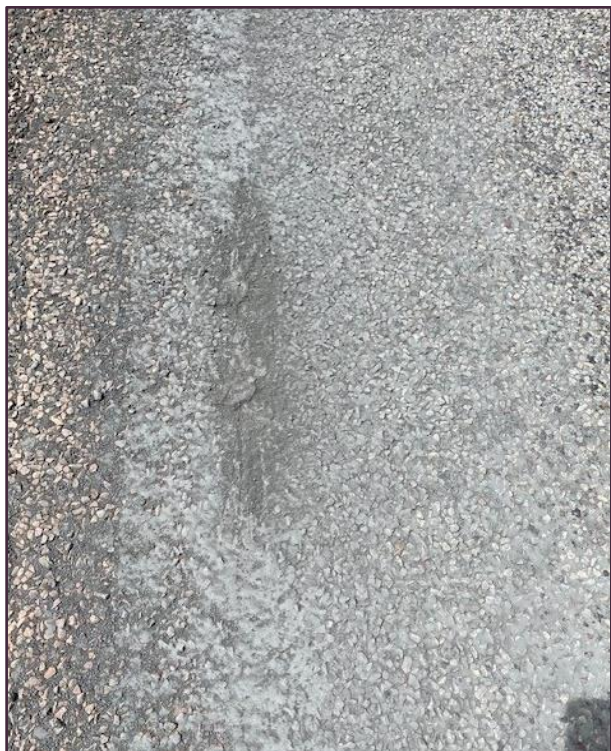
<p>(d) how the pollution has occurred, is occurring or may occur</p>	<p>As shown in the photographs provided, the volume of concentrate spilled was minor and was contained to the bitumen highway and immediate roadside (refer Image 1 and 2 in Attachment B). The area of impact is estimated to be 0.004 hectares (ha).</p> <p>The risk of environmental harm from this incident is considered low, because:</p> <ul style="list-style-type: none"> ▪ The extent of concentrate loss was limited to the bitumen road and immediate roadside. ▪ Remediation works were completed within 24 hours of the incident being reported to the MRM Environment Team, minimising the potential risk of migration beyond the incident location. ▪ The incident occurred during the dry season. As a result, no rainfall occurred in the period between the incident occurring and completion of clean-up works. This is confirmed by the Bureau of Meteorology weather observations provided in Attachment C. ▪ No sensitive receptors were impacted as a result of the incident or subsequent remediation works.

Image 1: Bulk concentrate observed on the Carpentaria Highway.

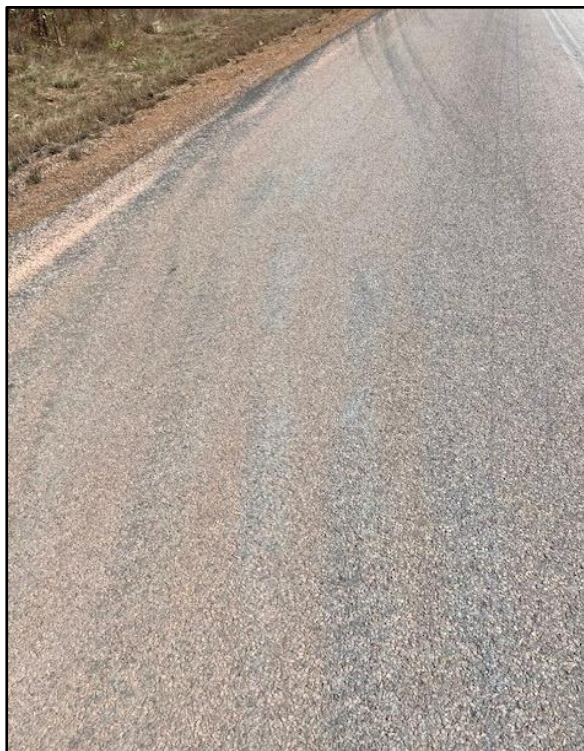
Image 2: Extent of bulk concentrate loss along the Carpentaria Highway.

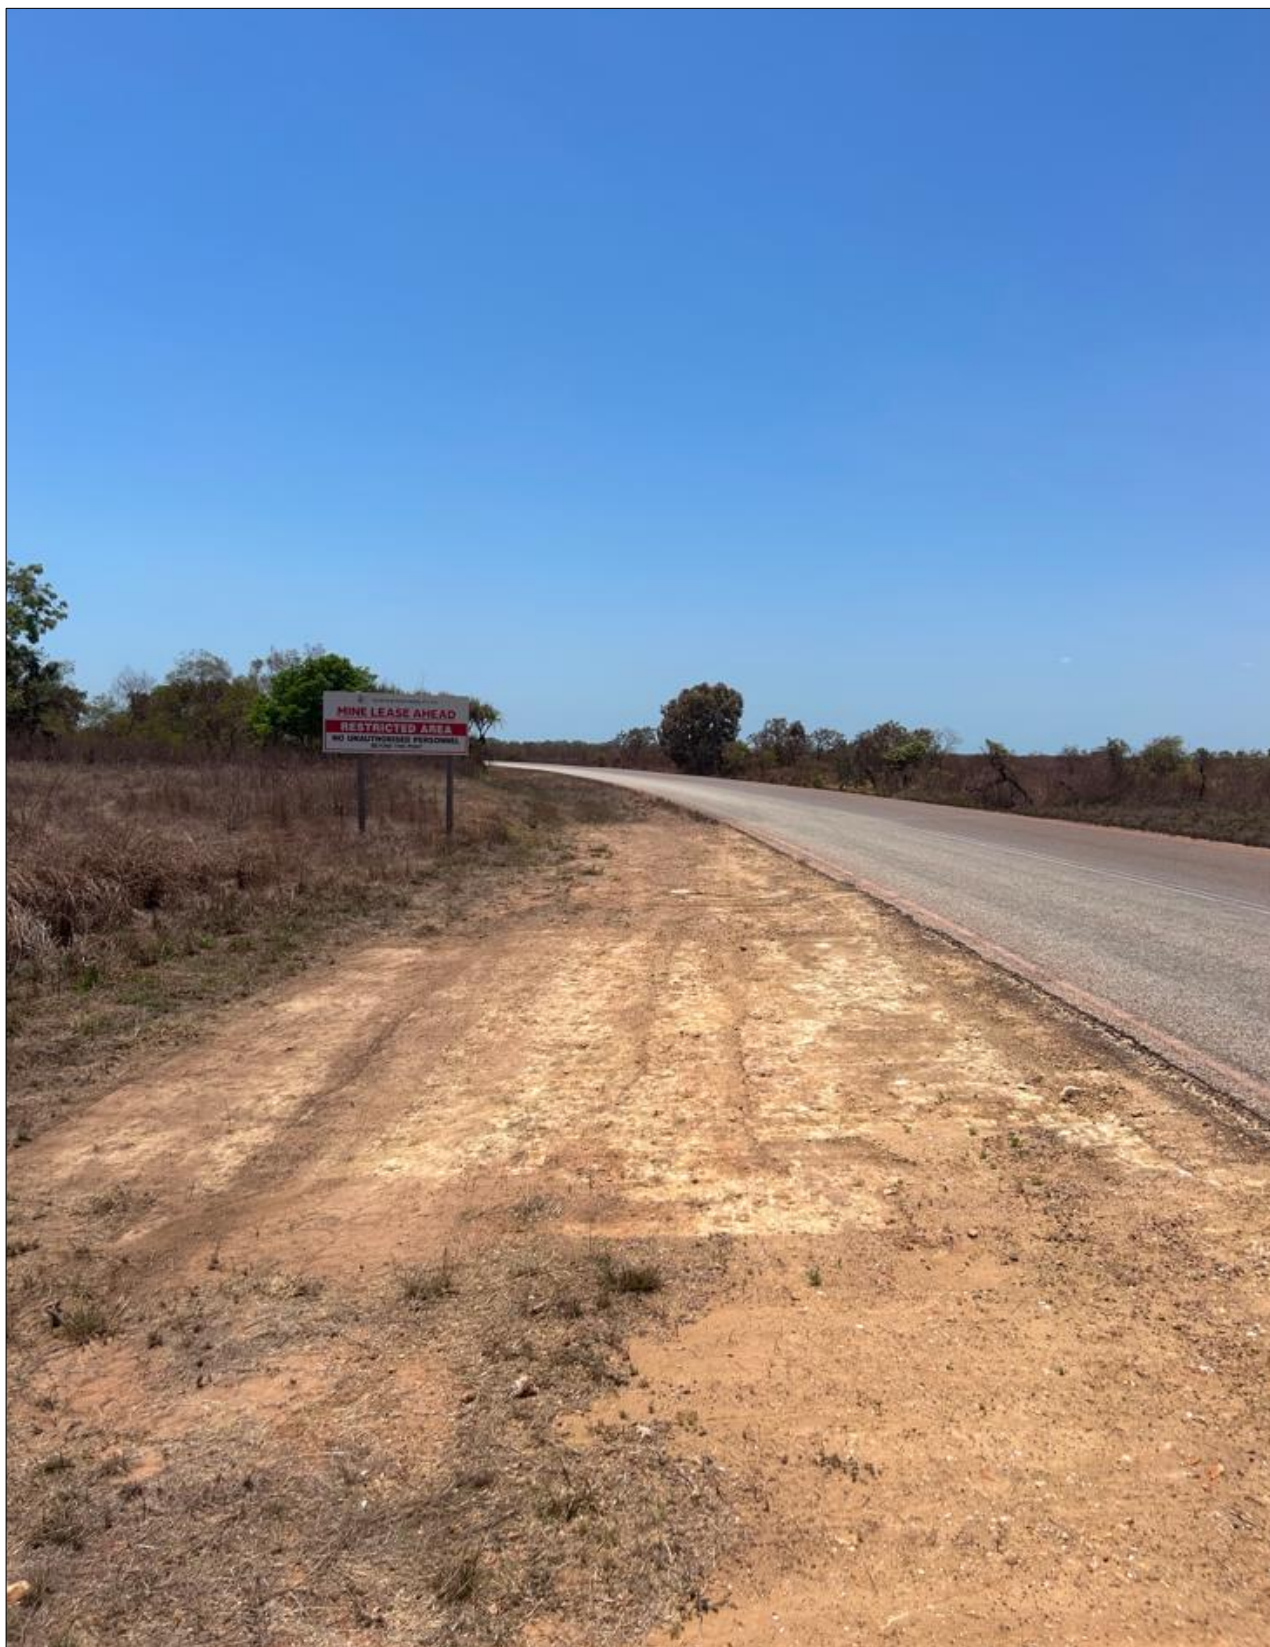
While one sample taken within the investigation area (HS4) exceeded the EIL for zinc, the concentration of 4,960 milligrams per kilogram (mg/kg) is less than that detected at control sites CS2 and CS4 which reported 5,790 and 6,980 mg/kg respectively.

However, for the avoidance of doubt, MRM conducted further remediation works at the incident location to reduce the metal concentrations at HS4 (refer Image 5 in **Attachment B**). Final sample results are provided in the table below.

Image 5: Additional remediation works 10 October 2023; a bobcat was again used to remove potentially impacted surface material from the roadside adjoining the incident location.

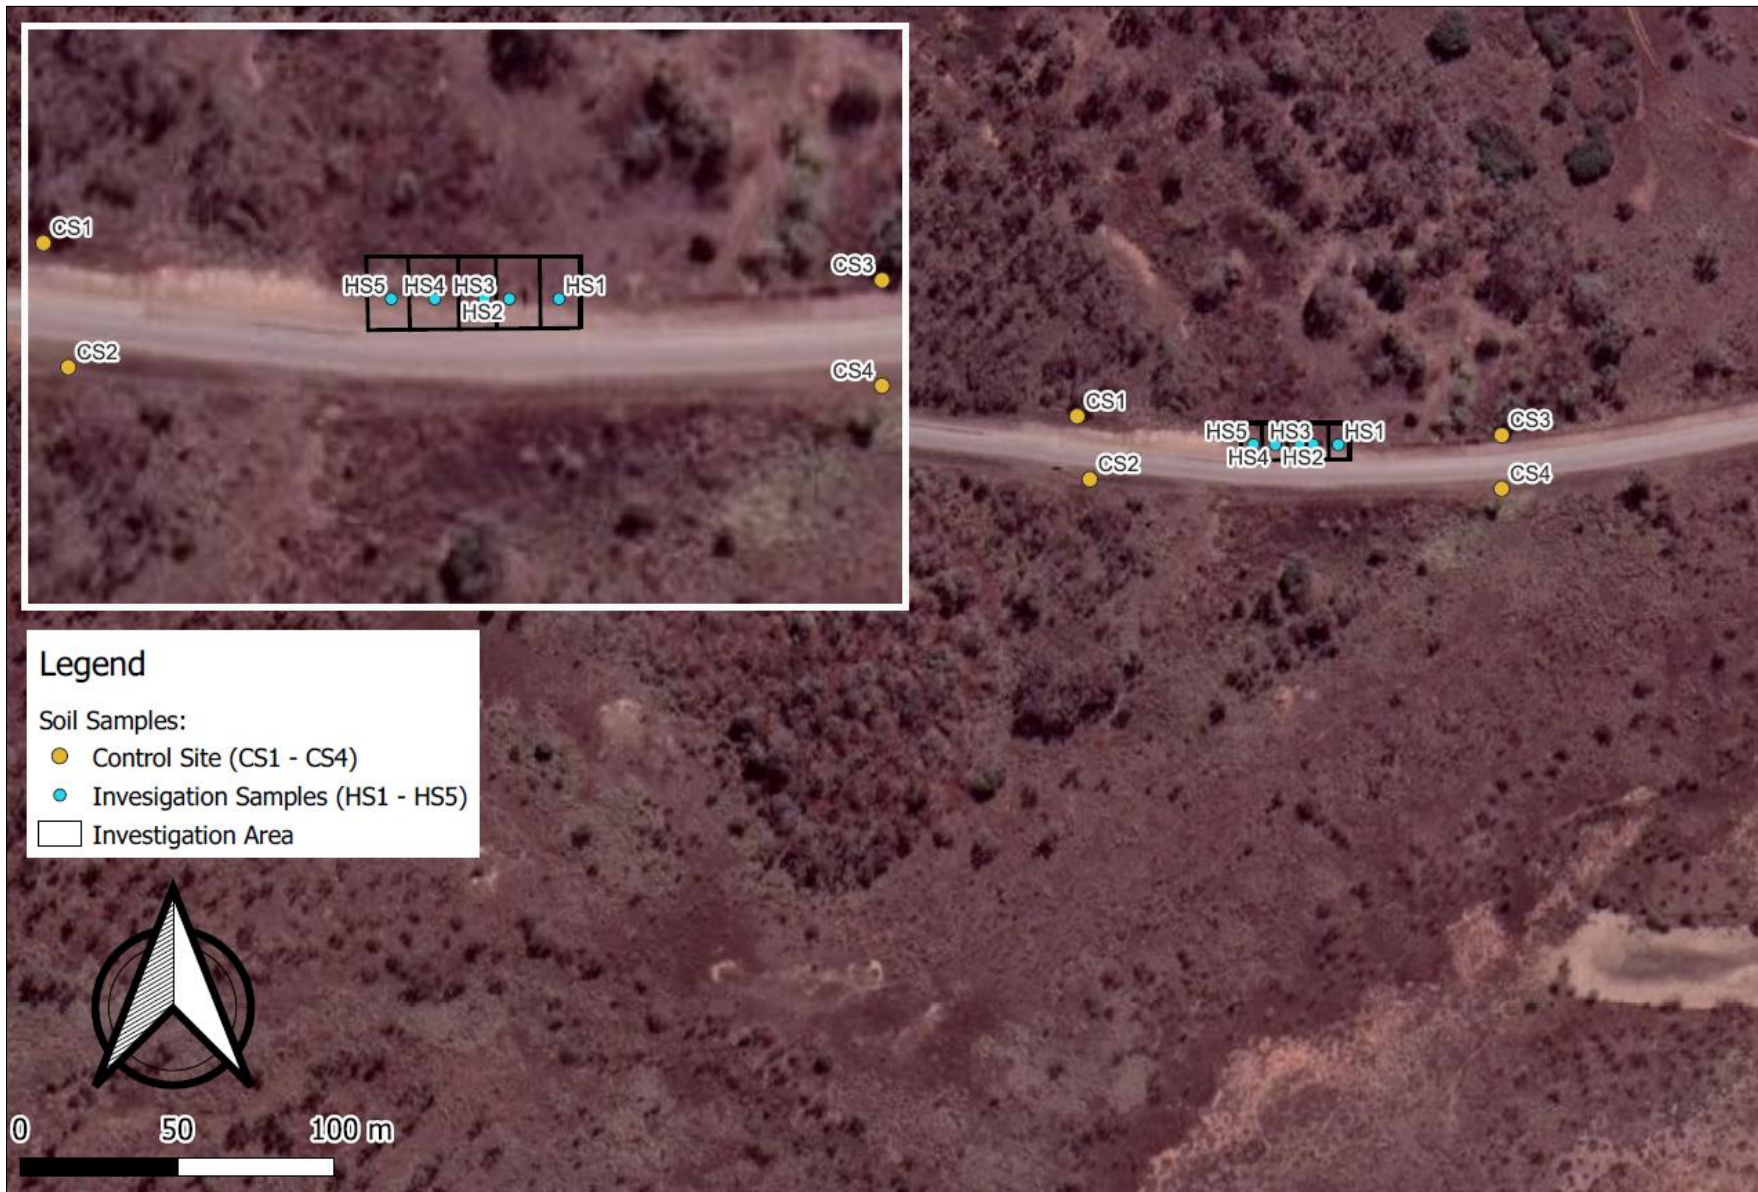
Control samples (CS1 to CS4) recorded elevated zinc and lead concentrations greater than those taken from the incident location. Of the four control samples collected, two exceeded the EIL for zinc, and also recorded elevated lead concentrations. These two samples were taken from the opposite side of the highway to that of the incident location (as demonstrated in **Attachment D**), and therefore cannot be attributed to the incident.

Figure 2: Locations of soil sampling undertaken at the Incident location to verify successful remediation.
