SECTION 14 INCIDENT REPORT (*Waste Management and Pollution Control Act*)

Date and Time of Notification:	Tuesday 5 th April 2022
Person / Company:	Power and Water Corporation (PWC)
Incident:	Wilora (Stirling) power station diesel fuel leak

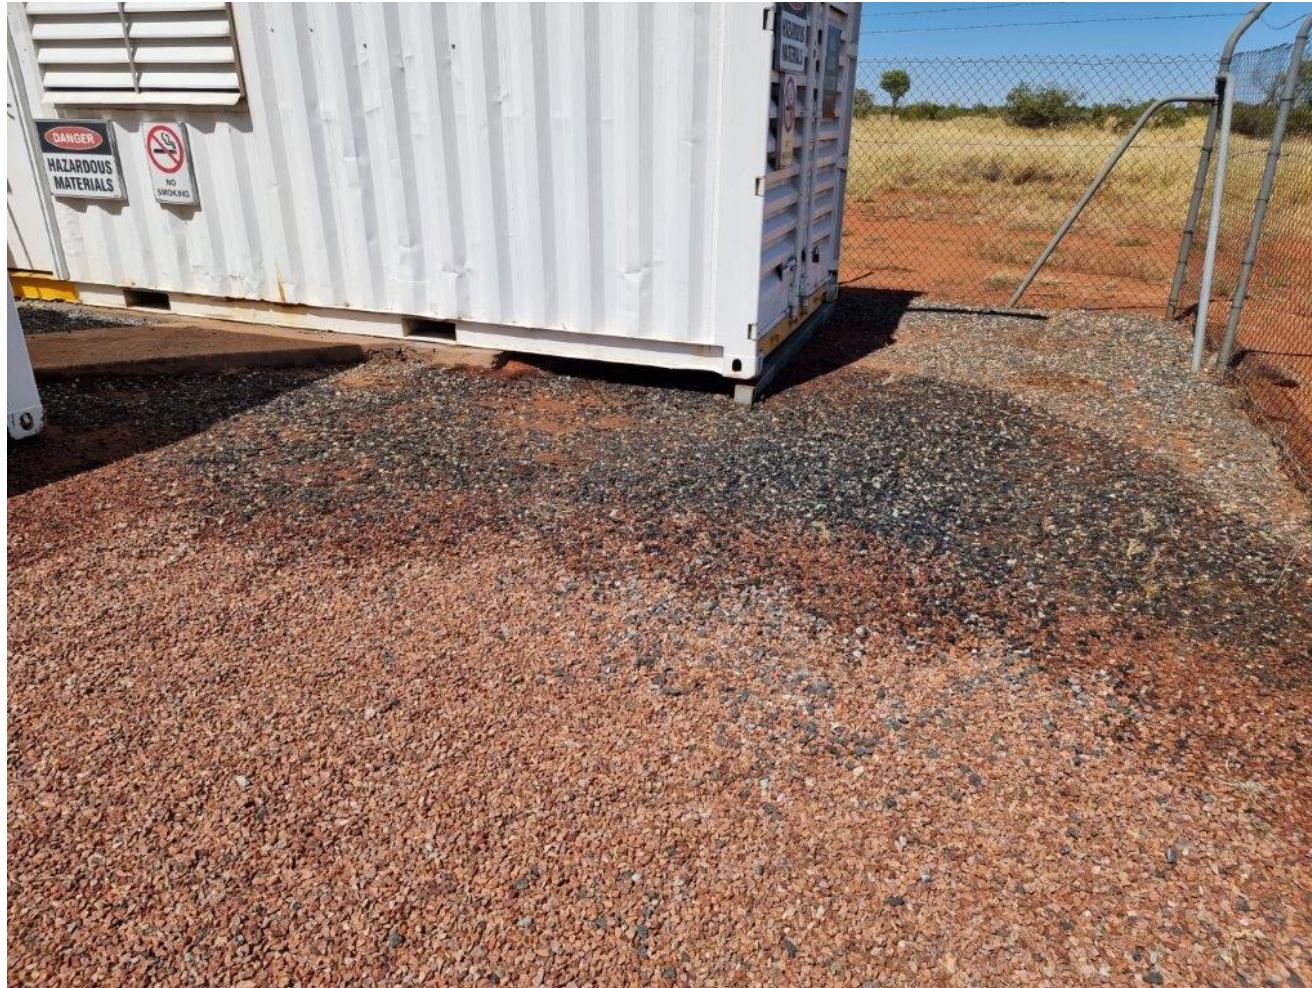
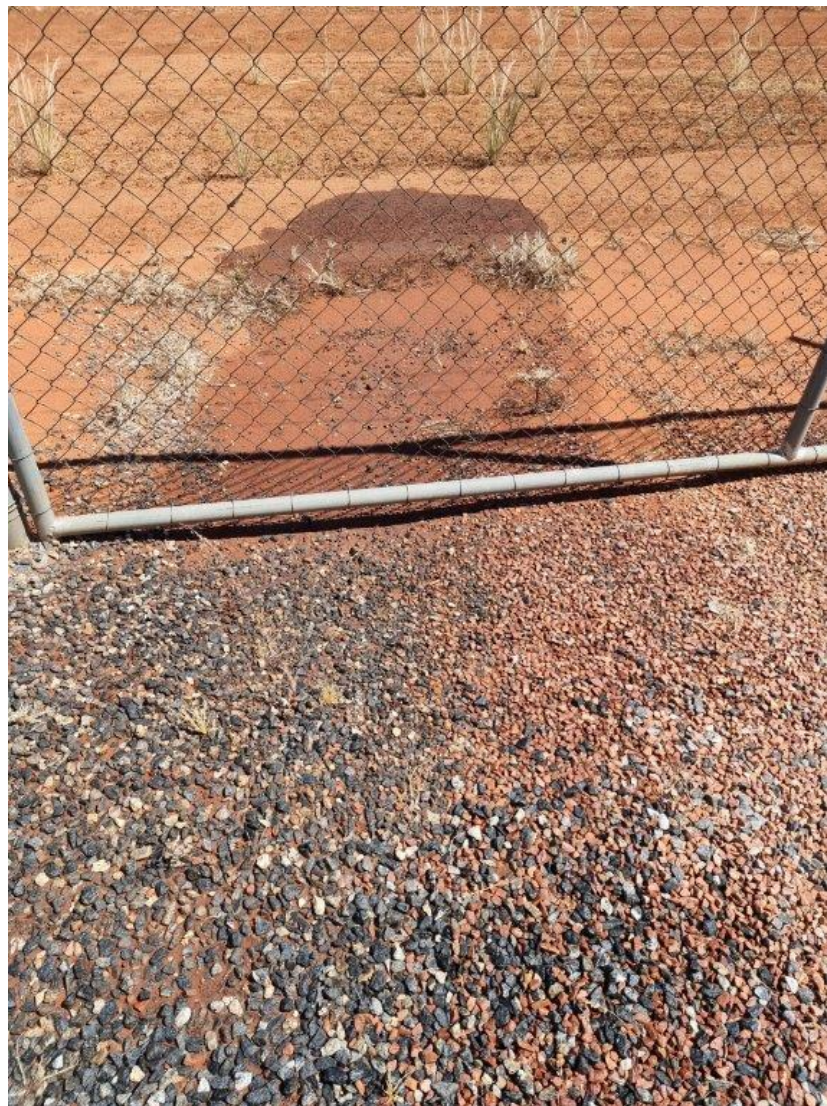
Appendix B – Photographs of the spill site.

(a) the incident causing or threatening to cause pollution	<p><i>i. Description of the waste that was discharged.</i></p> <p>Diesel fuel</p> <p><i>ii. Volume of the waste that was discharged.</i></p> <p>The volume of diesel is estimated to be around 12,000 litres that spilled, based on tank fuel dips and calculations of average fuel use. The majority having escaped the generator's container building and seeped into the surrounding soil.</p>

(b) the place where the incident occurred	<p><i>i. Description of the PWC asset from which the discharge occurred.</i></p> <p>Generator number 1 within the Wilora (Stirling) power station, from a faulty fuel float shut off valve, caused by a hole in the float within the shut off valve.</p> <p><i>ii. GPS coordinates of the discharge point from the PWC asset, and the final coordinates of the final discharge point.</i></p> <p>Discharge Point: 133.7298640, -21.7402612 Final Discharge Point: 133.7298187, -21.7402278</p> <p><i>iii. Indicate any locations nearby to the discharge point where public can gain ready-access, such as public open spaces through which the discharge moves.</i></p> <p>There is only a very small area outside the power station compound where the public has access to the spill site; the vast majority is within the power station's fenced compound. Temporary fencing will be erected to eliminate access by pedestrians.</p>

<p>over the weekend. The spill was stopped immediately after becoming aware of it.</p> <p><i>ii. How PWC were notified, or became aware of the discharge.</i></p> <p>PWC Environmental Services first became aware of the event at 16:54hrs on the 4th March 2022 via notification from the Mechanical Coordinator.</p> <p><i>iii. The process by which the discharge occurred.</i></p> <p>The leak is due to a faulty fuel shut off valve, the float inside the shut off valve had a hole in it, causing it to fill up with diesel and hence not function as a float anymore, making the shut off valve inoperable, resulting in an overflow from the breather valve.</p> <p><i>iv. The reason why the discharge occurred.</i></p> <p>A faulty fuel shut off valve.</p>

(d) how the pollution has occurred, is occurring or may occur	As per (c) iii & (c) iv.
(e) the attempts made to prevent, reduce, control, rectify or clean up the pollution or resultant environmental harm caused or threatening to be caused by the incident	<p><i>i. Confirmation signage and fencing has been erected, as appropriate.</i></p> <p>The spill largely occurred within the fenced power station compound, and only a small affected area is outside the fence line. Where needed, temporary fencing will be erected, to eliminate access by pedestrians.</p> <p><i>ii. Decontamination of the site as appropriate.</i></p> <p>The ESO has cleaned the diesel spilt within the power house floor utilising spill kit materials.</p> <p>The ESO is sourcing plastic sheeting to cover the contaminated soils to prevent human contact, and assist with shielding from any potential weather events.</p> <p>A civil contractor will attend the site this Thursday, and carry out an initial inspection of the extent of the spill and carry out any immediate excavation of contaminated soils if possible and safe to do so.</p> <p>Environmental consultants have also been engaged to undertake a preliminary site investigation and assist in the remediation of the spill, in consultation with PWC staff. More details will be provided as they become available.</p>
