SECTION 14 INCIDENT REPORT (*Waste Management and Pollution Control Act*)

Date and Time of Notification:	Thursday 3 rd March 2023, 15:39hrs
Person / Company:	Power and Water Corporation (PWC)
Incident:	Discharge of sewage from sewage network

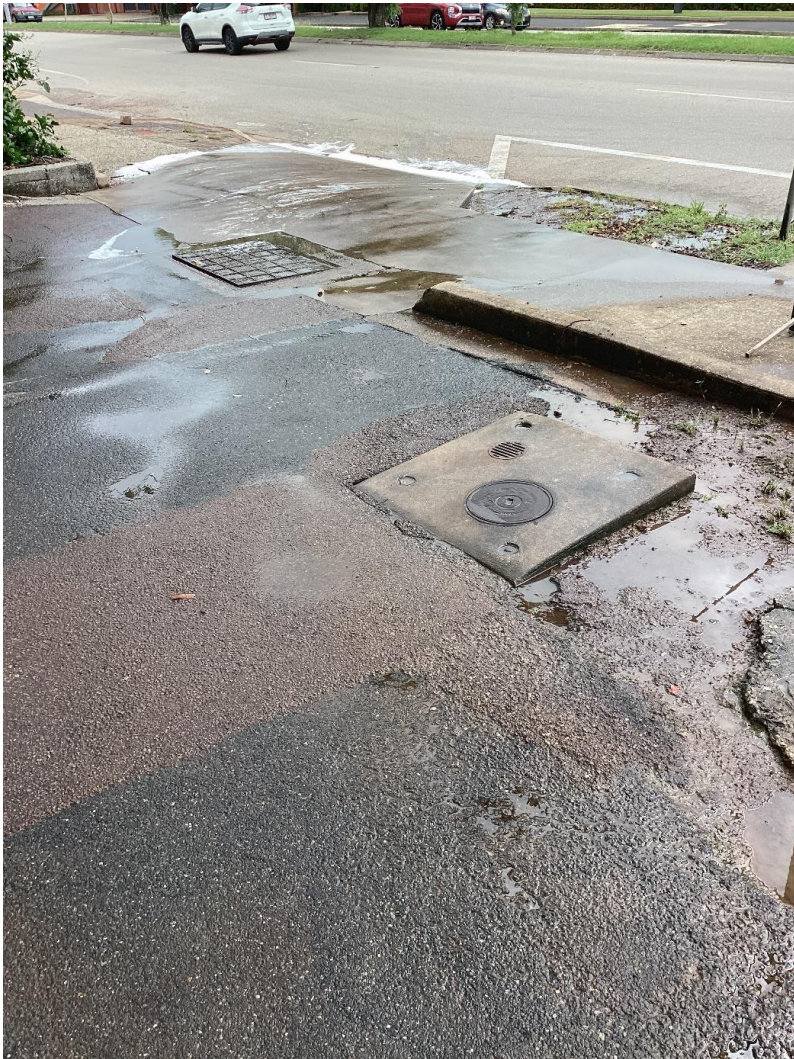
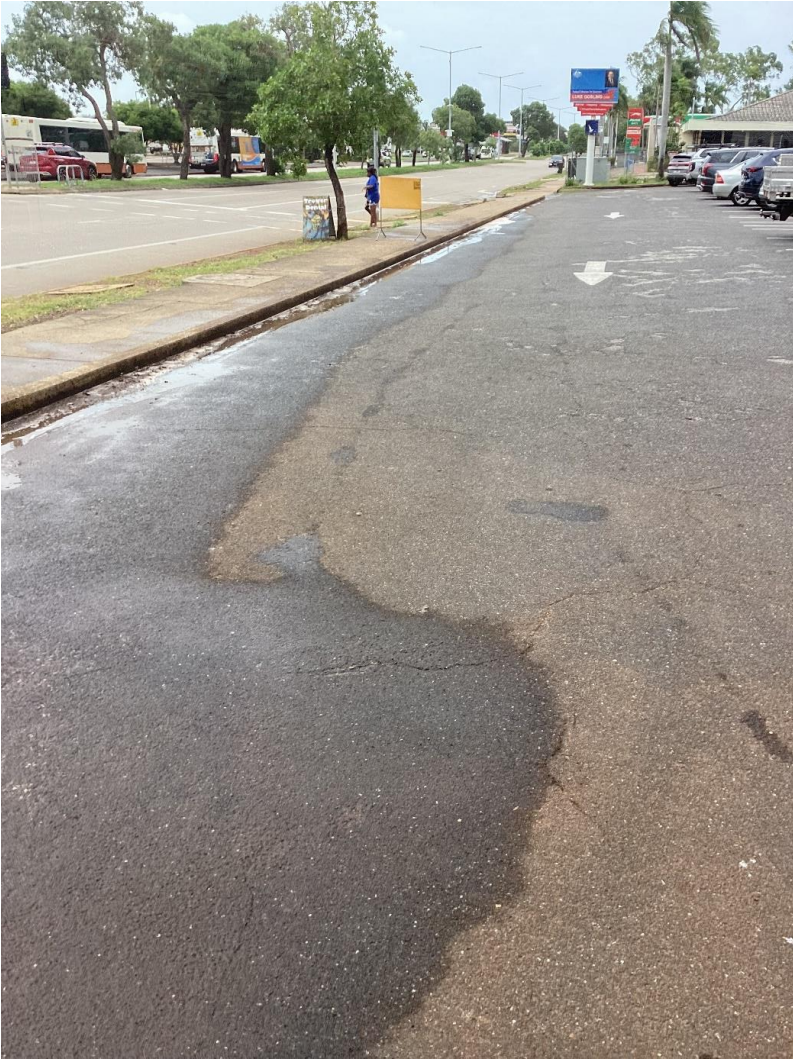
(c) the date and time of the incident	<p><i>i. The time and date of commencement and cessation of the discharge.</i></p> <p>The commencement time of the overflow is unknown. The overflow was observed at approximately 14:30hrs by Power and Water staff on 02/03/2023, and the spill was stopped by 15:30hrs 02/03/2023.</p> <p><i>ii. How PWC were notified, or became aware of the discharge.</i></p> <p>A member of the public advised Power and Water, who then dispatched a sewer reticulation field crew to initiate repairs and make the area safe.</p> <p><i>iii. The process by which the discharge occurred.</i></p> <p>It is believed that tree roots caused a partial blockage of the sewer main downstream of the inspection opening, which then caused sewage to build up within the sewer line and eventually overflow.</p> <p><i>iv. The reason why the discharge occurred.</i></p> <p>As per (c) iii, Sewerage network infrastructure has been designed to overflow with the best public health and environmental outcomes possible. Design focuses on not overflowing directly inside houses; rather discharge is designed to occur in a controlled manner at locations which can be accessed for infrastructure repair and clean up and with minimal public health or environmental impacts.</p>

Appendix B – Photographs of the discharge point and travel path to final discharge point (stormwater drain), post clean-up

Environment. Blockage was cleared and upon resolution of the blockage, the site was left in a clean state, free from any gross pollutants and the surrounding surface was cleaned and disinfected.
(f) the identity of the person notifying the NT EPA	Power and Water Environmental Team on behalf of Water Services
