Asbestos Clearance Certificate

Client	Removal Site Address	Removalist	Clearance Outcome
Best Contracting	Koongarra Exploration Mining Lease, Nourlangie, Kakadu National Park, Kakadu Highway, Jabiru NT	Asbestos Solutions NT	Pass

Start Date	End Date	Site Address
Tue, 03 Jun 2025	Tue, 03 Jun 2025	Koongarra Exploration Mining Lease, Nourlangie, Kakadu National Park, Kakadu Highway, Jabiru NT

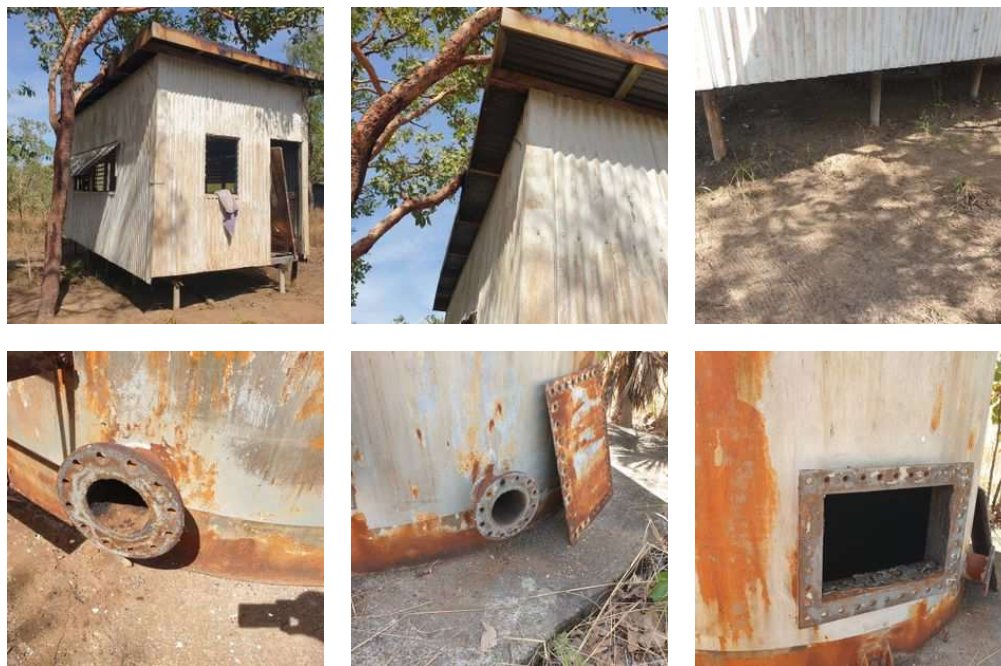
Removal Work Area Photos

ACM Material	Volume (m2/m3) / Qty	Location / Work Area	Notes
Eaves	1.6 m2	Shed / Office	Eaves were only on East side of shed
Debris	Small section of eave damaged with debris on the ground	Shed / Office	Ground surfaces surrounding the shed were raked
Debris	Gasket debris from flanges	Diesel tank	Make safe works only

Inspection of the specific work area(s) detailed in the above table found no visible asbestos or asbestos dust remaining as a result of the asbestos removal work carried out. Yes

Inspection of the external area surrounding the work area(s) detailed in the above table found no visible asbestos or asbestos dust remaining as a result of the asbestos removal work carried out. Yes

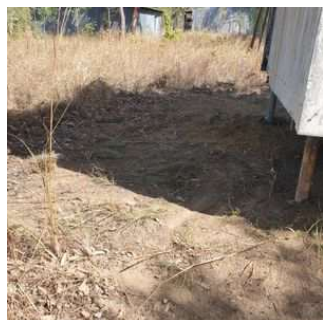
Waste Transit Route & Disposal Storage Area Photos

<p>Inspection of the Waste Transit Area and Disposal storage area found no visible asbestos remaining as a result of the work carried out.</p>	<p>Yes</p>
--	------------

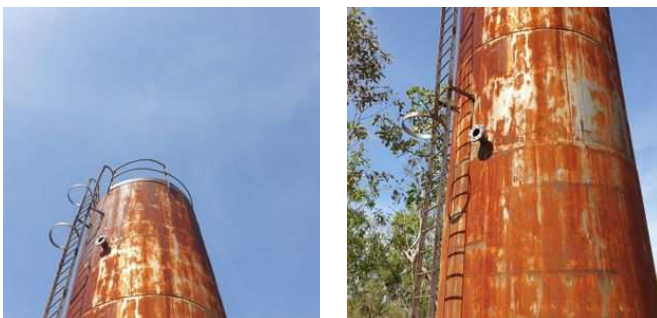
Exclusions Photos

Gaskets from diesel tank could not be removed safely due to working at heights issues or without disturbing friable asbestos containing materials. Asbestos containing debris was removed from the area and gasket surfaces were sealed with PVA glue.
