SECTION 14 INCIDENT REPORT (*Waste Management and Pollution Control Act*)

Date and Time of Notification:	Thursday 19 th May 2022, 16:14hrs
Person / Company:	Power and Water Corporation (PWC)
Incident:	Oil spill from pole mount transformer, caused by a vehicle accident (not PWC related), corner of Toupein Road and Temple Terrace, Palmerston.

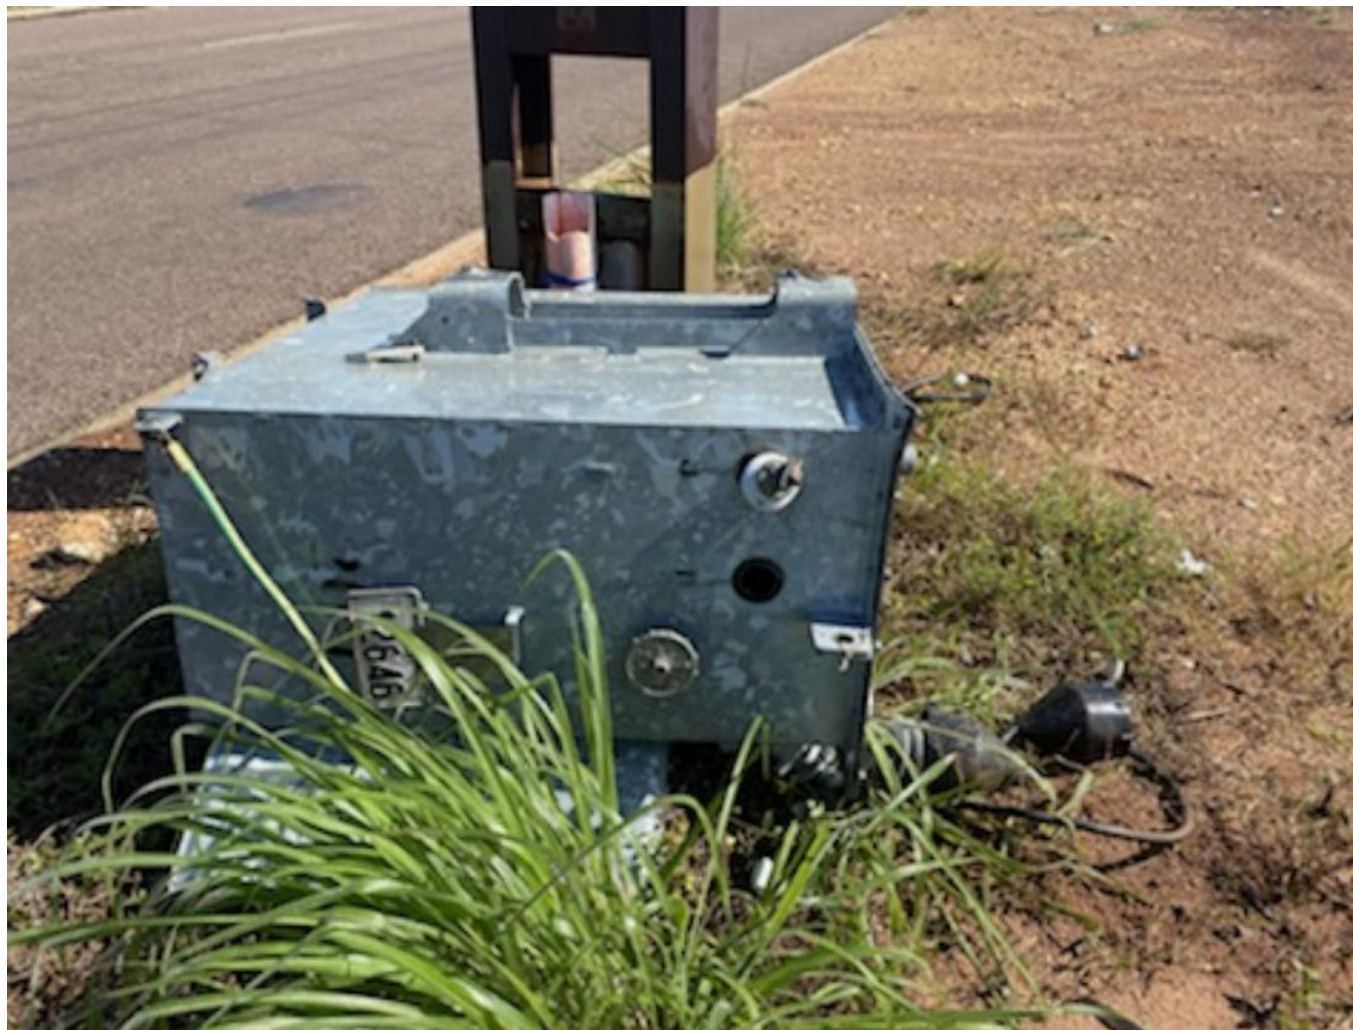
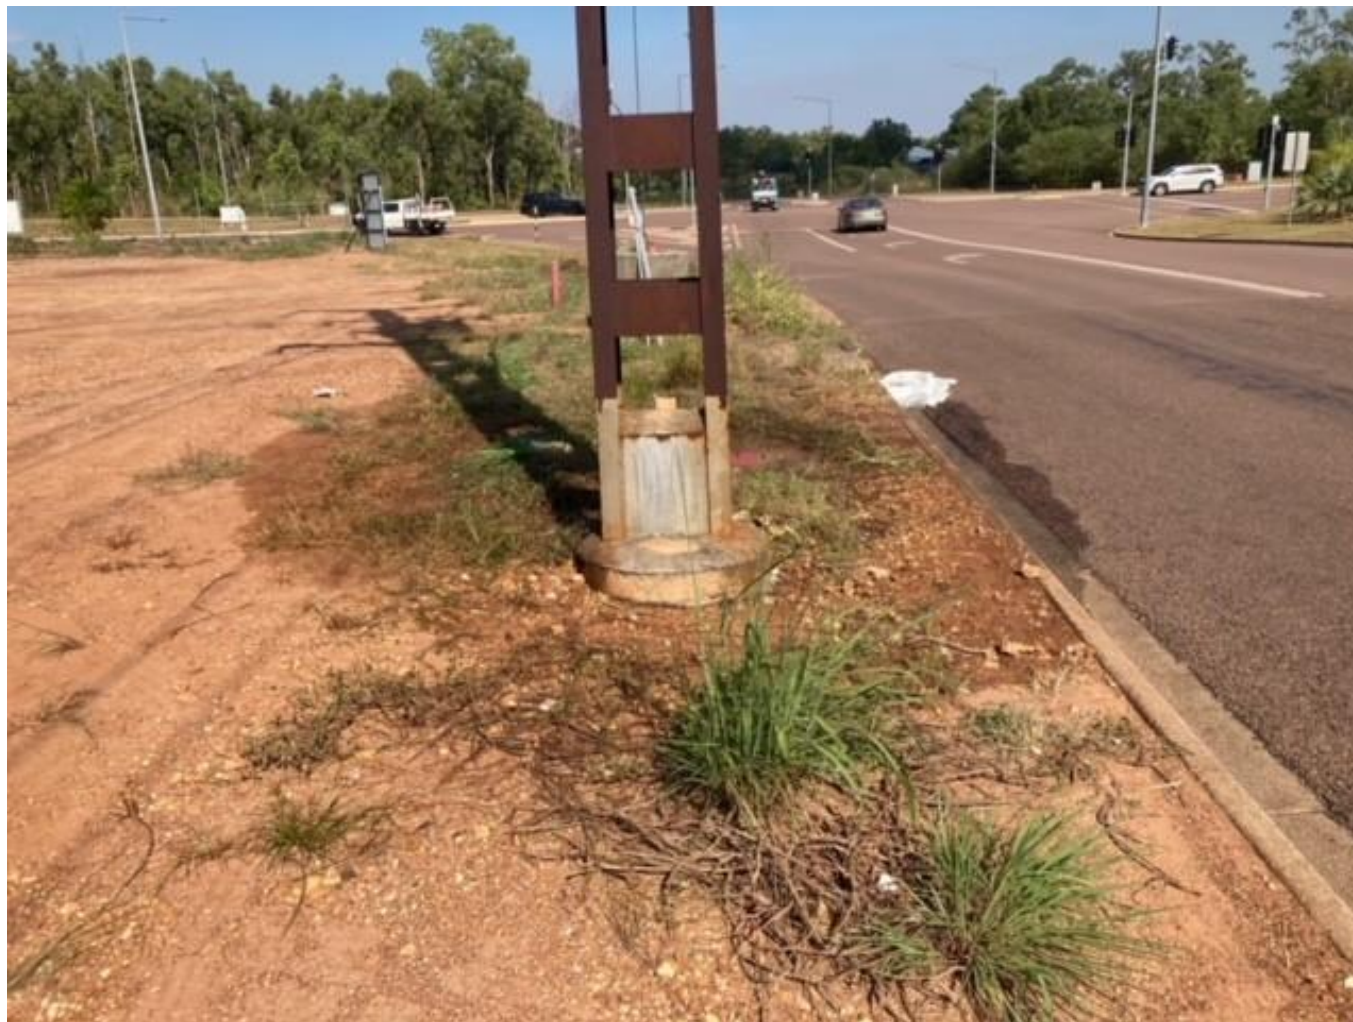
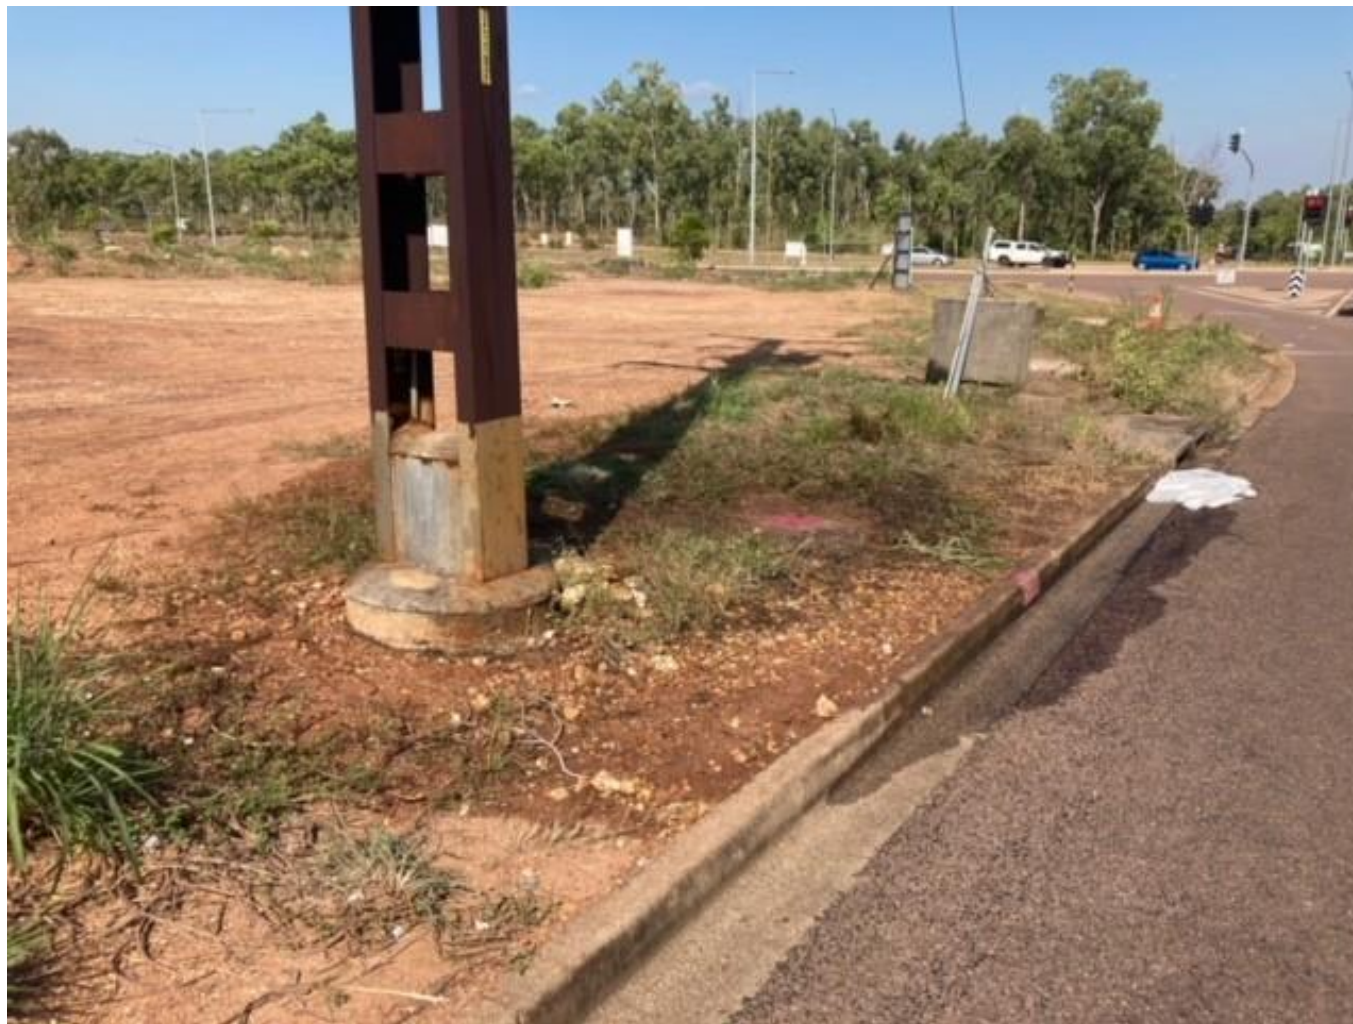
Appendix B – Photographs of the spill area

(a) the incident causing or threatening to cause pollution	<p><i>i. Description of the waste that was discharged.</i></p> <p>Transformer oil. Not identified as an asset containing PCB.</p> <p><i>ii. Volume of the waste that was discharged.</i></p> <p>The volume of transformer oil spilt is estimated to be 250 litres, with an unknown portion having entered the stormwater drainage network, and the remaining portion having entered the surrounding soils.</p>

(d) how the pollution has occurred, is occurring or may occur	As per (c) iii & (c) iv.
(e) the attempts made to prevent, reduce, control, rectify or clean up the pollution or resultant environmental harm caused or threatening to be caused by the incident	<p><i>i. Attempts made to prevent, reduce or control the discharge</i></p> <p>Upon arrival of the PWC overhead day fault crew, the crew attempted to contain the spill as best as possible with their vehicle spill kits, with booms and sheets being placed in and around the nearby stormwater drain. The asset was repositioned to prevent any further loss of oil.</p> <p>The damaged asset was then placed within a containment bag before being transferred to our operations yard bunded storage area. From which it will go through the Board of Survey (BOS) process, for either repair or most likely scrapping/recycling.</p> <p>The contaminated soil has been excavated from the site and will be disposed of via a licenced contractor. EcOz environmental consultants have been engaged to undertake soil sampling at the base of the excavation to confirm that contaminated materials have been removed before re-instating the site. A closure report containing results will be provided upon completion.</p> <p>The stormwater drain will be cleaned by Palmerston City Council or their preferred contractor, as Power and Water does not have the authority to lift council owned stormwater drains.</p>
