SECTION 14 INCIDENT REPORT (*Waste Management and Pollution Control Act*)

Date and Time of Notification:	Thursday 18 April 2024, 12:04 hrs
Person / Company:	Power and Water Corporation
Incident:	Discharge of treated sewage effluent from the Lajamanu wastewater stabilisation ponds

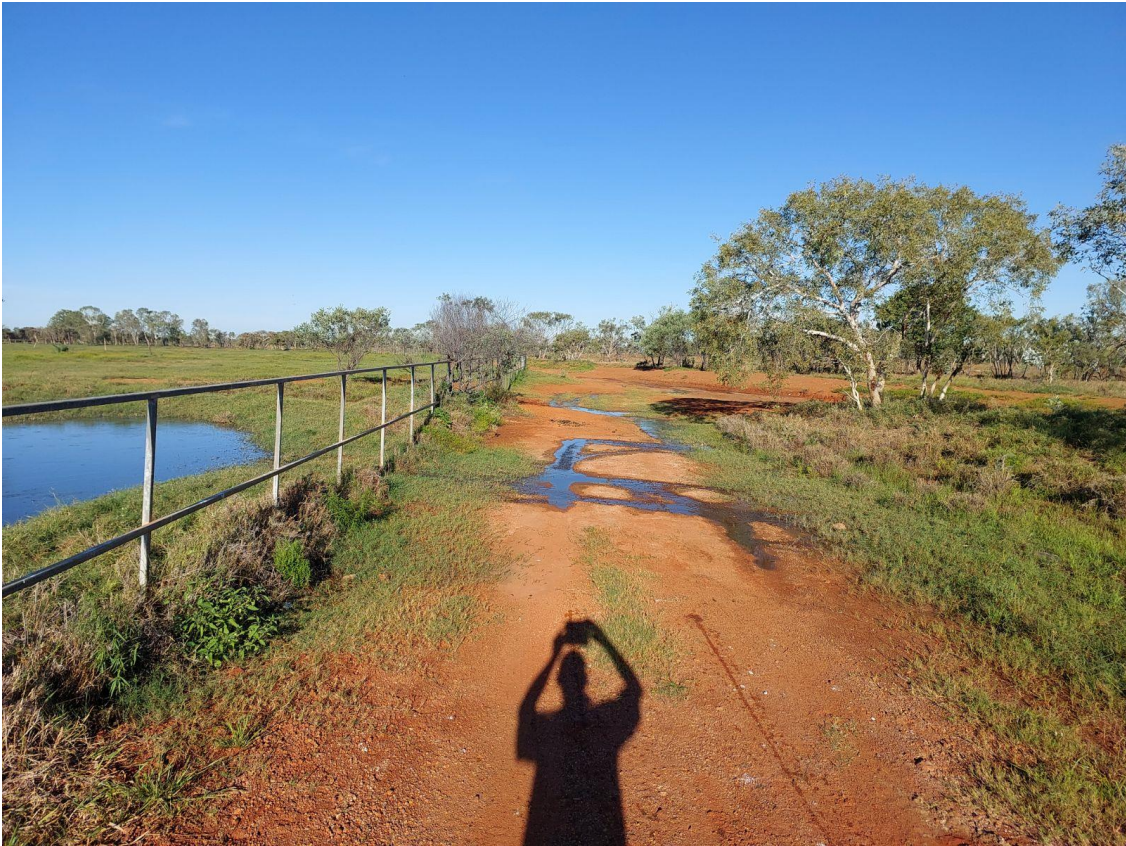
<p>stabilisation ponds fenced site, however it had then spread to the road. Makeshift warning signage has been erected to advise of the hazard. Access is in the process of being further restricted by use of barricading tape. Although access cannot be completely prevented, especially from the eastern side.</p>
<p>(c) the date and time of the incident</p>	<p><i>i. The time and date of commencement and cessation of the discharge.</i></p> <p>The timing of the overflow is unknown. Access to the facility has been prevented by the impassable road condition. The Utility Services Contract worker (USC), previously known as the Essential Services worker (ESO) responsible for this community only advised the Katherine Power and Water Co-ordinator recently of the overflow. The spill was being managed by pumping down pond levels to a drier area in the irrigation field, with a flexidrive pump, which caused the ponds to stop overflowing around lunchtime 18/04/2024</p> <p><i>ii. How Power & Water were notified or became aware of the discharge.</i></p> <p>The UCSW found that the ponds were overflowing, during a recent site inspection that was unfortunately delayed due to the recent extreme weather and flooding in the area preventing access to the ponds.</p> <p><i>iii. The process by which the discharge occurred.</i></p> <p>The cause of the overflow is recent high rainfall in the area, that led to elevated inflow volumes, exacerbated by a pump that had failed; potentially due to a lack of maintenance being able to be performed in the period of no access i.e., cleaning of filter screens.</p> <p><i>iv. The reason why the discharge occurred.</i></p> <p>As per (c) iii, Very high rainfall in the area.</p>

Figure 1. Discharge outside of facilities boundary, leading to Duck Ponds Access Road.

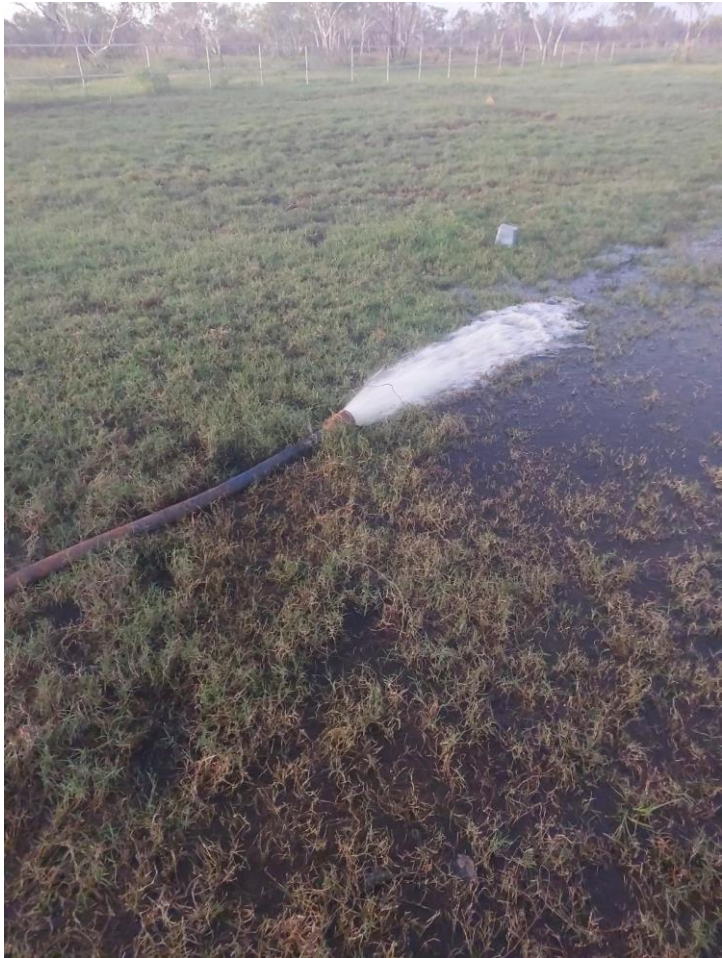
Figure 2. Discharge from current pumping to reduce pond levels, showing effluent quality.

<p>(d) how the pollution has occurred, is occurring or may occur</p>	<p>As per (c) iii & (c) iv.</p>
<p>(e) the attempts made to prevent, reduce, control, rectify or clean up the pollution or resultant environmental harm caused or threatening to be caused by the incident</p>	<p><i>i. Confirmation signage and fencing has been erected, as appropriate.</i></p> <p>Makeshift signage has already been erected on Duck Ponds Access Road warning of the hazard. Barricading tape or other available materials are being used to further warn of the hazard and reduce the possibility of the public contacting the spill.</p> <p><i>ii. Decontamination of the site as appropriate.</i></p> <p>Site was inspected for any wastewater gross pollutants, of which none were observed, as this is treated wastewater, that has already gone through all three ponds, although the retention time in pond three may have been reduced.</p>
