## SECTION 14 INCIDENT REPORT (*Waste Management and Pollution Control Act*)

<b>Date and Time of Notification:</b>	Tuesday 26 <sup>th</sup> October 2021, 13:14hrs
<b>Person / Company:</b>	Power and Water Corporation ( <b>PWC</b> )
<b>Incident:</b>	Discharge of raw sewage from sewerage network

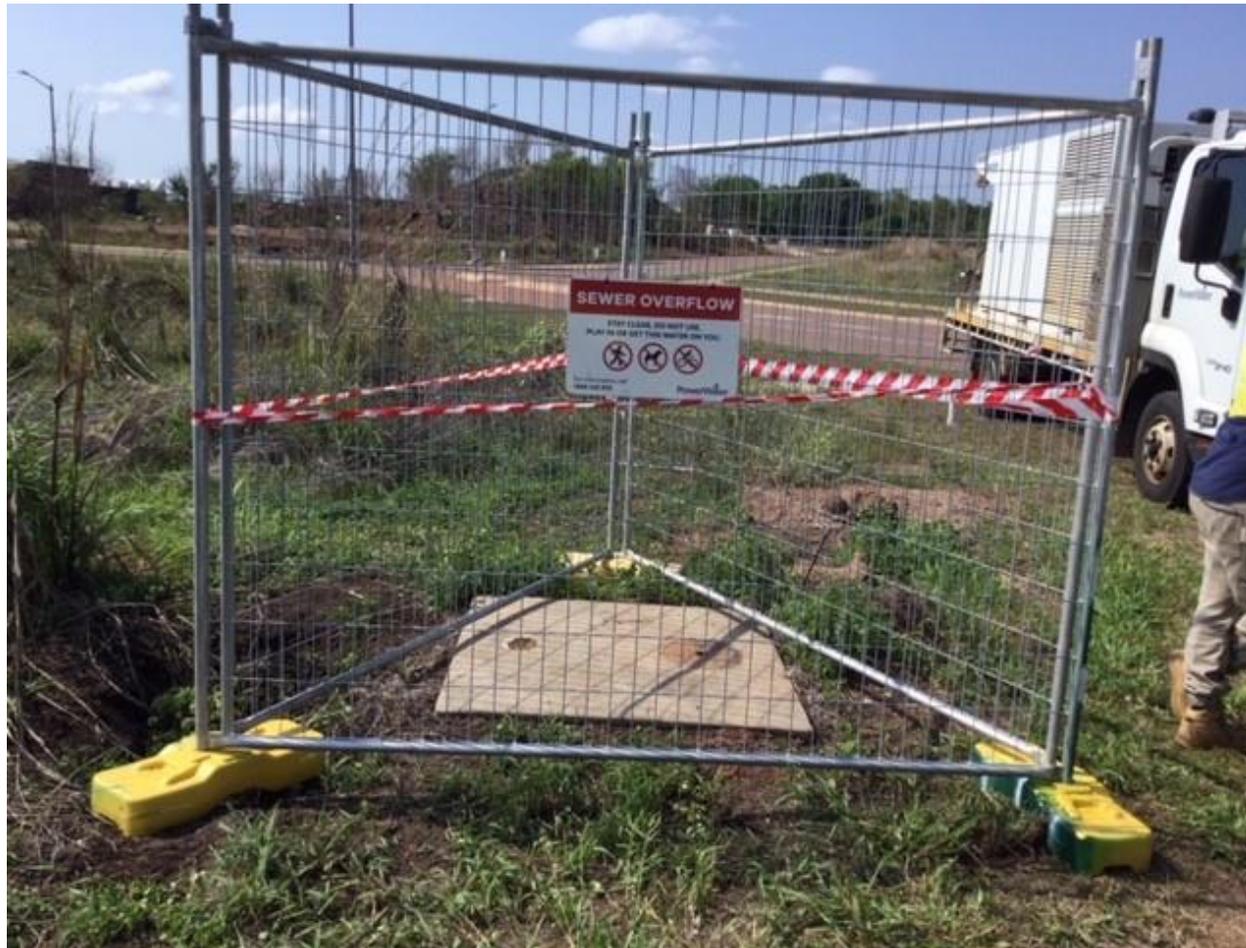
Appendix B – Photograph of fencing and warning signage

<p><b>(d) how the pollution has occurred, is occurring or may occur</b></p>	<p>As per (c) iii &amp; (c) iv.</p>
<p><b>(e) the attempts made to prevent, reduce, control, rectify or clean up the pollution or resultant environmental harm caused or threatening to be caused by the incident</b></p>	<p><i>i. Confirmation signage and fencing has been erected, as appropriate.</i></p> <p>Fencing and signage was erected around the manhole. The area immediately around the manhole, as well as the roadside between the manhole and the stormwater drain was cleaned and disinfected, consistent with the PWC Sewage Spills/Overflow Response Work Instruction, as appropriate to the location.</p> <p><i>ii. Decontamination of the site as appropriate.</i></p> <p>Clean up consistent with Sewage Spills/Overflow Response Work Instruction as appropriate to the location, and to minimise risk to the Environment. Site inspected for any gross pollutants, and the area disinfected.</p>
