SECTION 14 INCIDENT REPORT (*Waste Management and Pollution Control Act*)

Date and Time of Notification:	Sunday 18/09/2022 08:59hrs
Person / Company:	Power and Water Corporation (PWC)
Incident:	Overflow of fully treated effluent

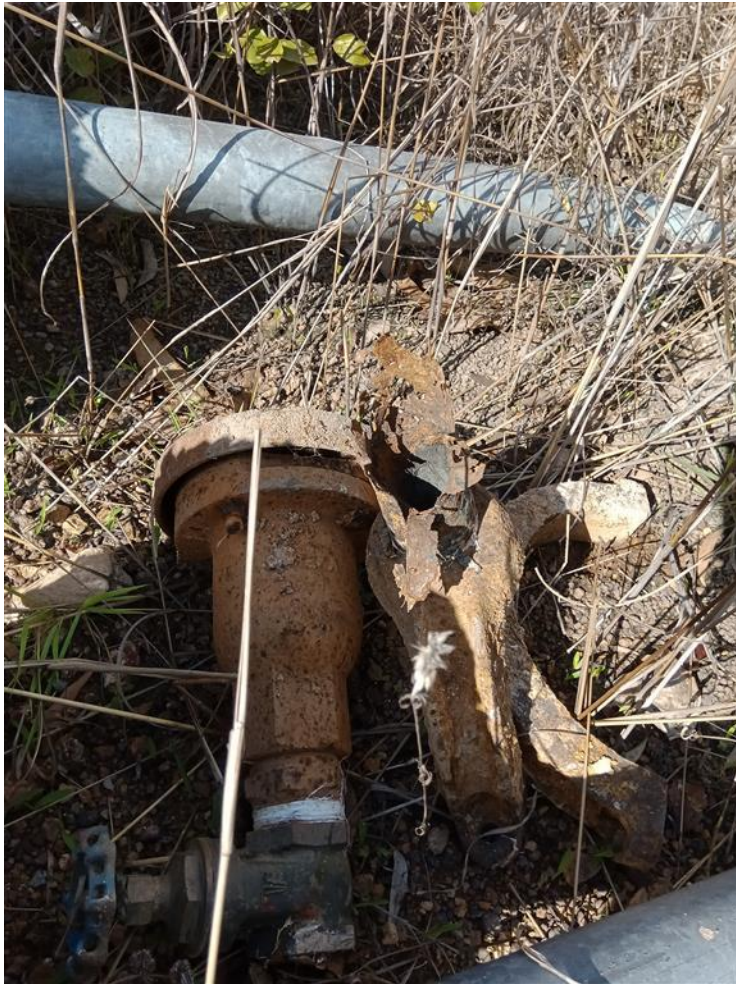
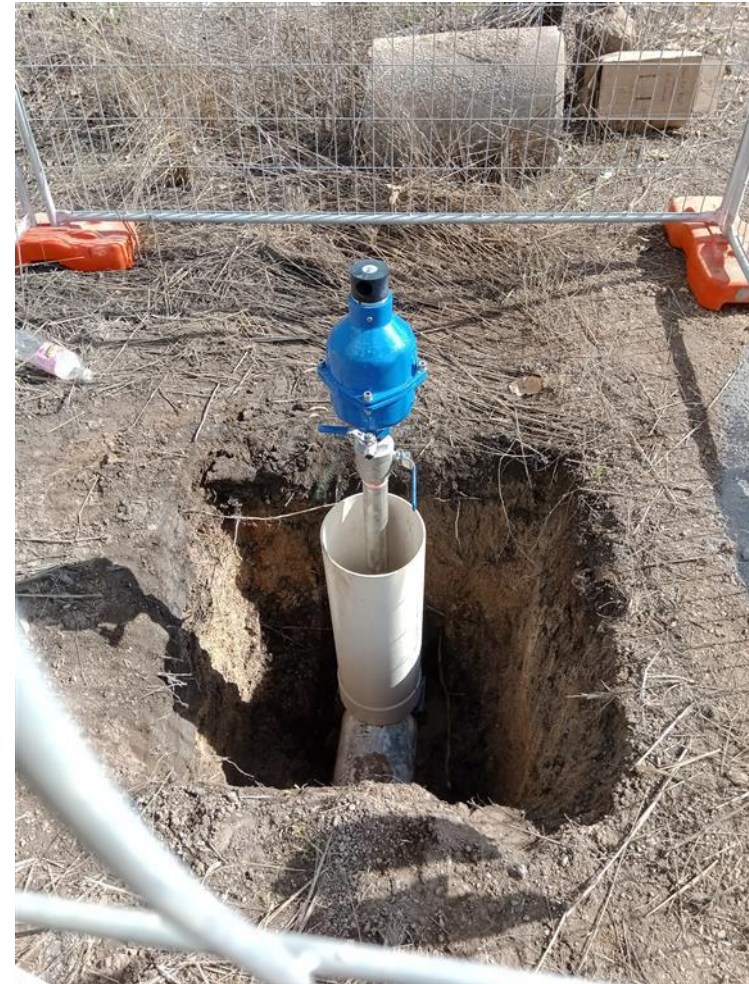
(c) the date and time of the incident	<p><i>i. The time and date of commencement and cessation of the discharge.</i></p> <p>Start date is the 16th September 2022, around 10:00hrs. PWC staff first observed the discharge at 09:00hrs on the 17th September 2022 and was stopped by 10:00hrs on the 17th September 2022.</p> <p><i>ii. How PWC were notified, or became aware of the discharge.</i></p> <p>A member of the public that was in the area notified PWC at approximately 08:00hrs on the 17th September 2022.</p> <p><i>iii. The process by which the discharge occurred.</i></p> <p>A mechanical failure of an air bleed valve on the pipeline, caused by a galvanized piece of pipe associated with the air bleed valve to corrode to the point of failure.</p> <p><i>iv. The reason why the discharge occurred.</i></p> <p>The pipeline being a buried pipeline and vegetation having obscured the view of all of the air bleed and scour valves, preventing proper inspections of these items.</p>

Appendix B – Photographs of the old highly corroded air valve and the newly fitted air valve.

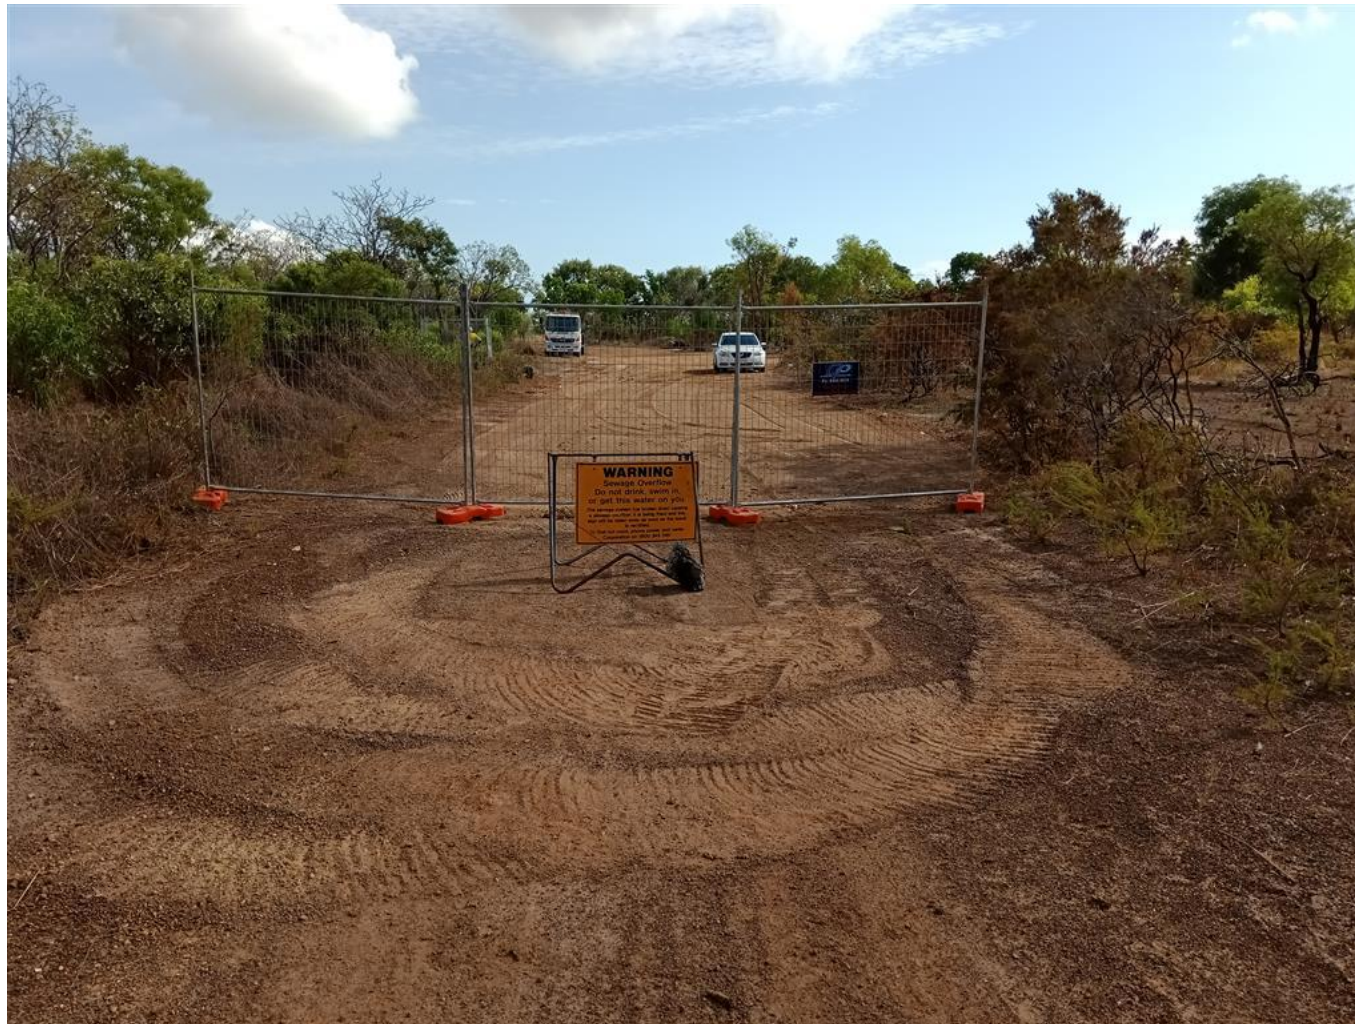
Appendix C – Photograph of the fencing blocking public access and the warning signage erected

<p><i>iii. Indicate any locations nearby to the discharge point where public can gain ready-access, such as public open spaces through which the discharge moves.</i></p> <p>Access to the public is technically possible but unlikely as the track on which the spill occurred is a dead end track. A fence and signage has since been erected at the public access end of the track.</p>

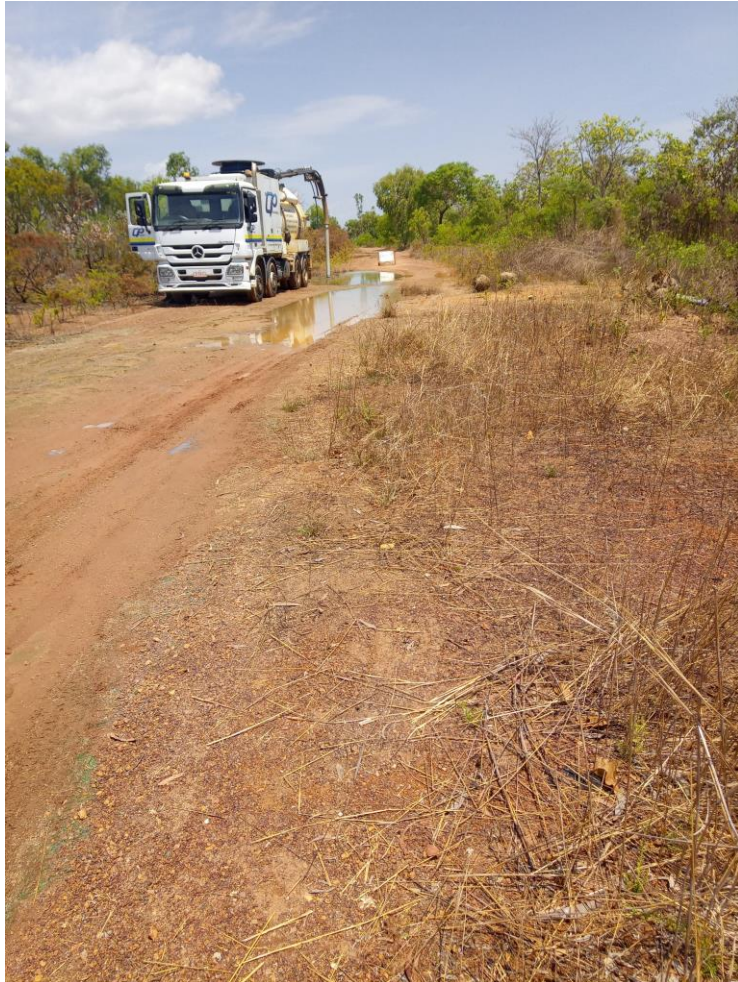
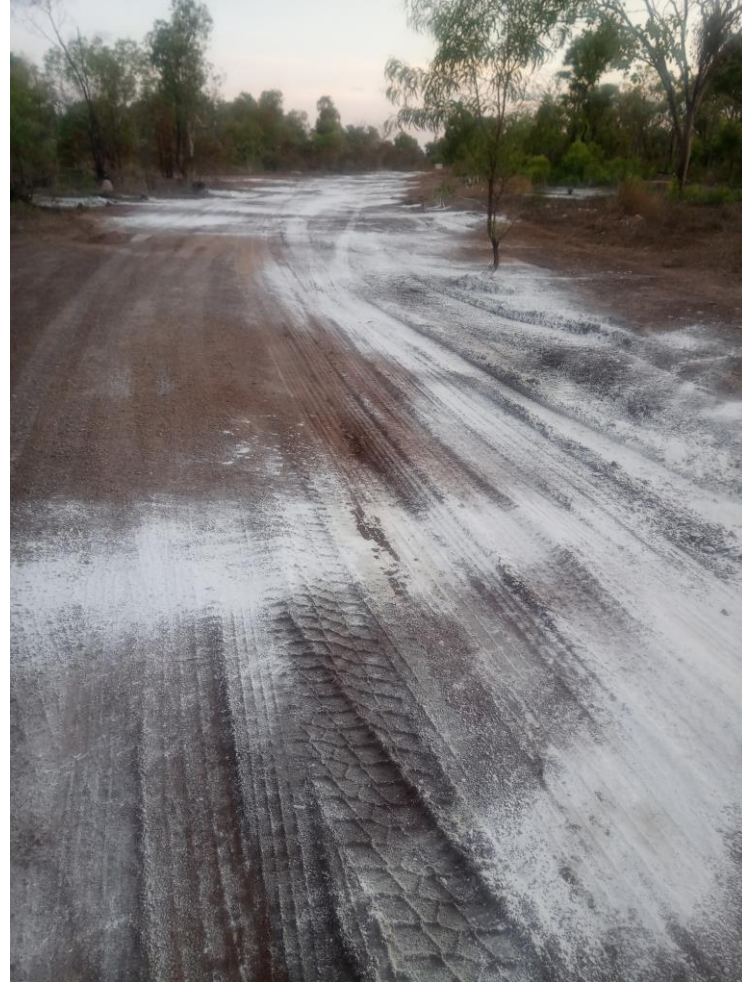
Appendix D – Photograph of vaccum truck removing pooling effluent and area after having lime applied

(d) how the pollution has occurred, is occurring or may occur	<p>As per (c) iii & (c) iv.</p>
(e) the attempts made to prevent, reduce, control, rectify or clean up the pollution or resultant environmental harm caused or threatening to be caused by the incident	<p><i>i. Confirmation signage and fencing has been erected, as appropriate.</i></p> <p>Both signage and fencing has been erected, with a temporary construction site fence having been placed across the only public access track prior to the spill area. Warning signage has been erected at both ends of the track near the area of the spill.</p> <p><i>ii. Decontamination of the site as appropriate.</i></p> <p>Overflow is fully treated effluent that has passed through five treatment ponds, with no gross pollutants being present. Clean up consistent with Sewage Spills/Overflow Response Work Instruction as appropriate to the location. Vacuum trucks removed what pooling effluent was able to be safely removed, contaminated soil were replaced with clean soil and all other affected areas had lime applied.</p>
