SECTION 14 INCIDENT REPORT (*Waste Management and Pollution Control Act*)

Date and Time of Notification:	Wednesday 15 th February 2023, 14:30hrs
Person / Company:	Power and Water Corporation (PWC)
Incident:	Overflow of treated effluent - Angurugu

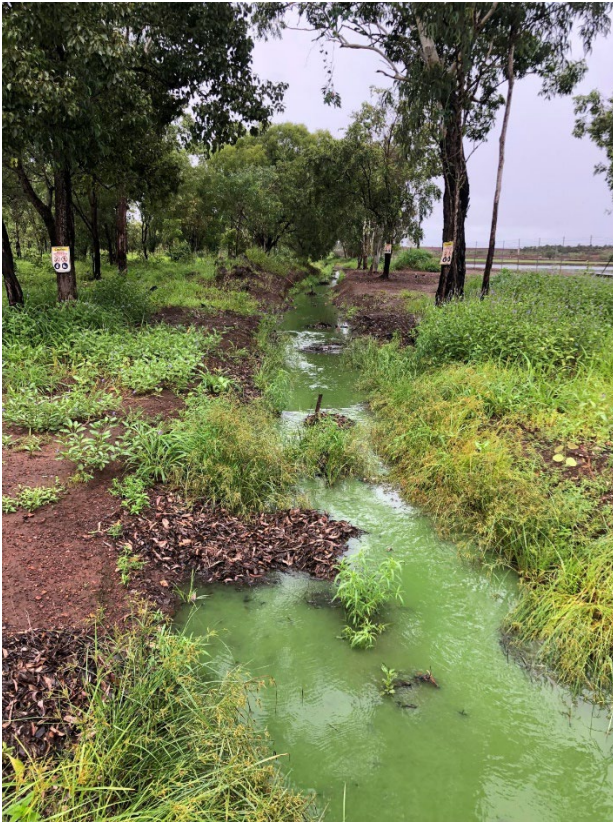
1. Eastern boundary drain

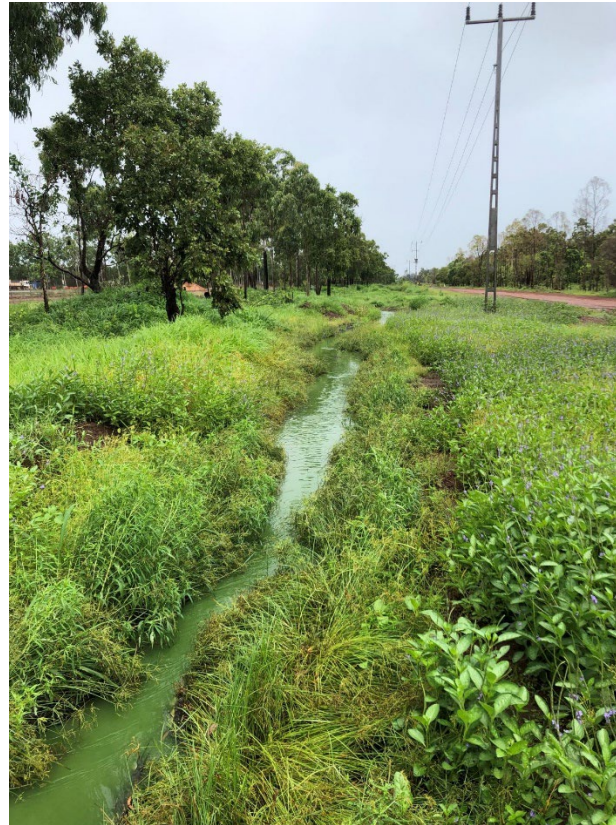
2. Northern boundary drain

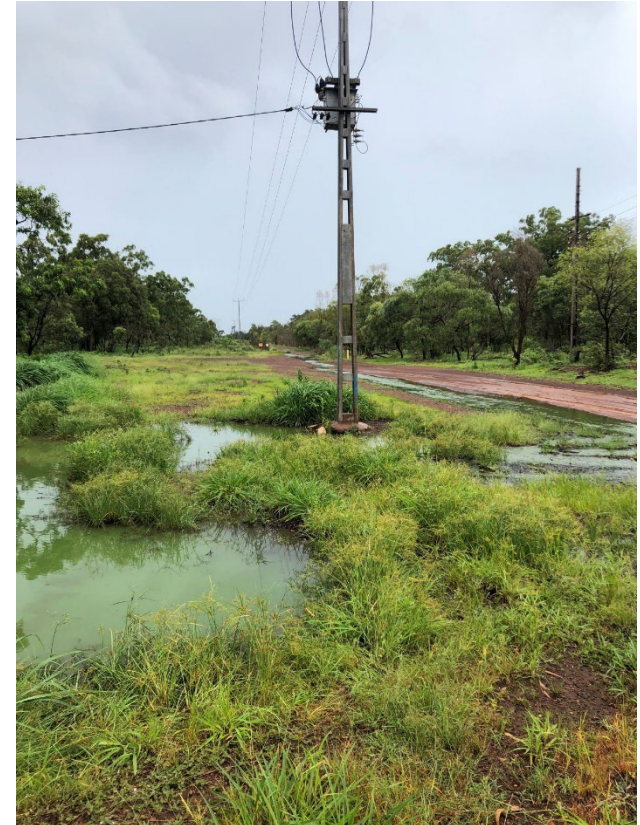
3. Flow onto private road
