## SECTION 14 INCIDENT REPORT (*Waste Management and Pollution Control Act*)

<b>Date and Time of Notification:</b>	Thursday 23 <sup>rd</sup> March 2023, 11:25hrs
<b>Person / Company:</b>	Power and Water Corporation
<b>Incident:</b>	Discharge of sewage from sewerage network, including privately owned infrastructure

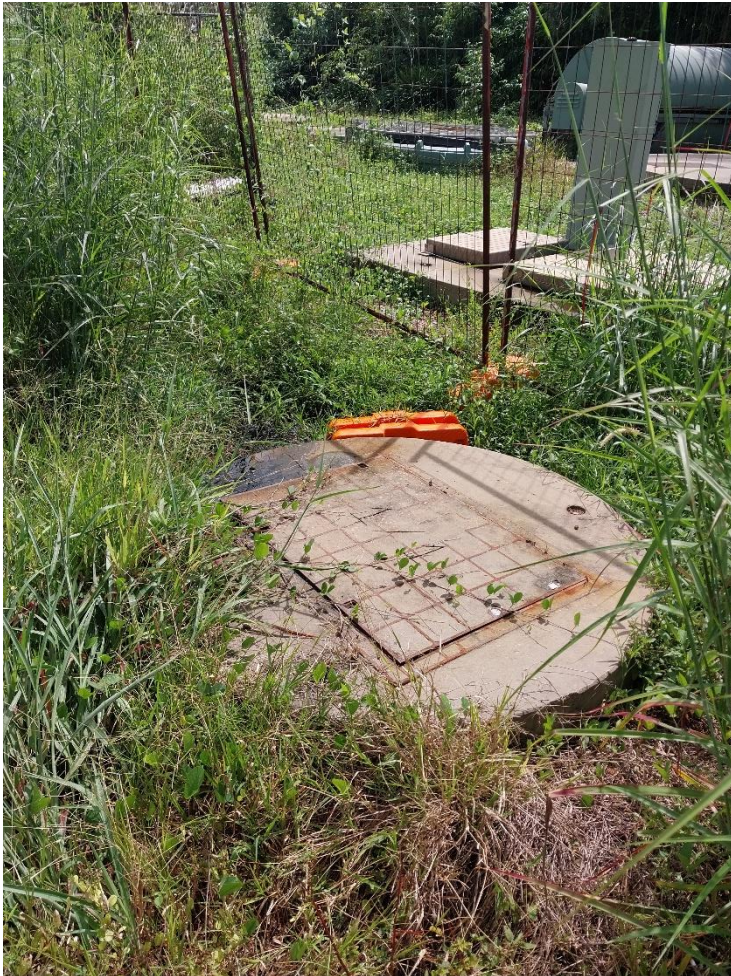
Figure1. Power & Water Manhole cover 1/1. Source: C. Briscoe

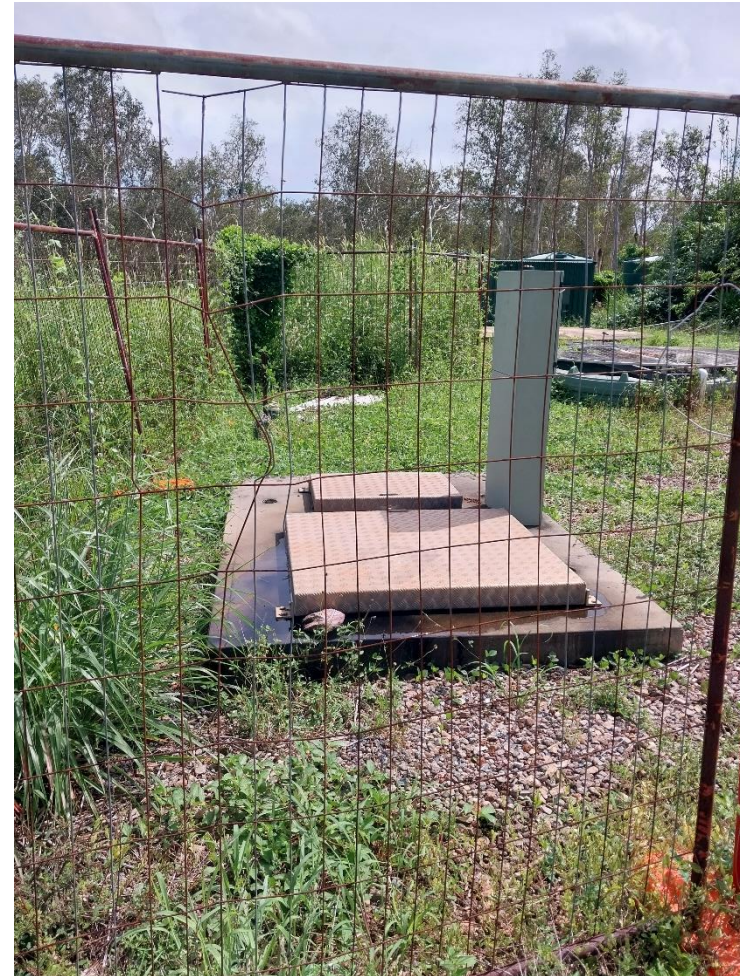
<p><i>iii. Indicate any locations nearby to the discharge point where public can gain ready-access, such as public open spaces through which the discharge moves.</i></p> <p>Public access is not possible, the area adjoins another fully fenced WWTP, the small adjoining WWTP is also fully fenced and a large portion of the remaining property boundary is fenced and has concrete blocks placed at key locations to prevent vehicle access. Swamp bushland is located to the north, making public access very unlikely.</p>
<b>(c) the date and time of the incident</b>	<p><i>i. The time and date of commencement and cessation of the discharge.</i></p> <p>The commencement time of the overflow is unknown. The overflow was observed at approximately 11:30hrs by Power and Water staff on 22/03/2023, and the spill was controlled by approximately 12:00hrs of 22/03/2023.</p> <p><i>ii. How PWC were notified, or became aware of the discharge.</i></p> <p>This overflow was discovered by a Power and Water staff member attending site on an unrelated matter. Power and Water's Environmental Services was advised of the overflow shortly after being discovered, 22/03/2023.</p> <p><i>iii. The process by which the discharge occurred.</i></p> <p>It was found that the privately owned sewage SPS that the reticulated sewage flows into had failed due to a mechanical issue.</p> <p><i>iv. The reason why the discharge occurred.</i></p> <p>As per (c) iii. Both pumps within the SPS had failed.</p>

Figure 2. Overflowing SPS within the privately owned WWTP. Source: C. Briscoe – Power & Water
