## SECTION 14 INCIDENT REPORT (*Waste Management and Pollution Control Act*)

<b>Date and Time of Notification:</b>	Tuesday 14 <sup>th</sup> September 2021, 16:00hrs
<b>Person / Company:</b>	Power and Water Corporation ( <b>PWC</b> )
<b>Incident:</b>	Discharge of raw sewage from sewerage network (sewer pit)

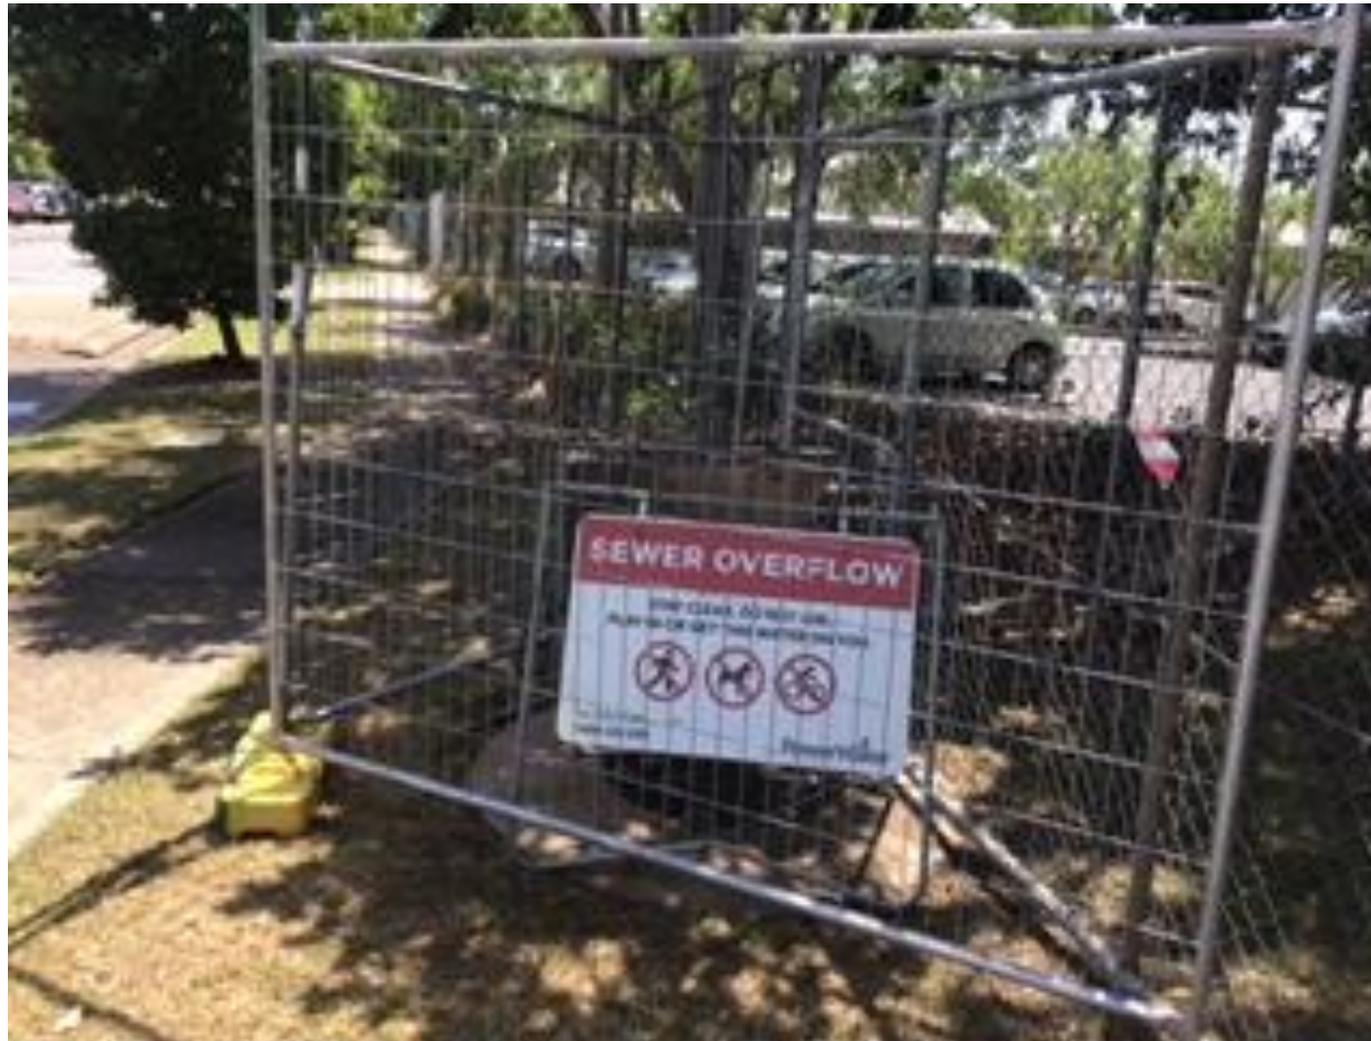
Appendix B – Photograph of the fencing and signage around the gas chamber manhole, post clean up and disinfection

<p><b>rectify or clean up the pollution or resultant environmental harm caused or threatening to be caused by the incident</b></p>	<p>Fencing and warning signage has been erected as can be seen in appendix B.</p> <p><i>ii. Decontamination of the site as appropriate.</i></p> <p>Clean up consistent with Sewage Spills/Overflow Response Work Instruction as appropriate to the location, and to minimise risk to the Environment. Blockage was cleared with a harben, and pit emptied with a vacuum truck. Upon resolution of the blockage, the site was left in a clean state, free from any gross pollutants and the surrounding surface was cleaned and disinfected.</p>
<p><b>(f) the identity of the person notifying the NT EPA</b></p>	<p>PWC Environmental Team on behalf of Water Services</p>

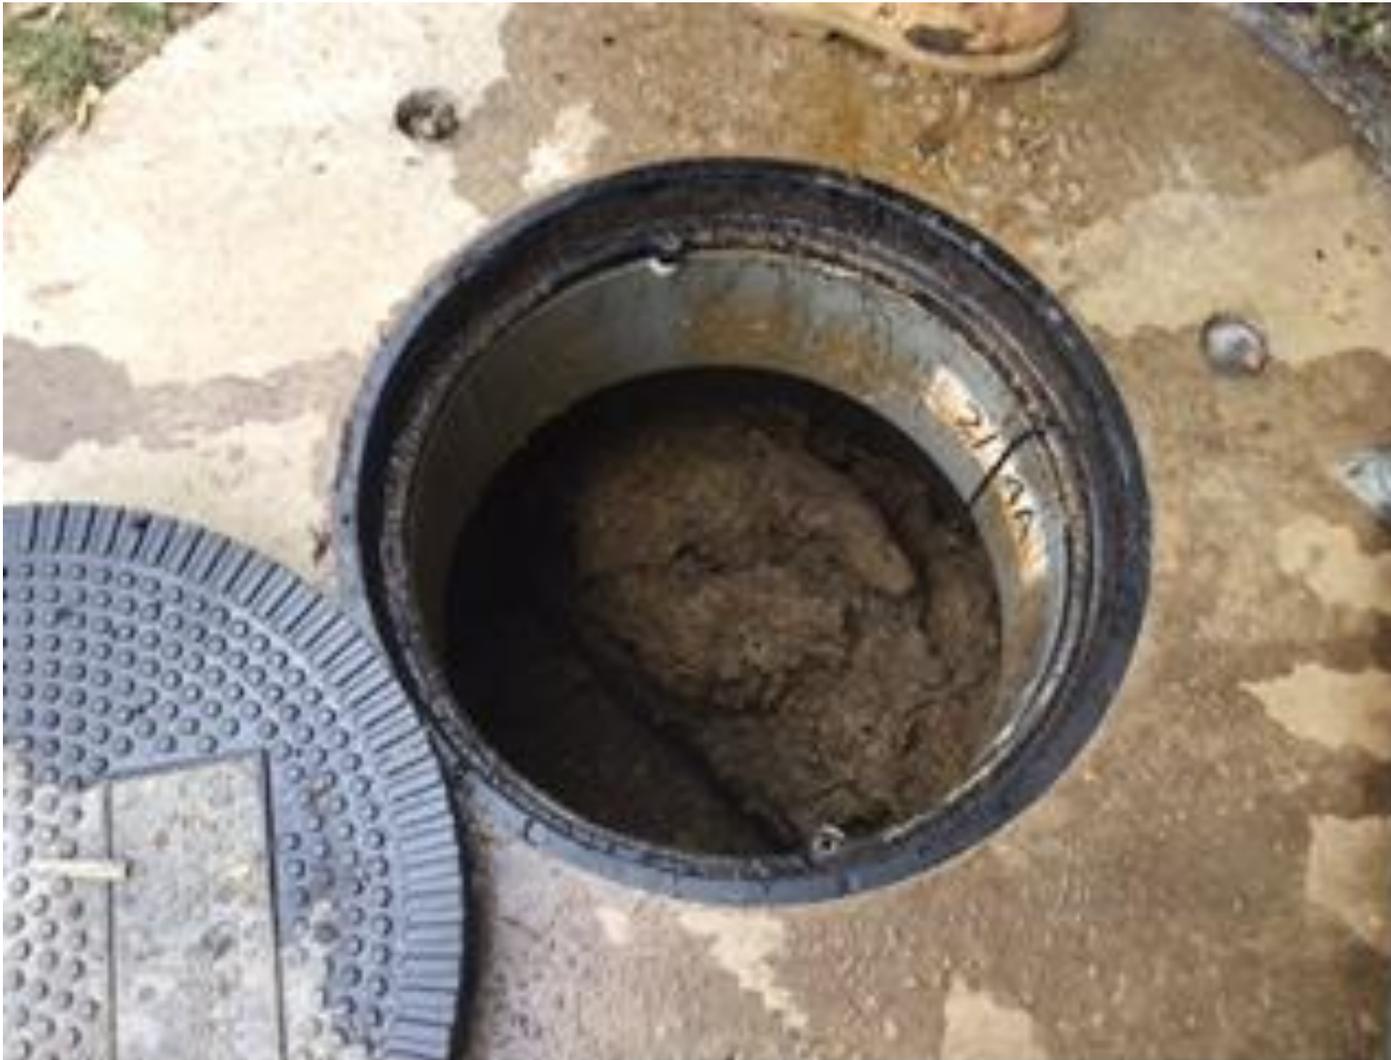
Appendix C – Photograph of the gas chamber showing the build-up of foreign material within.
