## SECTION 14 INCIDENT REPORT (*Waste Management and Pollution Control Act*)

<b>Date and Time of Notification:</b>	Friday 31 <sup>th</sup> December 2021, 15:45hrs
<b>Person / Company:</b>	Power and Water Corporation ( <b>PWC</b> )
<b>Incident:</b>	Discharge of sewage from sewerage network (manhole cover)

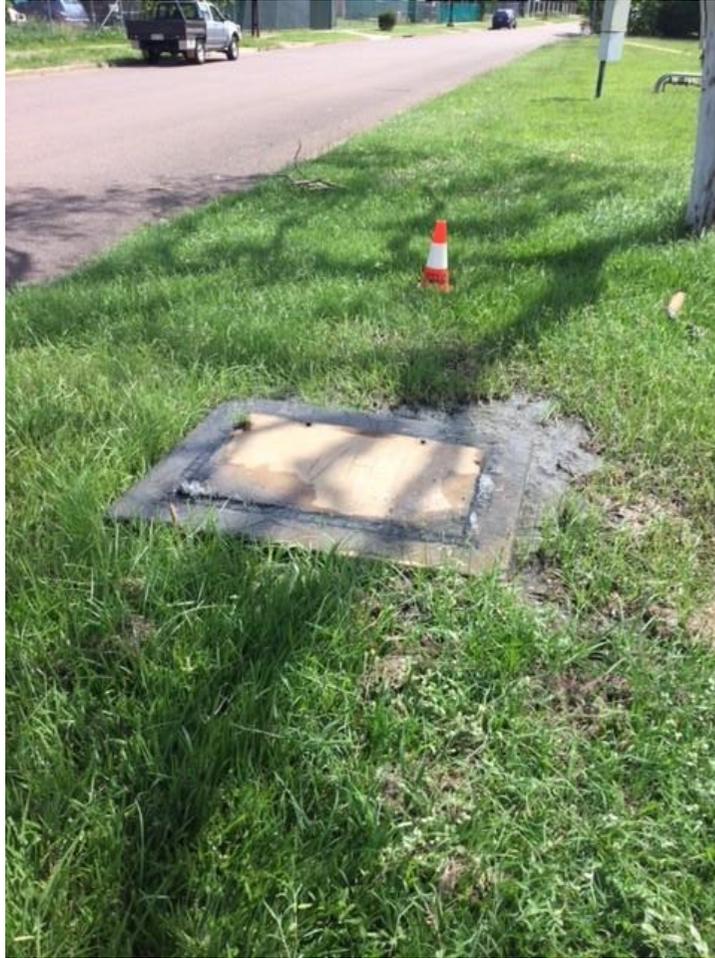
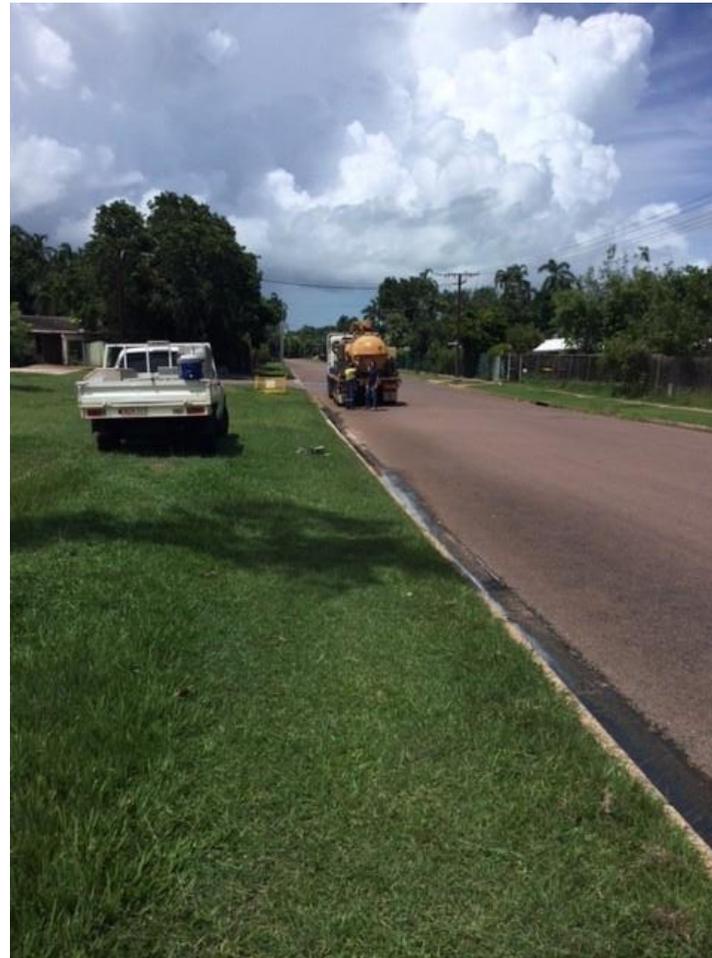
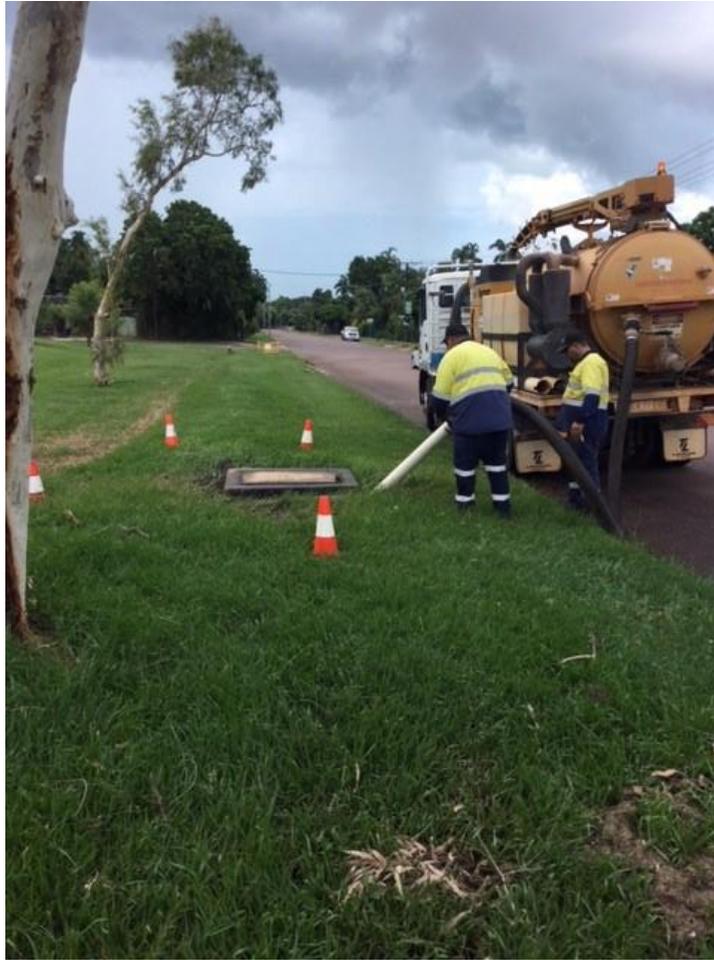
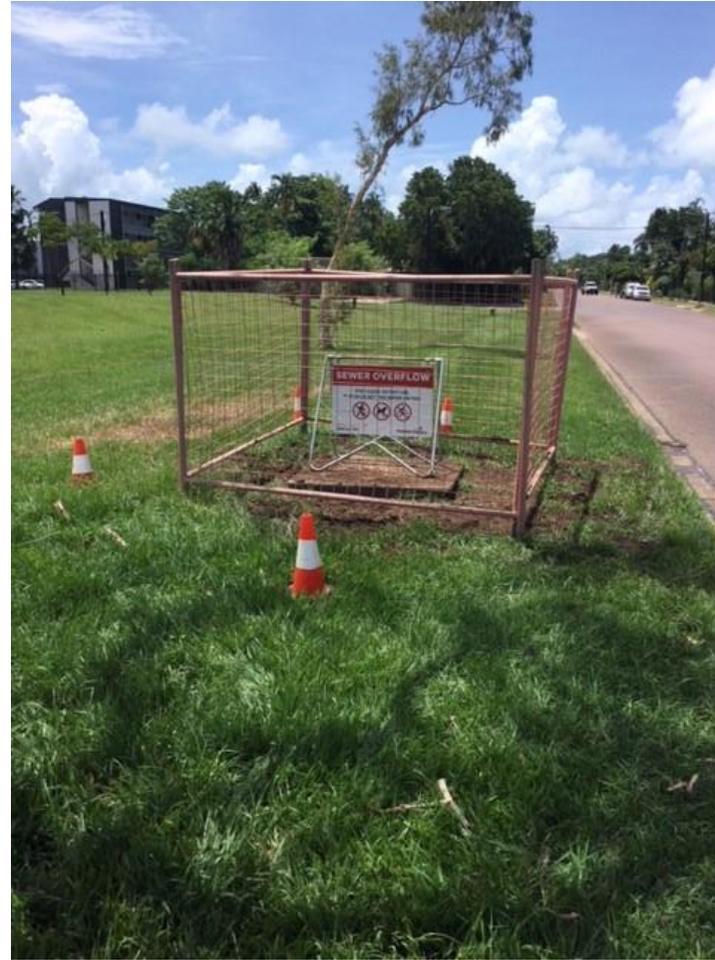
Appendix B – Photograph of the spill site, clean-up crew in action and erected fencing and signage post clean up.

<p><b>rectify or clean up the pollution or resultant environmental harm caused or threatening to be caused by the incident</b></p>	<p>Fencing and signage was erected once the blockage in the sewer main was cleared, and the area was cleaned up by vacuum truck.</p> <p><i>ii. Decontamination of the site as appropriate.</i></p> <p>Clean up consistent with Sewage Spills/Overflow Response Work Instruction as appropriate to the location, and to minimise risk to the Environment. Blockage was cleared and upon resolution of the blockage, the site was left in a clean state, free from any gross pollutants and the surrounding surface was cleaned and disinfected.</p>
<p><b>(f) the identity of the person notifying the NT EPA</b></p>	<p>PWC Environmental Team on behalf of Water Services</p>
