SECTION 14 INCIDENT REPORT (*Waste Management and Pollution Control Act*)

Date and Time of Notification:	Tuesday 28 th February 2023 16:00hrs
Person / Company:	Power and Water Corporation
Incident:	Discharge of sewage from sewerage network, Sewage Pumping Station Kilgariff, Alice Springs

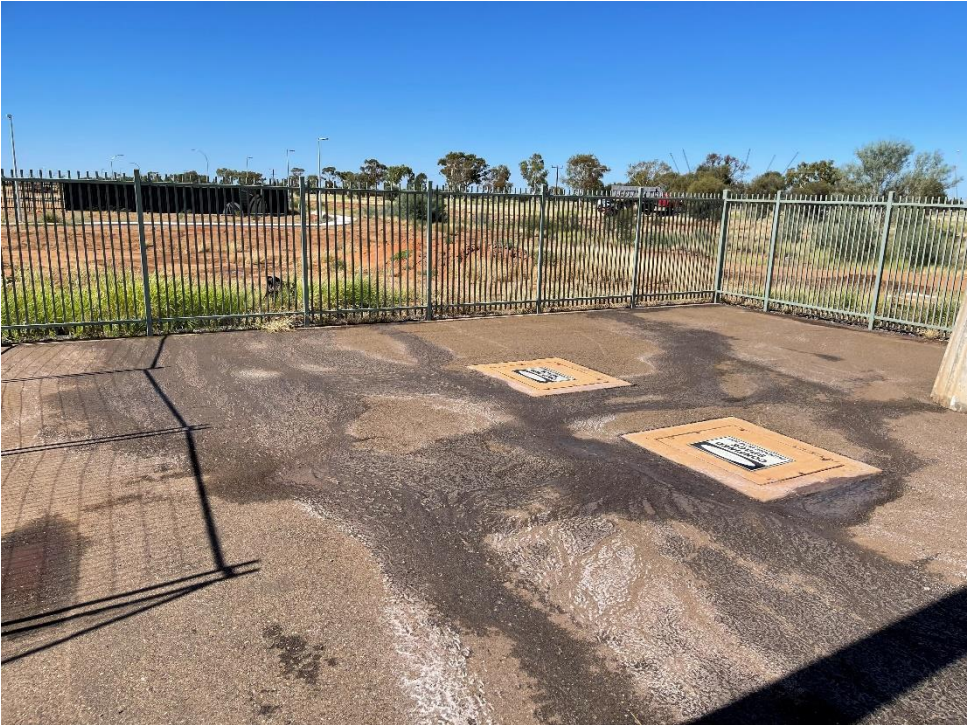
Image 1: Part of spill affected area at SPS736

<p>(d) how the pollution has occurred, is occurring or may occur</p>	<p>As per (c) iii & (c) iv.</p>
<p>(e) the attempts made to prevent, reduce, control, rectify or clean up the pollution or resultant environmental harm caused or threatening to be caused by the incident</p>	<p><i>i. Confirmation signage and fencing has been erected, as appropriate.</i></p> <p>A fencing contractor will be erecting temporary fencing around the spill affected area and erect warning signage, to reduce the likelihood of community members coming into contact with the affected area.</p> <p><i>ii. Decontamination of the site as appropriate.</i></p> <p>Clean up consistent with Sewage Spills/Overflow Response Work Instruction as appropriate to the location, and to minimise risk to the Environment. The size of the discharge point, only being very small, prevented gross pollutants from entering the environment. The affected area had chlorine applied as an initial response.</p>

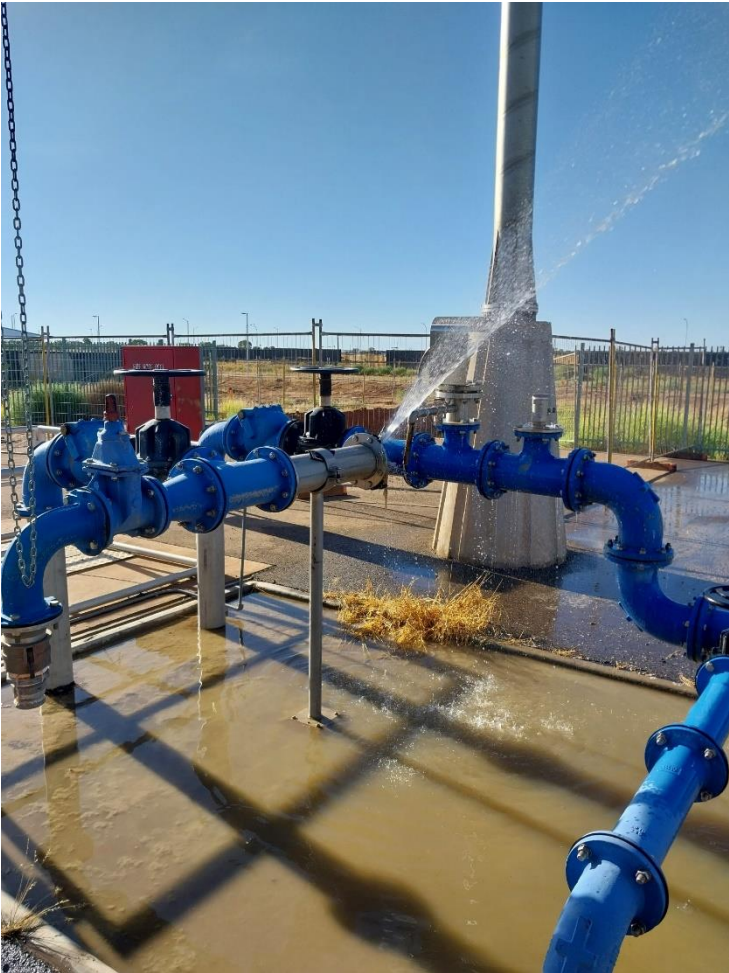
<p>Access to the public was possible prior to a Power and Water field crew arriving on the scene to rectify the issue. The affected area is being fenced this afternoon, 28/02/2023 and signage will be erected as well.</p>
<p>(c) the date and time of the incident</p>	<p><i>i. The time and date of commencement and cessation of the discharge.</i></p> <p>The exact time the overflow began is unknown but would have occurred a short time before the Power and Water field crew arrived on the scene at 07:24hrs 28/02/2023. The spill was stopped by 08:30hrs 28/02/2023.</p> <p><i>ii. How PWC were notified, or became aware of the discharge.</i></p> <p>A member of the public notified the Power and Water call centre, who promptly dispatched a field crew to the scene.</p> <p><i>iii. The process by which the discharge occurred.</i></p> <p>A failure of the gasket material used on an above ground manifold that connects the two pumps within the pump station into the one rising main pipe. As this manifold was downstream of a non-return-valve, every time the sewer main was pressurised the manifold would begin to leak.</p> <p><i>iv. The reason why the discharge occurred.</i></p> <p>As per (c) iii.</p>

Image 2: The manifold with the leaking gasket, spraying sewage.
