Appendix D Audit Site Inspection Photos

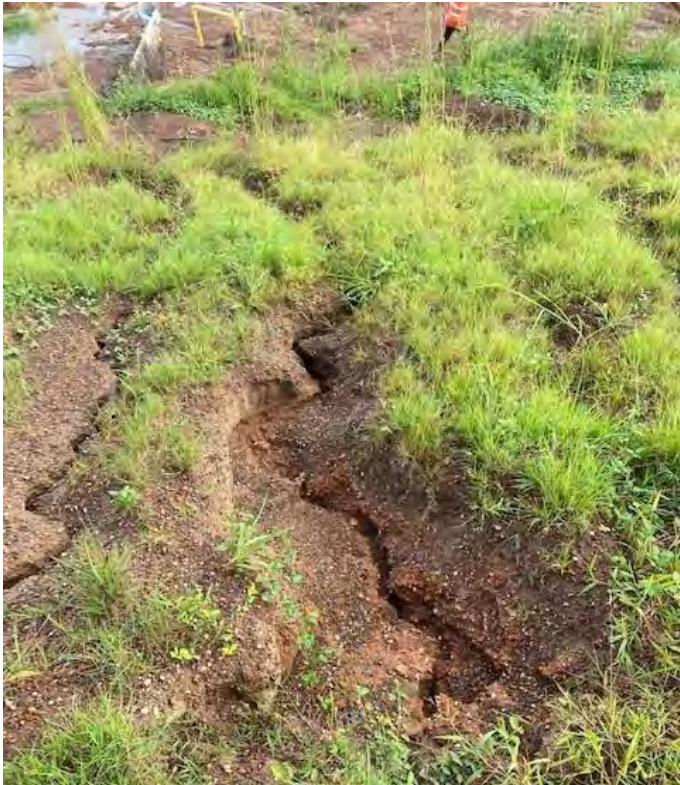
Date Photo Taken: 15/03/2023			
Description: Erosion channels on Stage 4 cap (to be repaired as part of capping works)

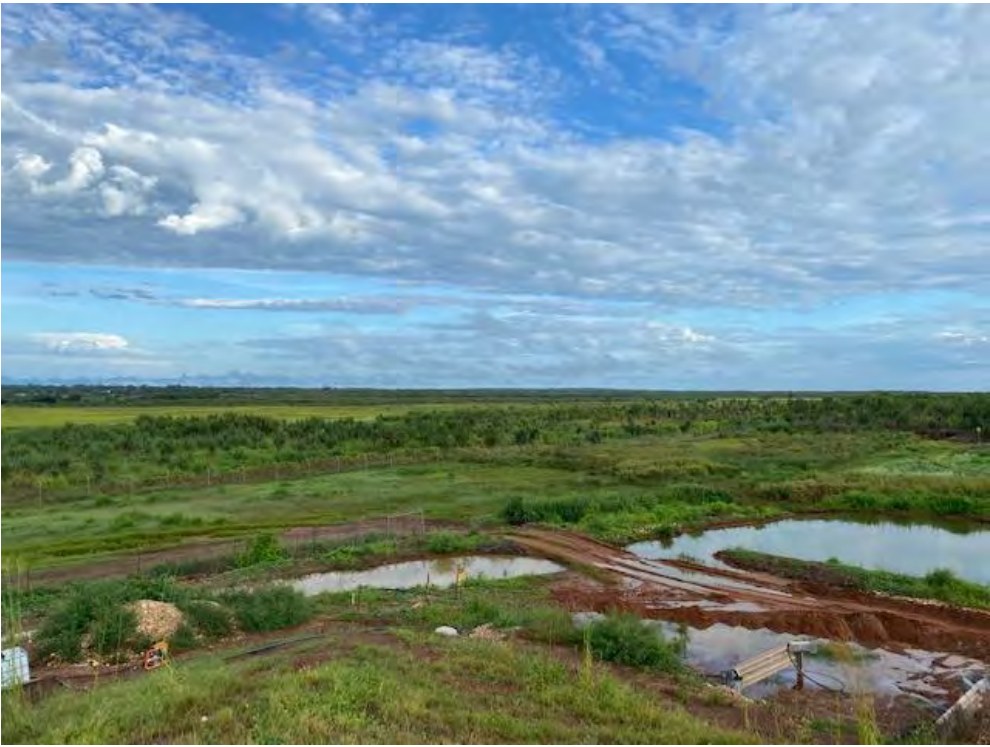
Date Photo Taken: 15/03/2023			
Description: Sediment ponds and water pooling NW area of Stage 4			
Photo No.	30.

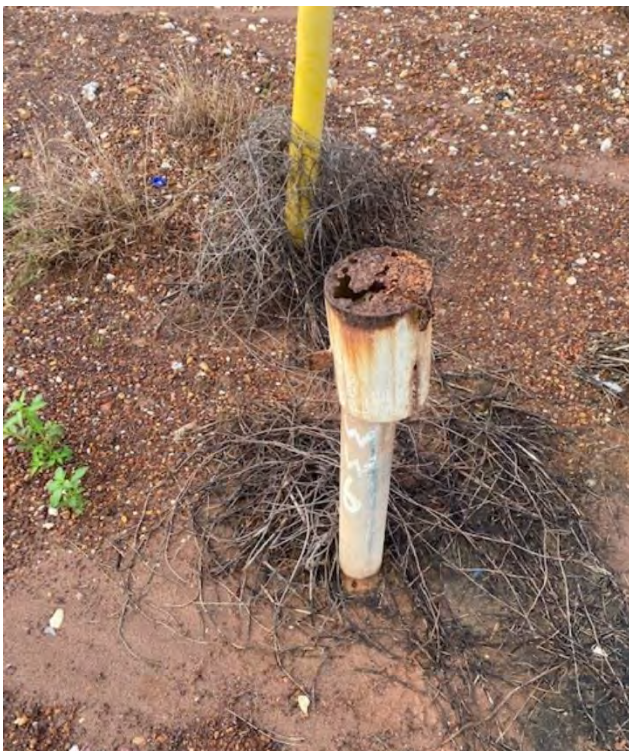
Date Photo Taken: 15/03/2023			
Description: Corrosion of well cover at WW6

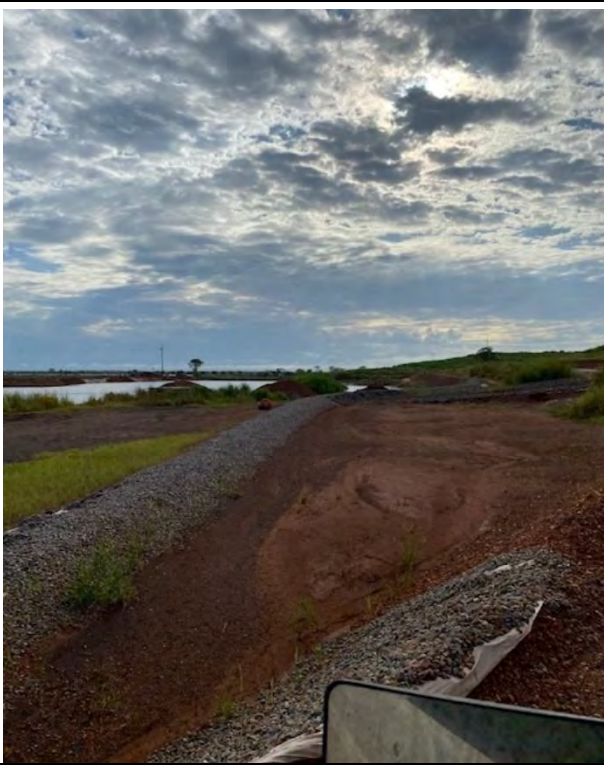
Date Photo Taken: 15/03/2023			
Description: Sedimentation of surface water drain north of Stage 3 and 4. To be repaired as part of cap construction contract			
Photo No.	36.

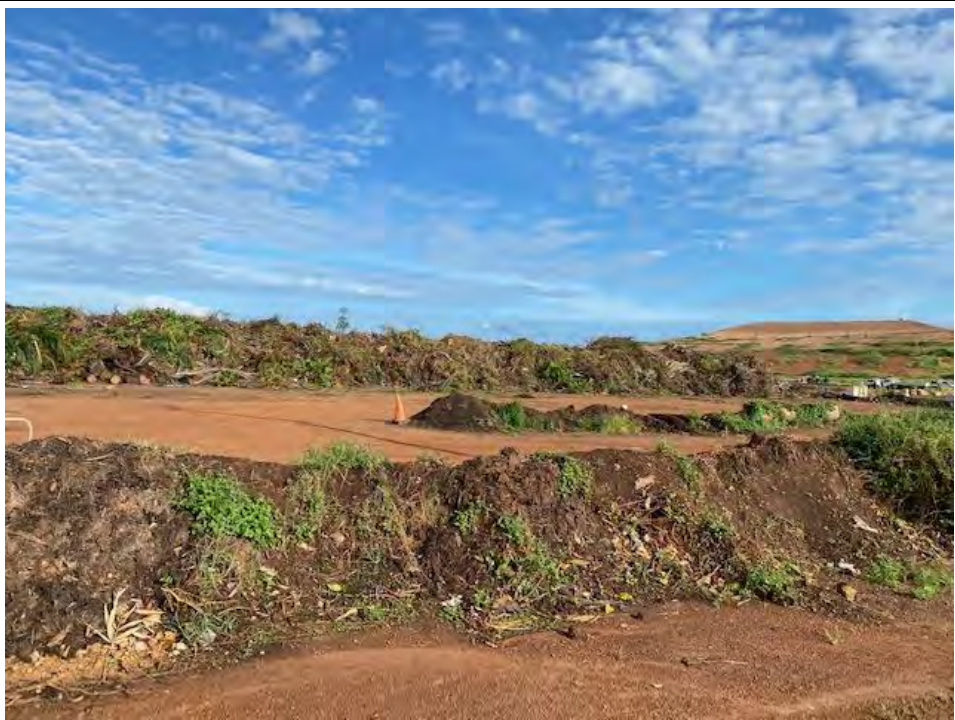
Date Photo Taken: 15/03/2023			
Description: Green waste processing area

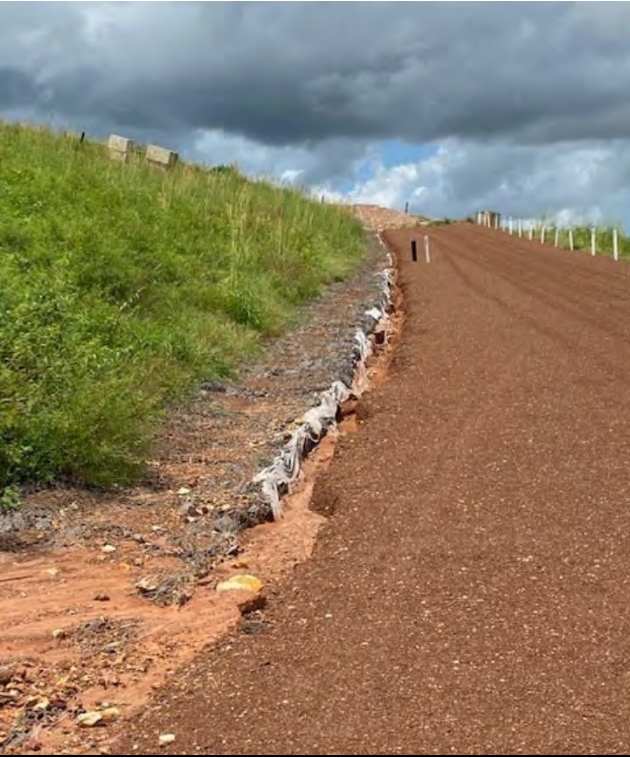
Date Photo Taken: 15/03/2023			
Description: Erosion requiring repair on Stage 4 access ramp. Note: part of Cap Construction Audit not S48 Audit.			
Photo No.	56.

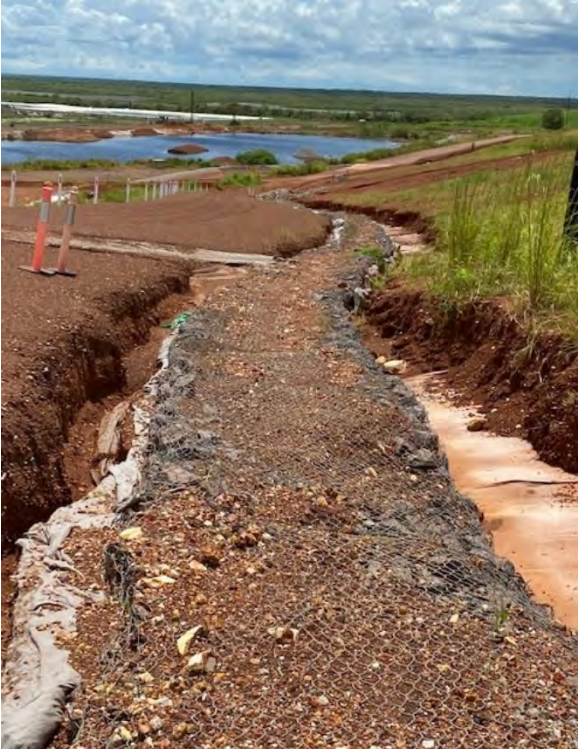
Date Photo Taken: 15/03/2023			
Description: Erosion requiring repair on Stage 4 access ramp. Note: part of Cap Construction Audit not S48 Audit.

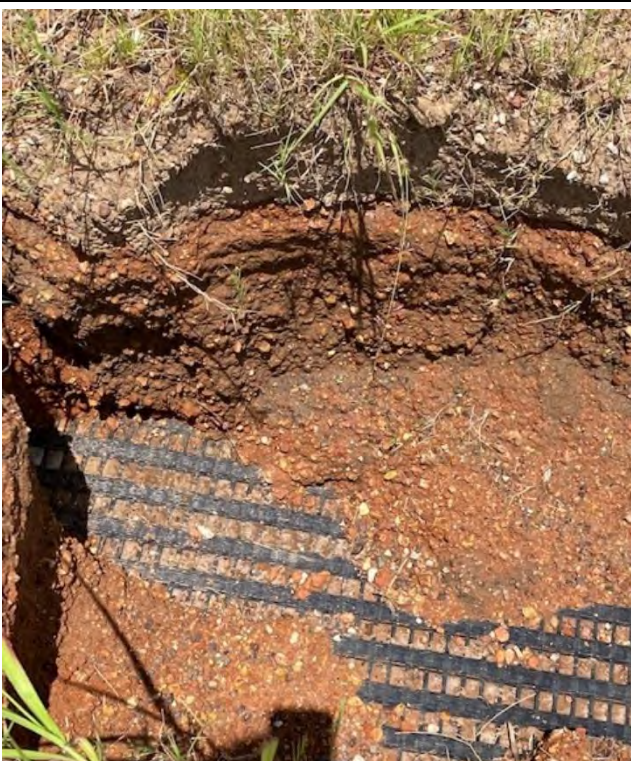
Date Photo Taken: 15/03/2023			
Description: Erosion requiring repair on Stage 4 access ramp. Note: part of Cap Construction Audit not S48 Audit			
Photo No.	58.

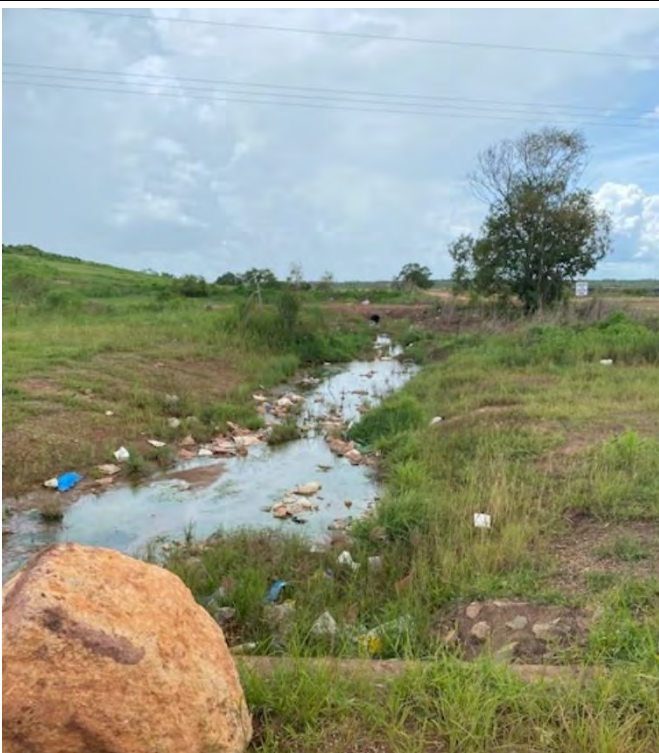
Date Photo Taken: 15/03/2023			
Description: Litter and sediment in main stormwater drain (on site) to east of Stage 6 (Note: check if its been cleaned out during next Audit inspection)
