## SECTION 14 INCIDENT REPORT (*Waste Management and Pollution Control Act*)

| <b>Person / Company:</b> | Power and Water Corporation ( <b>PWC</b> ) |
| <b>Incident:</b> | Discharge of raw sewage from sewerage network (ORG) |

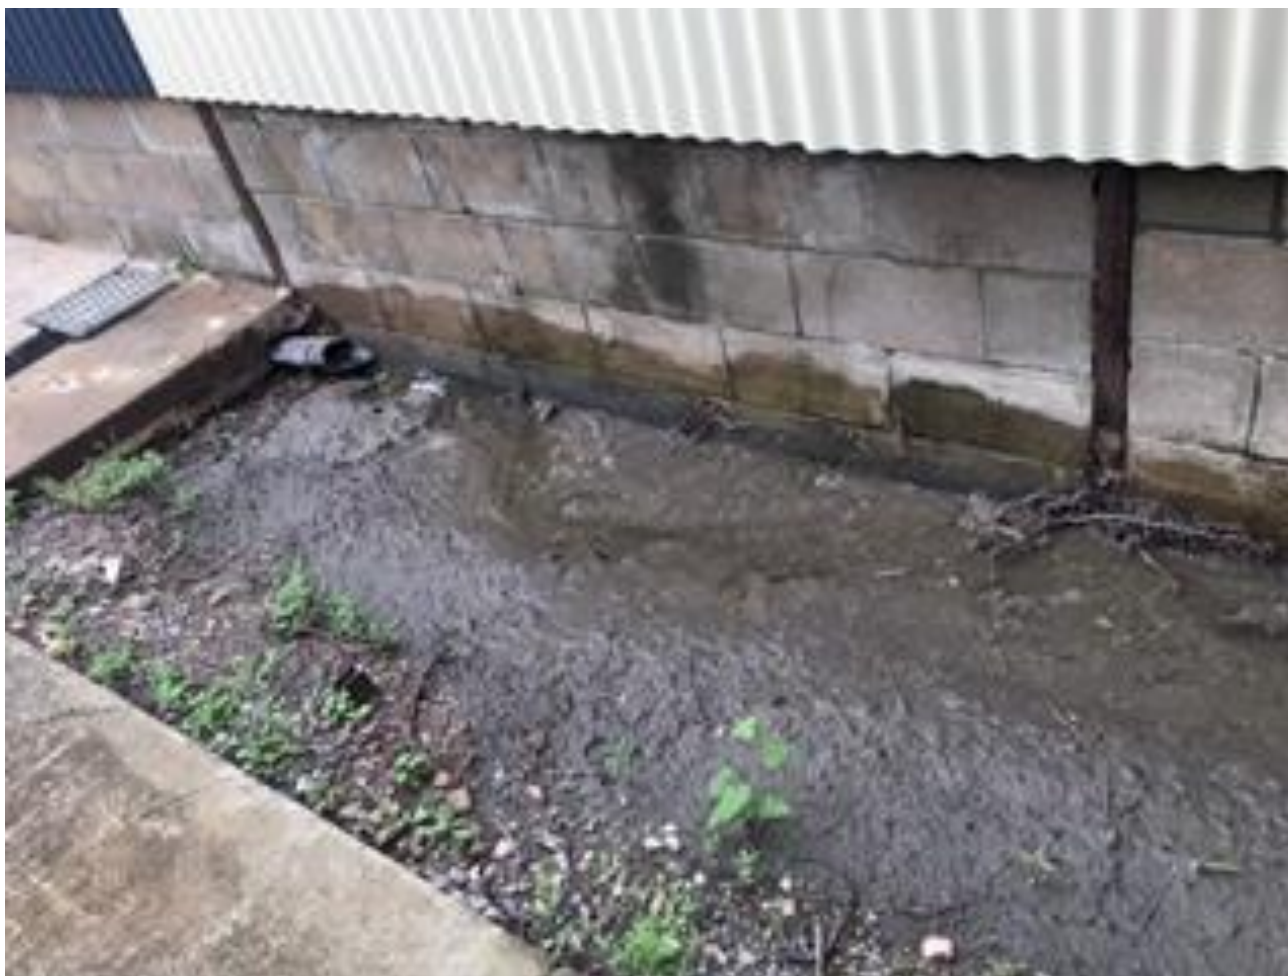
| <b>(c) the date and time of the incident</b> | <p><i>i. The time and date of commencement and cessation of the discharge.</i><br/>The exact commencement time of the overflow is unknown. The overflow was first observed by PWC staff at approximately 14:50pm on 21/12/2020 and was stopped an hour later by site crews at 15:50pm (21/12/2020).</p> <p><i>ii. How PWC were notified, or became aware of the discharge.</i><br/>A resident of 3 McKay Place called the Power and Water customer service centre, who then notified the relevant sewerage networks department. PWC staff attended the site at approximately 14:50hrs on 21/12/2020 and resolved the overflow.</p> <p><i>iii. The process by which the discharge occurred.</i><br/>The cause of the spill was due to a blockage in the nearby sewer rising main, caused by a build-up of fat. Fat and other substances have been incorrectly disposed of into the sewer network by customers, resulting in the blockage and the overflow. When fats, oils and meat juices are put down the sink it is usually as a liquid, but as it cools it can become more solid and cause build-up, resulting in bad odours and blockages in the sewerage system. This can lead to the sewage overflows into the environment, households and businesses.</p> <p>Public education about what can be disposed in sewer/is flushable:<br/><a href="https://www.powerwater.com.au/about/what-we-do/wastewater/sewer-blockages-and-overflows/think-before-you-put-it-down-the-sink">https://www.powerwater.com.au/about/what-we-do/wastewater/sewer-blockages-and-overflows/think-before-you-put-it-down-the-sink</a><br/>In the aim of prevention, this material is available on the PWC website and is used as an educational tool for customers.</p> <p><i>iv. The reason why the discharge occurred.</i><br/>As per (c) iii.</p> |

Appendix B – Photographs – Spill site, ORG on northern side of residence.

| <b>(e) the attempts made to prevent, reduce, control, rectify or clean up the pollution or resultant environmental harm caused or threatening to be caused by the incident</b> | <p><i>i. Confirmation signage and fencing has been erected, as appropriate.</i><br/>No signage or fencing was erected in this instance, as the spill occurred at a fenced, private residence. All residents residing there were advised to avoid contact with the area.</p> <p><i>ii. Decontamination of the site as appropriate.</i><br/>Clean up consistent with Sewage Spills/Overflow Response Work Instruction as appropriate to the location, and to minimise risk to the Environment. Site inspected for any gross pollutants of which none were observed, and the surrounding surface was cleaned and disinfected. Landholders advised not to enter affected areas for a minimum of 5 days after clean-up.</p> |

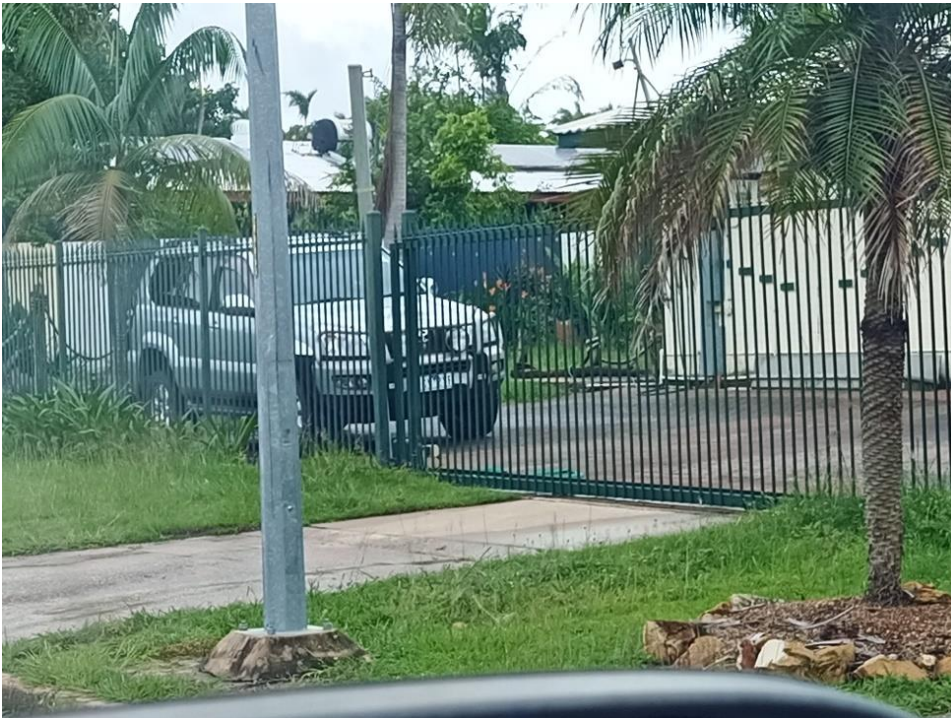
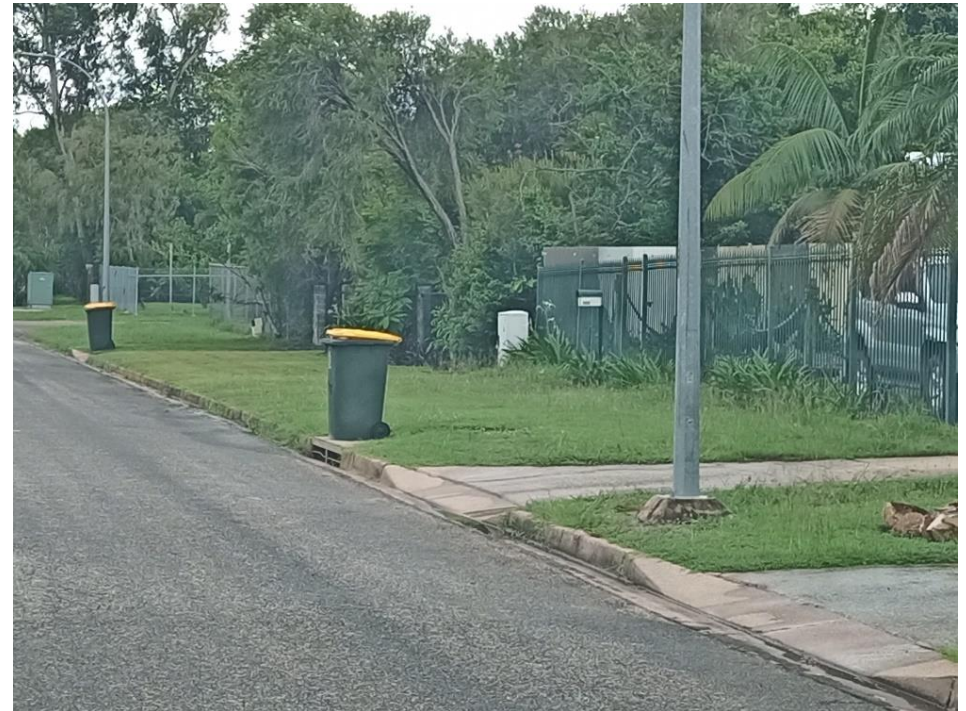
| | Access to the public is not possible as it occurred on a fenced private property. Automatic gate prevents access except when undertaken by residents. |

Appendix B – Photographs – Automatic gate (preventing access) & Stormwater drain, adjacent to resident's driveway. Both photos taken the following day, post clean up.
