## SECTION 14 INCIDENT REPORT (*Waste Management and Pollution Control Act*)

| <b>Person / Company:</b> | Power and Water Corporation ( <b>PWC</b> ) |
| <b>Incident:</b> | Discharge of highly diluted sewage from sewerage network due to wet weather |

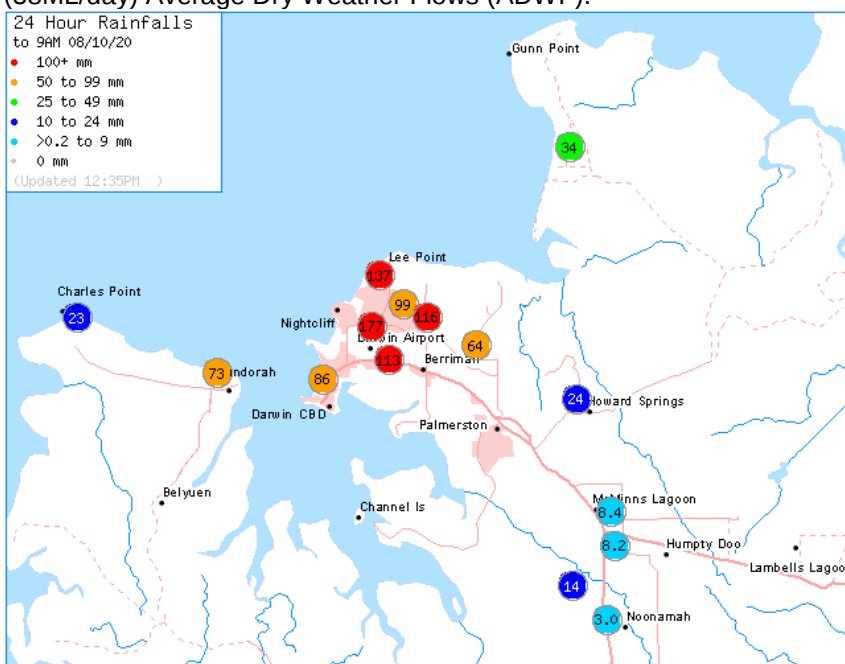
Indicative wastewater quality for this overflow can be found in Table 1. Rainfall leading up to the overflow was 148mm for the previous 3 days (Darwin Airport Weather Station – 014015), with high rainfall events occurring within short timeframes resulting in flash flooding – as shown in Figure 1 below several downpours ranging from 3 – 177mm were received throughout the Darwin region in a matter of hours on 08/10/20. As a result inflows of up to 62ML/day were received at Ludmilla Wastewater Treatment Plant (WWTP) equating to >4x (58ML/day) Average Dry Weather Flows (ADWF).
