## SECTION 14 INCIDENT REPORT (*Waste Management and Pollution Control Act*)

| <b>Person / Company:</b> | Power and Water Corporation ( <b>PWC</b> ) |
| <b>Incident:</b> | Discharge of raw sewage from sewerage network (manhole). |

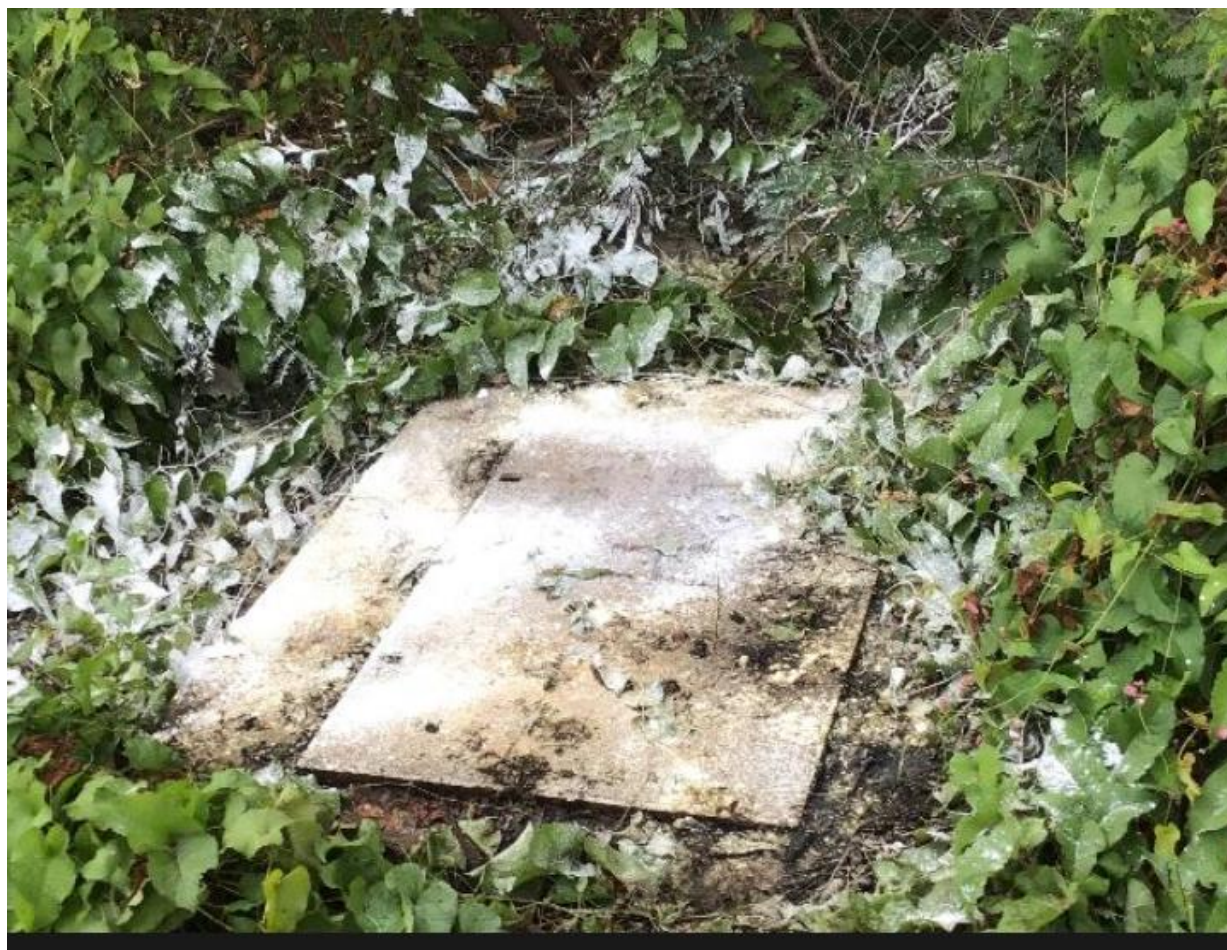
Photo 1 – Manhole (post cleanup)

| | <p>to determine an exact volume of the overflow. However, the estimated vol. is approx. 80 litres.</p> <p>The overflow was observed at approximately 16:30pm (09/11/2020) by PWC staff and resolved shortly after at approx. 17:00pm (09/11/2020).</p> <p>The cause of the blockage is unknown, however, as the manhole was being harbened/cleared, grease was observed indicating the blockage may have been due to a fat build-up.</p> |

| | <p>PWC staff. PWC staff attended the area at approx. 16:30pm (09/11/20). From this PWC resolved the overflow and cleaned the area.</p> <p><i>iii. The process by which the discharge occurred.</i></p> <p>The overflow was the result of a blockage within the sewer main. The cause of the blockage is unknown, however, grease was observed during the harben process, indicating the blockage may have been due to a fat build-up.</p> <p><i>iv. The reason why the discharge occurred.</i></p> <p>As per (c) iii. Sewerage network infrastructure has been designed to overflow with the best public health and environmental outcomes possible. Design focuses on not overflowing directly inside houses; rather discharge is designed to occur in a controlled manner at locations which can be accessed for infrastructure repair and clean up and with minimal public health or environmental impacts.</p> |

| <b>(e) the attempts made to prevent, reduce, control, rectify or clean up the pollution or resultant environmental harm caused or threatening to be caused by the incident</b> | <p>The blockage was cleared and the overflow was stopped. Clean up undertaken as per Sewage Spills/Overflow Response Work Instruction.</p> <p><i>i. Confirmation signage and fencing has been erected, as appropriate.</i></p> <p>Upon resolution of the blockage the area was cleaned comprehensively to ensure the area was safe. Due to the location temporary fencing was not appropriate. Therefore cleaning undertaken was performed to ensure access. PWC contractors attended the site on 10<sup>th</sup> Nov, 2020 and removed contaminated soil.</p> <p><i>ii. Decontamination of the site as appropriate.</i></p> <p>Clean up consistent with Sewage Spills/Overflow Response Work Instruction as appropriate to the location, and to minimise risk to the environment.</p> <p>Area was observed for gross pollutants of which none were detected. The manhole lid appeared to have trapped these only allowing liquid to overflow. The area was then limed and PWC contractors attended the site on 10<sup>th</sup> Nov, 2020 and removed contaminated soil, replacing it with imported top soil.</p> <p>In the aim of preventing blockages, public education about what can be disposed in sewer/is flushable is accessible online:<br/> <a href="https://www.powerwater.com.au/_data/assets/pdf_file/0003/91578/Think_before_you_put_it_down_the_sink.pdf">https://www.powerwater.com.au/_data/assets/pdf_file/0003/91578/Think_before_you_put_it_down_the_sink.pdf</a><br/> In the aim of prevention this material is available on the PWC website and is used as an educational tool for customers.</p> |
