## SECTION 14 INCIDENT REPORT (*Waste Management and Pollution Control Act*)

| Incident: | Discharge of raw sewage from sewerage network (Overflow Relief Gully (ORG) and manhole) |

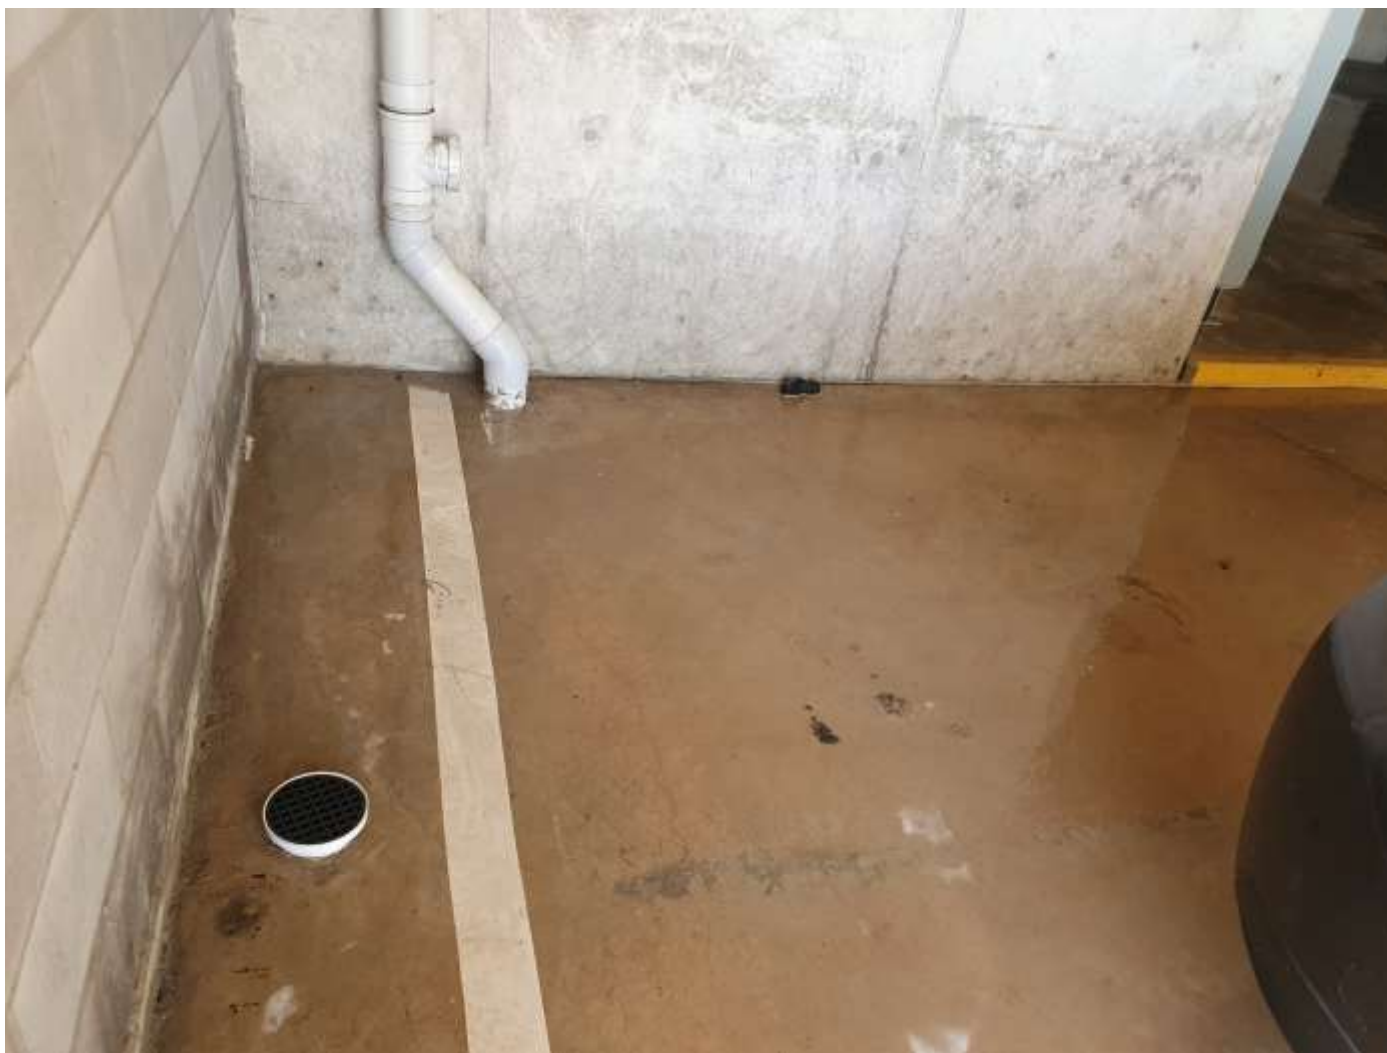
Photo 1 – ORG (post cleanup)

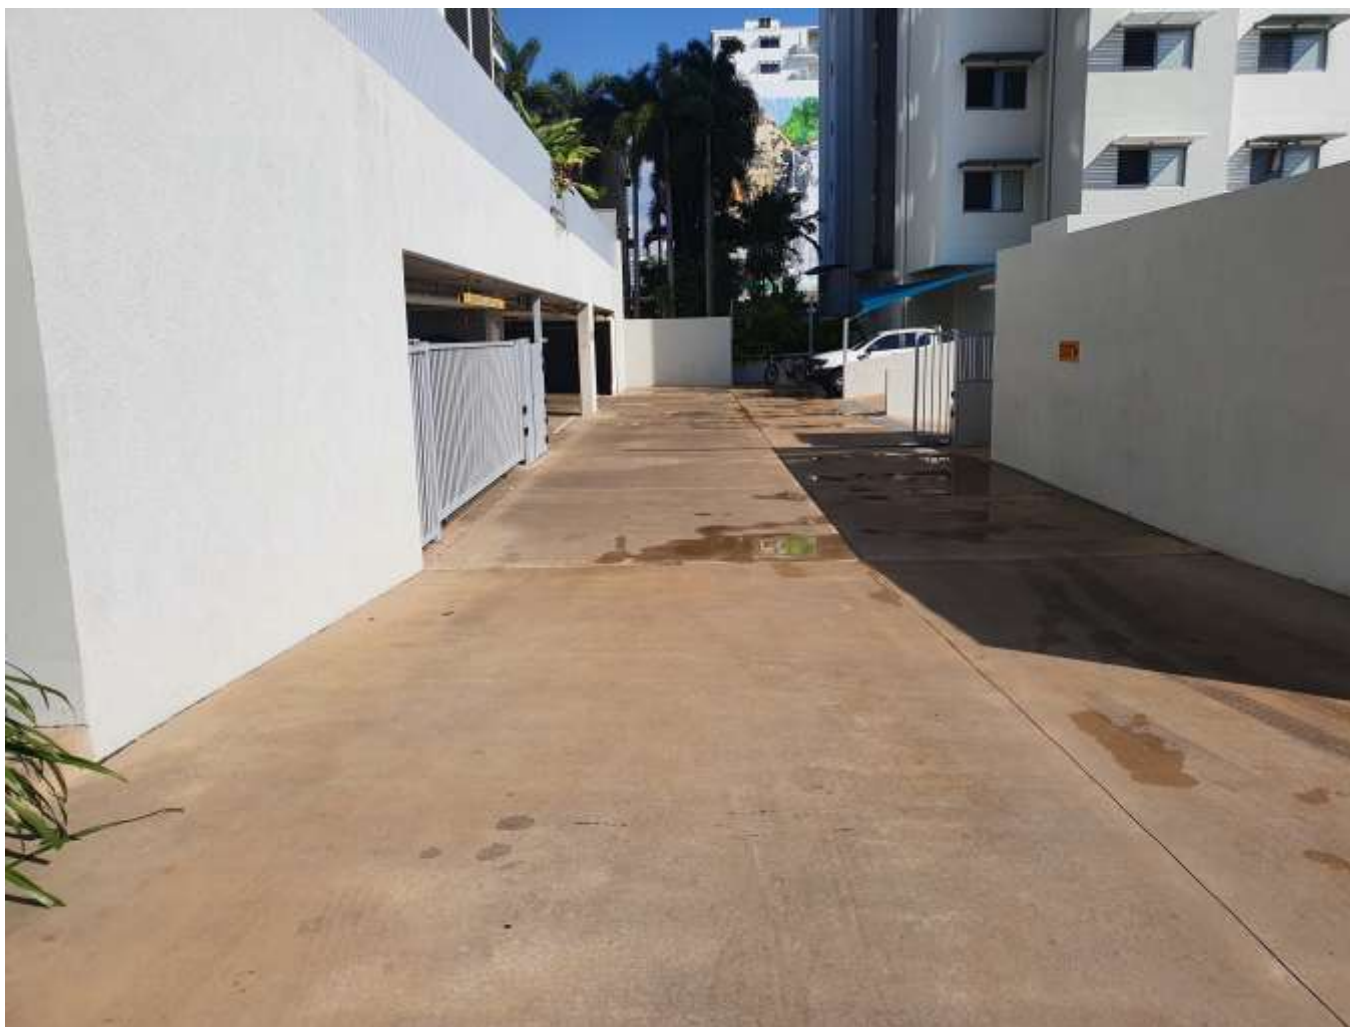
Photo 2 – Carpark driveway (post cleanup)

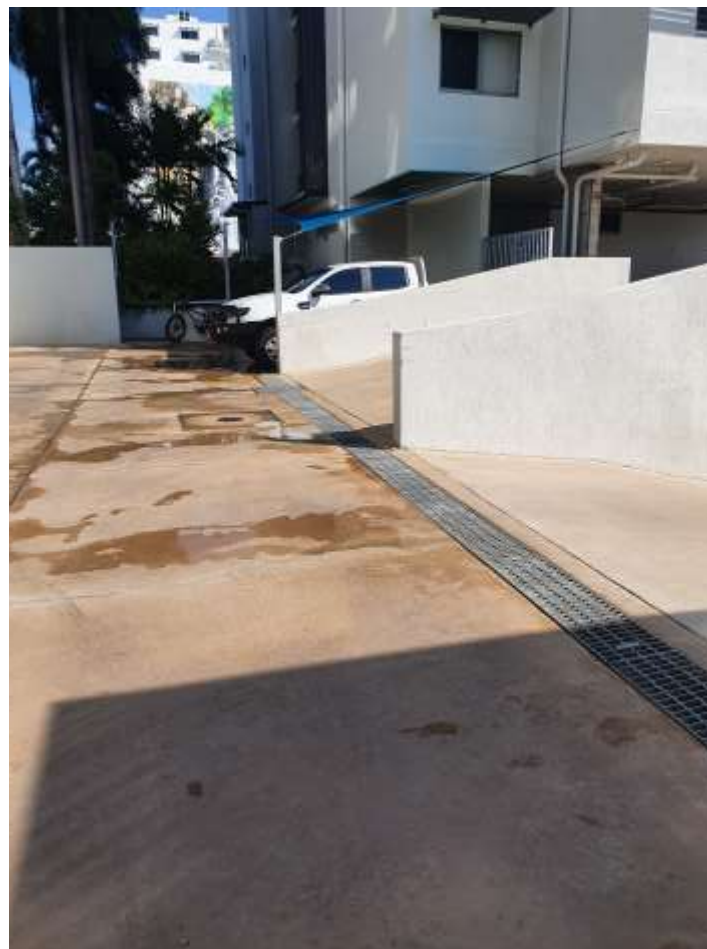
Photo 3 – Stormwater Drain (post cleanup)
