## SECTION 14 INCIDENT REPORT (*Waste Management and Pollution Control Act*)

| Person / Company: | Power and Water Corporation ( <b>PWC</b> ) |
| Incident: | Discharge of raw sewage from sewerage network (no gross pollutants) |

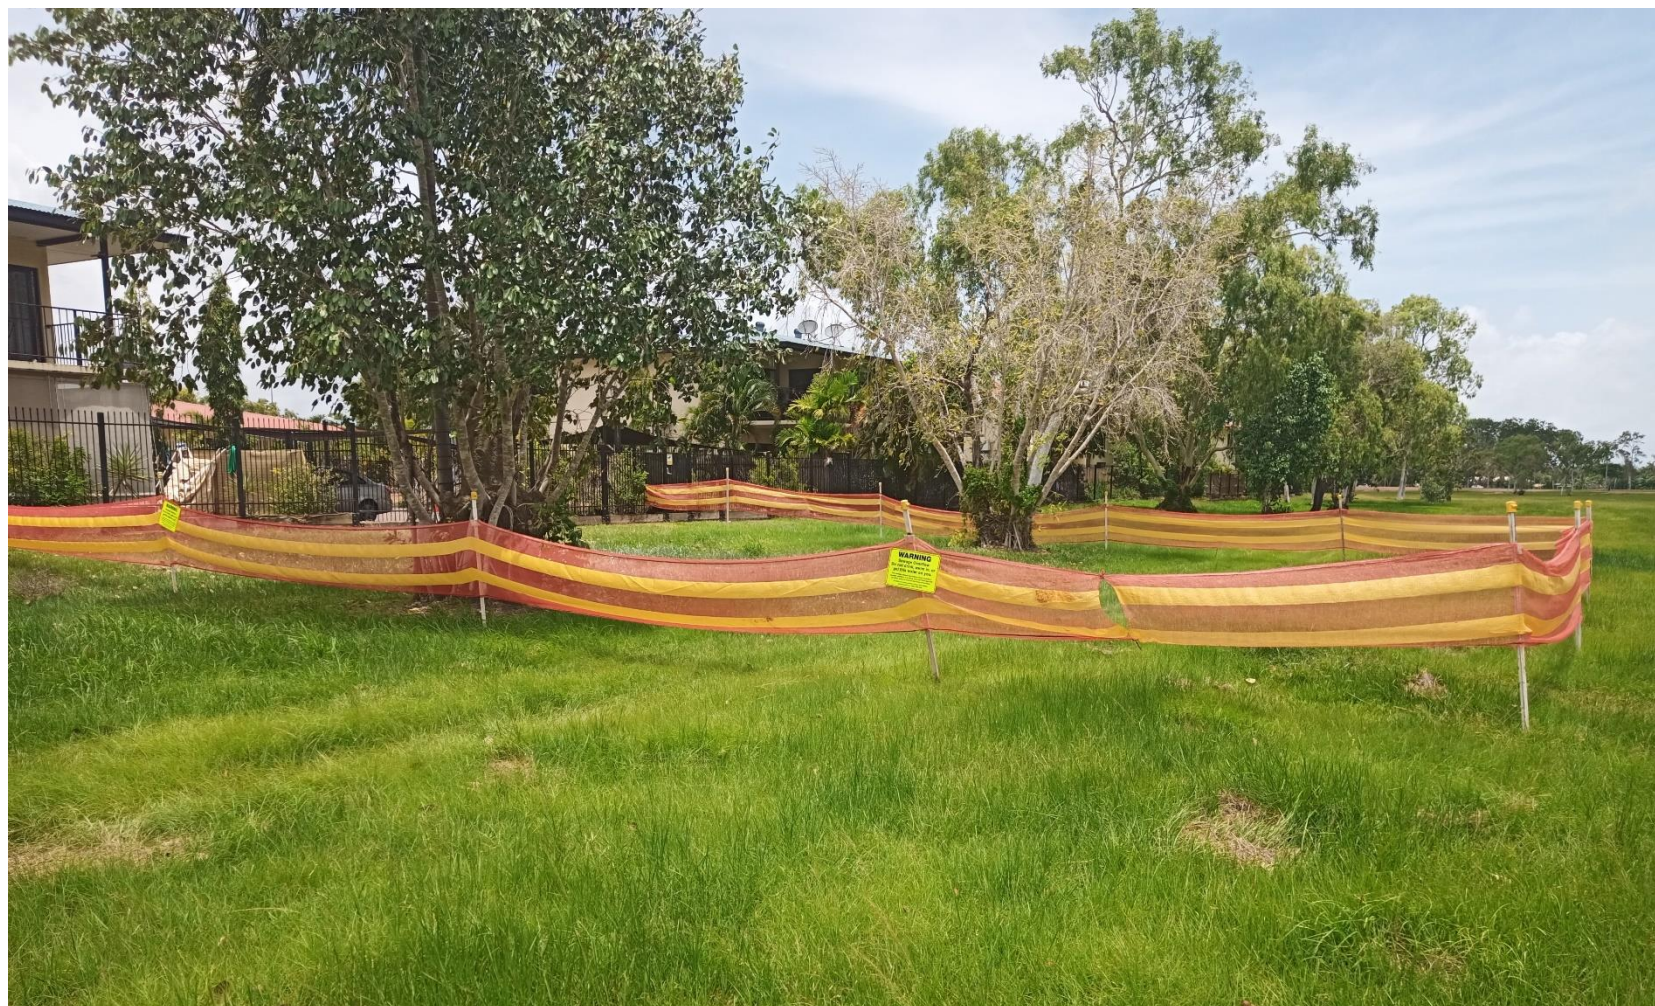
Photo 1 - Fencing and warning signage in place

| <p><b>environmental harm caused or threatening to be caused by the incident</b></p> | <p>The site has had barricading and warning signage installed to alert the general public as per Sewage Spills/Overflow Response Work Instruction, see photographs below.</p> <p>PWC has attempted to prevent this type of overflow by providing public education material on their website, see above link. PWC is unable to control the actions of individual residents and what they dispose of into the sewage system, including waste cooking oils and fats, rags or other items.</p> <p>Clean up was consistent with PWC's Sewage Spills/Overflow Response Work Instruction, to minimise risk to public health. Response undertaken as per an 'Unsealed Land' receiving environment, as per 'Attachment 1 - Receiving environment and clean-up procedures' of the PWC Sewage Spills/Overflow Response Work Instruction – attached for your reference.</p> <p>Based upon the small discharge area, no gross pollutants being present in the discharge, and receiving environment (open land), any environmental impact as a result of this event is believed to be minimal and short lived. The discharge was localised, allowing liming of the area, followed by access restriction by fencing and signage. Liming reduces pathogen risks (as per Department of Health requirements) and aids in odour reduction.</p> <p><i>ii. Decontamination of the site as appropriate.</i></p> <p>Clean up consistent with Sewage Spills/Overflow Response Work Instruction as appropriate to the location, and to minimise risk to public health and the environment.</p> <p>Response undertaken as per an 'Unsealed Land' receiving environment, as per 'Attachment 1 - Receiving environment and clean-up procedures' of the PWC Sewage Spills/Overflow Response Work Instruction – attached for your reference.</p> |

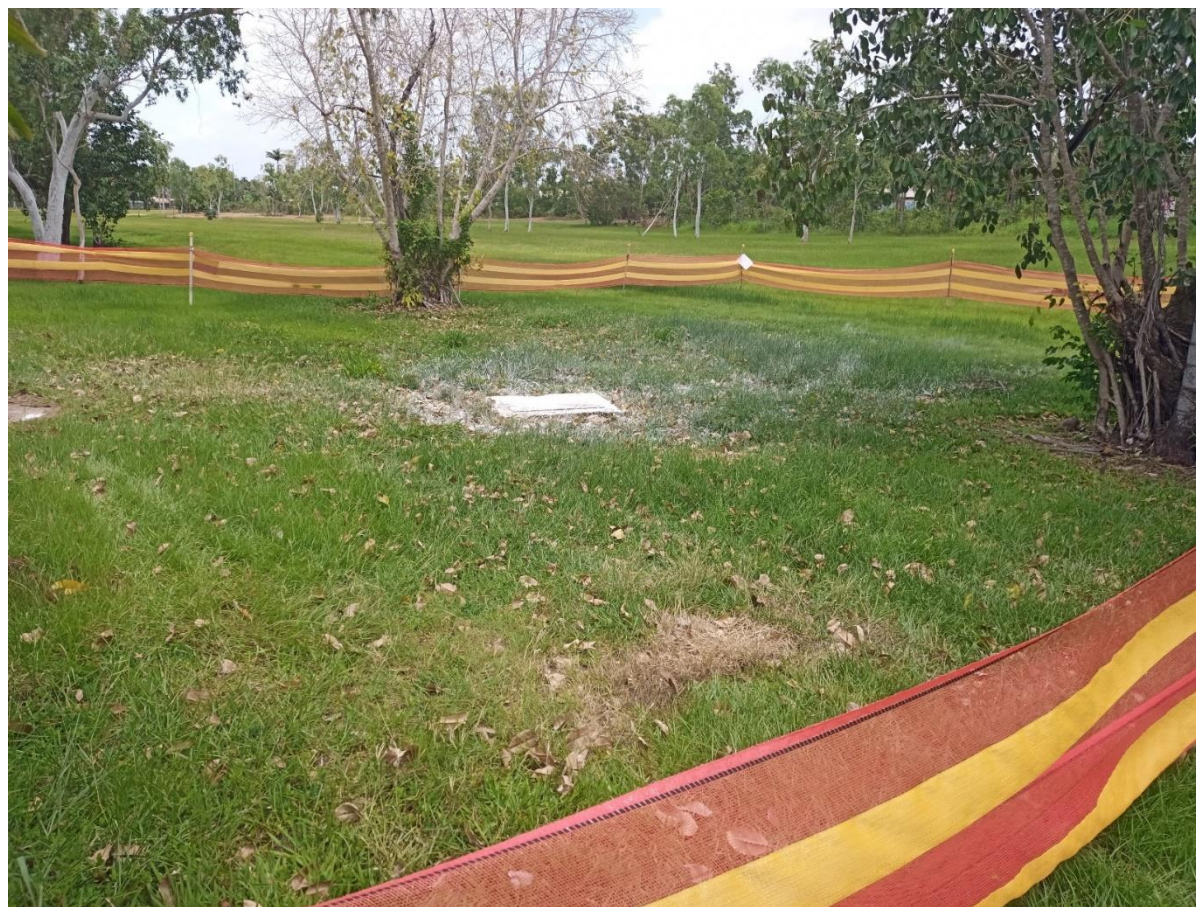
Photo 2 - Fencing, signage and liming of area

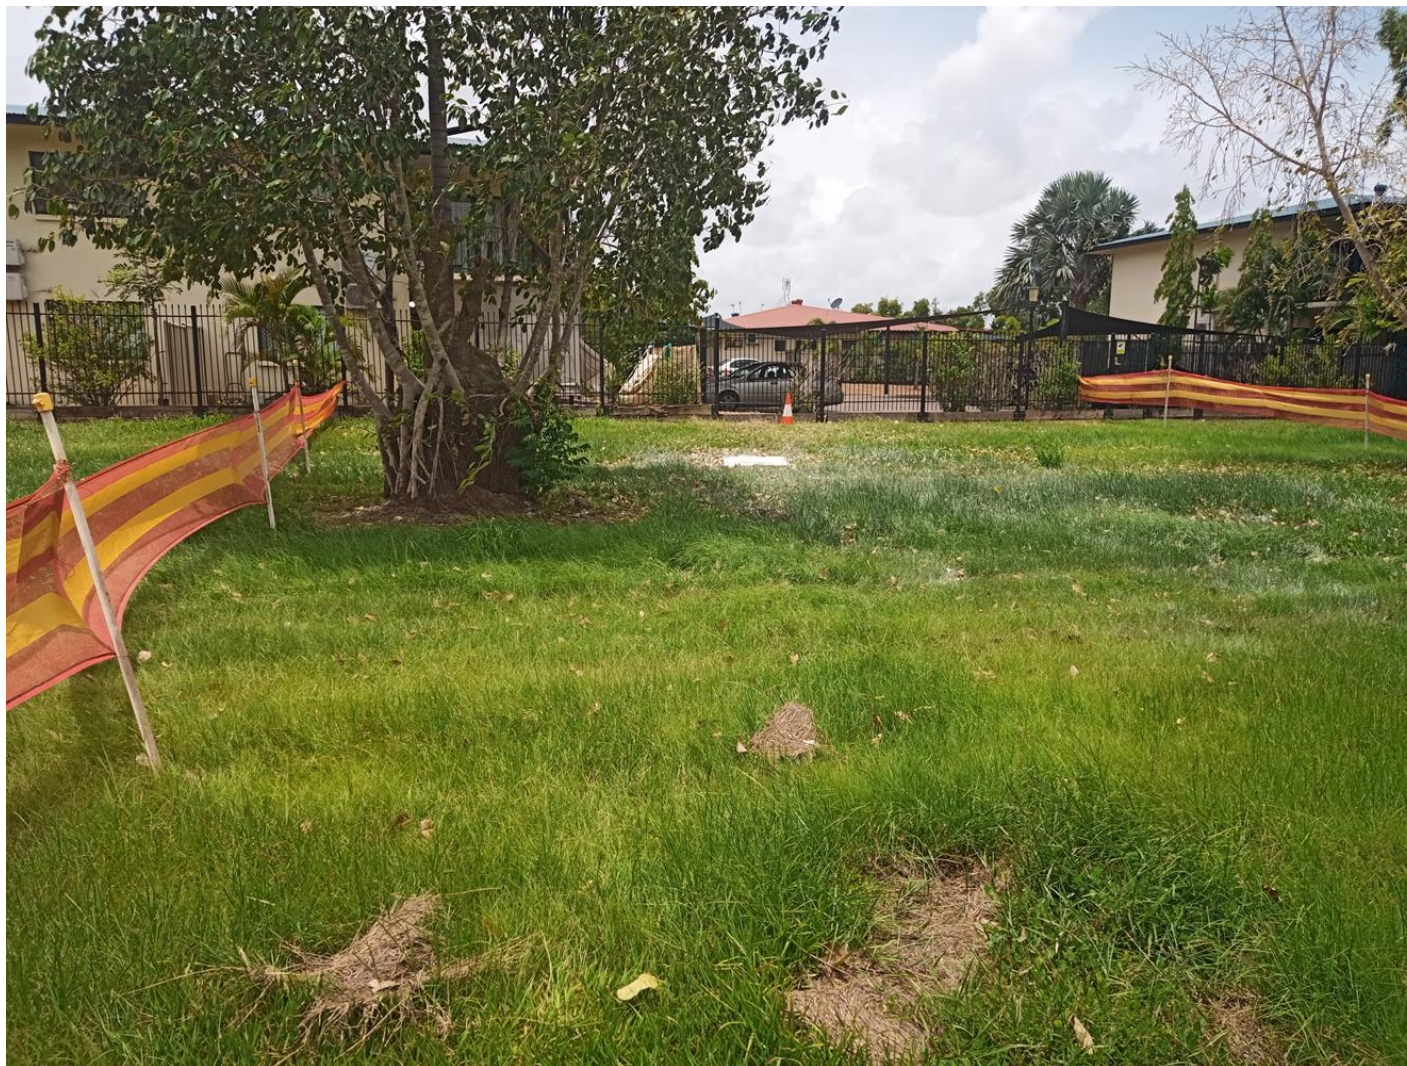
Photo 3 - Fencing, signage and liming of area
