## SECTION 14 INCIDENT REPORT (*Waste Management and Pollution Control Act*)

| Person / Company: | Power and Water Corporation ( <b>PWC</b> ) |
| Incident: | Discharge of raw sewage from sewerage network (no gross pollutants) |

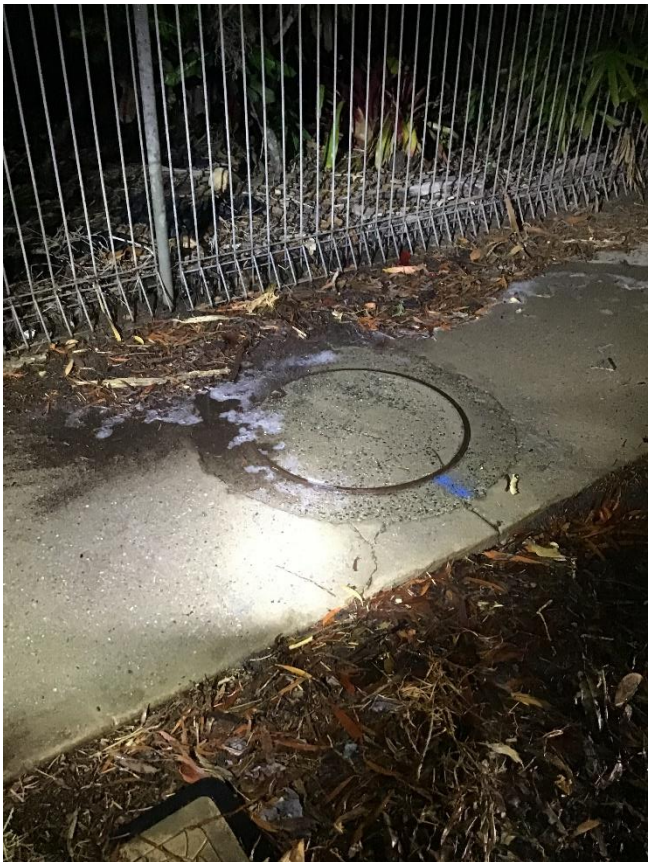
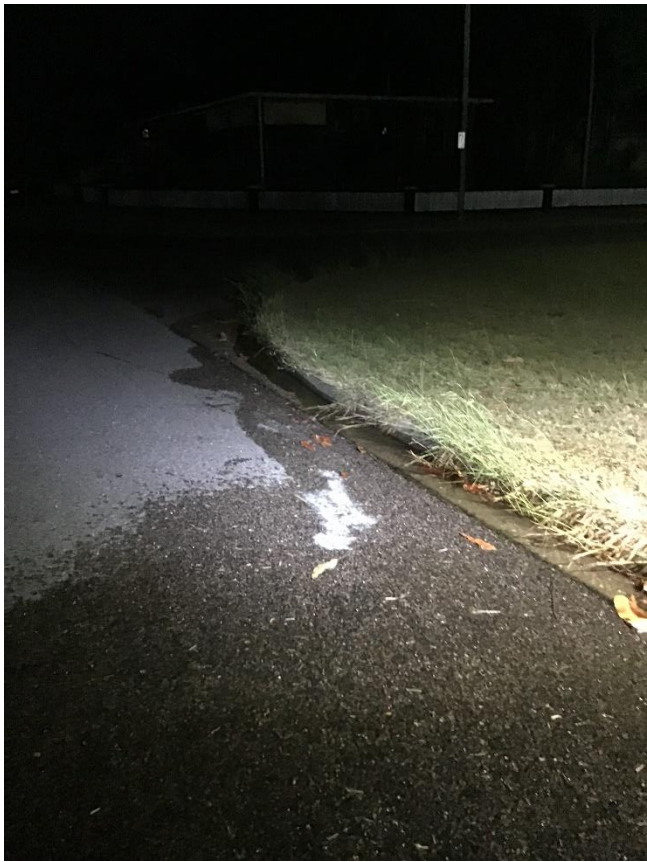
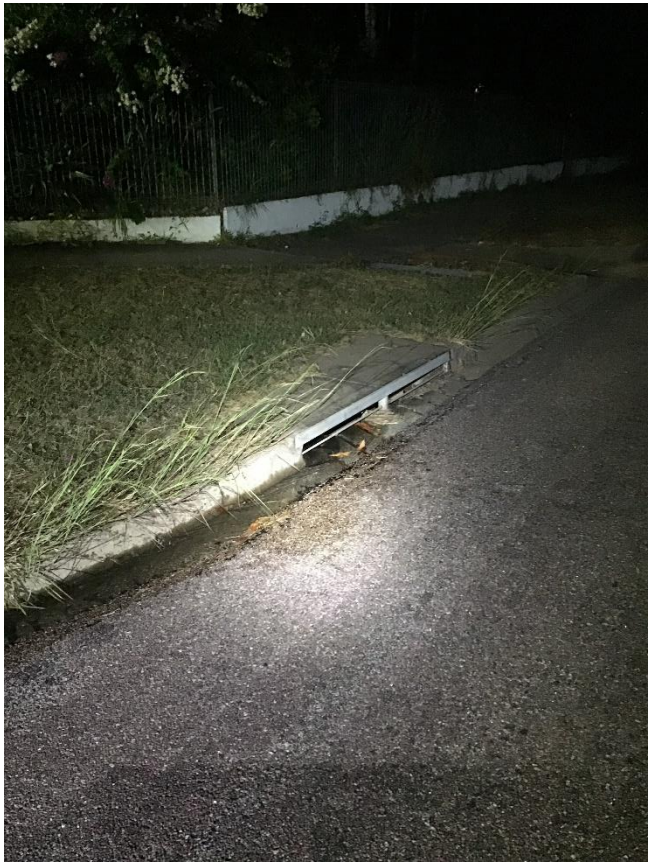
Appendix B – Photographs of spill location

| <b>(c) the date and time of the incident</b> | <p><i>i. The time and date of commencement and cessation of the discharge.</i></p> <p>The commencement time of the overflow is unknown. The overflow was observed at approximately 21:20hrs by PWC staff on 05/05/2020 and the spill stopped by 21:30hrs 05/05/2020.</p> <p><i>ii. How PWC were notified, or became aware of the discharge.</i></p> <p>This overflow was reported by one of the residents to the PWC call centre, who then relayed the information to the on-call PWC operations staff. PWC personnel attended the site at 21:20hrs (05/05/20) and undertook action to resolve the situation and make it safe.</p> <p><i>iii. The process by which the discharge occurred.</i></p> <p>The cause of the spill was due to a blockage in the main line, as a result of wet wipes being incorrectly disposed of into the sewage system.</p> <p>Public education about what can be disposed in sewer/is flushable: <a href="https://www.powerwater.com.au/about/what-we-do/wastewater/sewer-blockages-and-overflows/think-before-you-put-it-down-the-sink">https://www.powerwater.com.au/about/what-we-do/wastewater/sewer-blockages-and-overflows/think-before-you-put-it-down-the-sink</a><br/>In the aim of prevention this material is available on the PWC website and is used as an educational tool for customers. Additionally, PWC has recently been running an educational campaign on social media, print media and radio on the 3P's.</p> <p><i>iv. The reason why the discharge occurred.</i></p> <p>As per (c) iii. Sewerage network infrastructure has been designed to overflow with the best public health and environmental outcomes possible. Design focuses on not overflowing directly inside houses/businesses; rather discharge is designed to occur in a controlled manner at locations which can be accessed for infrastructure repair and clean up and with minimal public health or environmental impacts.</p> |

| <b>(e) the attempts made to prevent, reduce, control, rectify or clean up the pollution or resultant environmental harm caused or threatening to be caused by the incident</b> | <p><i>i. Confirmation signage and fencing has been erected, as appropriate.</i></p> <p>No barricading or signage was erected in this instance, as the spill occurred on hard sealed surfaces, which were cleaned and disinfected straight away, as per Sewage Spills/Overflow Response Work Instruction.</p> <p><i>ii. Decontamination of the site as appropriate.</i></p> <p>Clean up consistent with Sewage Spills/Overflow Response Work Instruction - Stormwater Drain – Sealed and Unsealed; Remove any</p> |

| | gross contamination (including paper, rags, etc.) from impacted area, wash down the entire area with clean water and disinfecting biodegradable detergent and use sucker truck to remove water from clean up area. |
