## SECTION 14 INCIDENT REPORT (*Waste Management and Pollution Control Act*)

| Incident: | Discharge of raw sewage from sewerage network (sewer manhole cover to roadside stormwater drain) |

| <b>(b) the place where the incident occurred</b> | <p>57 Benison Road, Winnellie</p> <p><i>i. Description of the PWC asset from which the discharge occurred.</i></p> <p>Sewer manhole cover (1/4/3) located at 57 Benison Road, Winnellie, – as per map below.</p> <p><i>ii. GPS coordinates of the discharge point from the PWC asset, and the final coordinates of the final discharge point.</i></p> <p>Discharge Point: 130.8688624, -12.4306549</p> <p><i>iii. Indicate any locations nearby to the discharge point where public can gain ready-access, such as public open spaces through which the discharge moves.</i></p> <p>Access to the public is possible in the small section of grassed road verge between the manhole cover and the road. Spill has been fenced and signage erected. Clean up was undertaken as per Sewage Spills/Overflow Response Work Instruction.</p> |

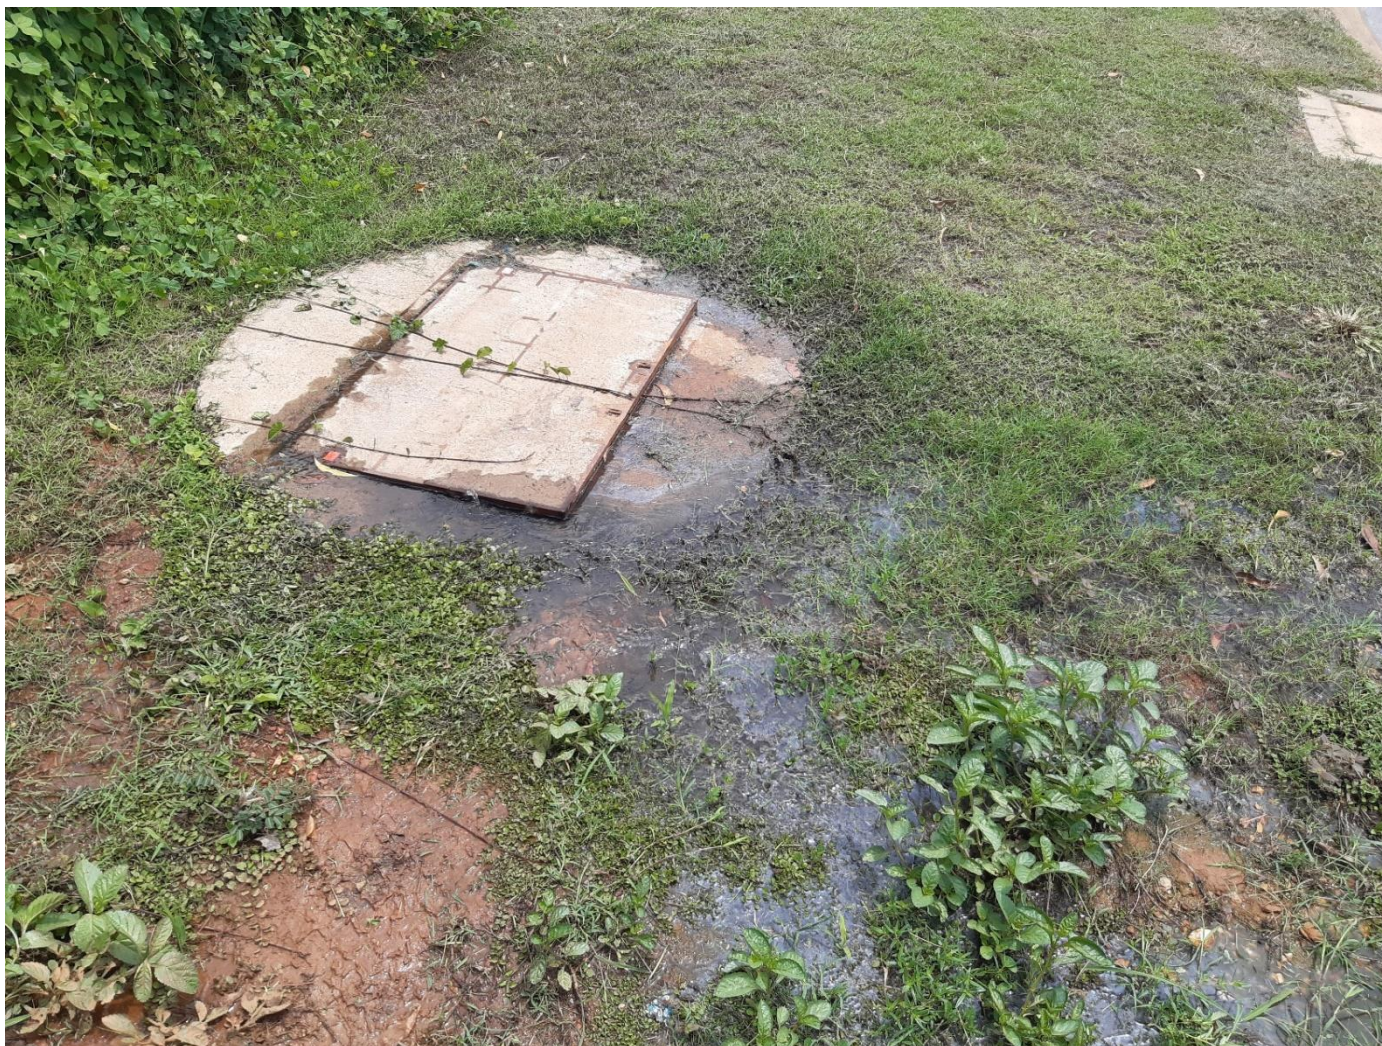
Photo 1 – Pre-clean up

This overflow was noticed by a PWC contractor driving past the location, who then notified the relevant sewerage networks department, which shortly after attended the scene. Upon arrival it was noticed that the sewer manhole cover (Ac 1/4/3) was overflowing onto the grassed verge. The start time of the overflow is unknown and there is no metered data available for manholes to determine a volume of the overflow. The affected area was limited to approximately 2 square meters.
