## SECTION 14 INCIDENT REPORT (*Waste Management and Pollution Control Act*)

| Incident: | Discharge of diluted sewage from sewerage network |

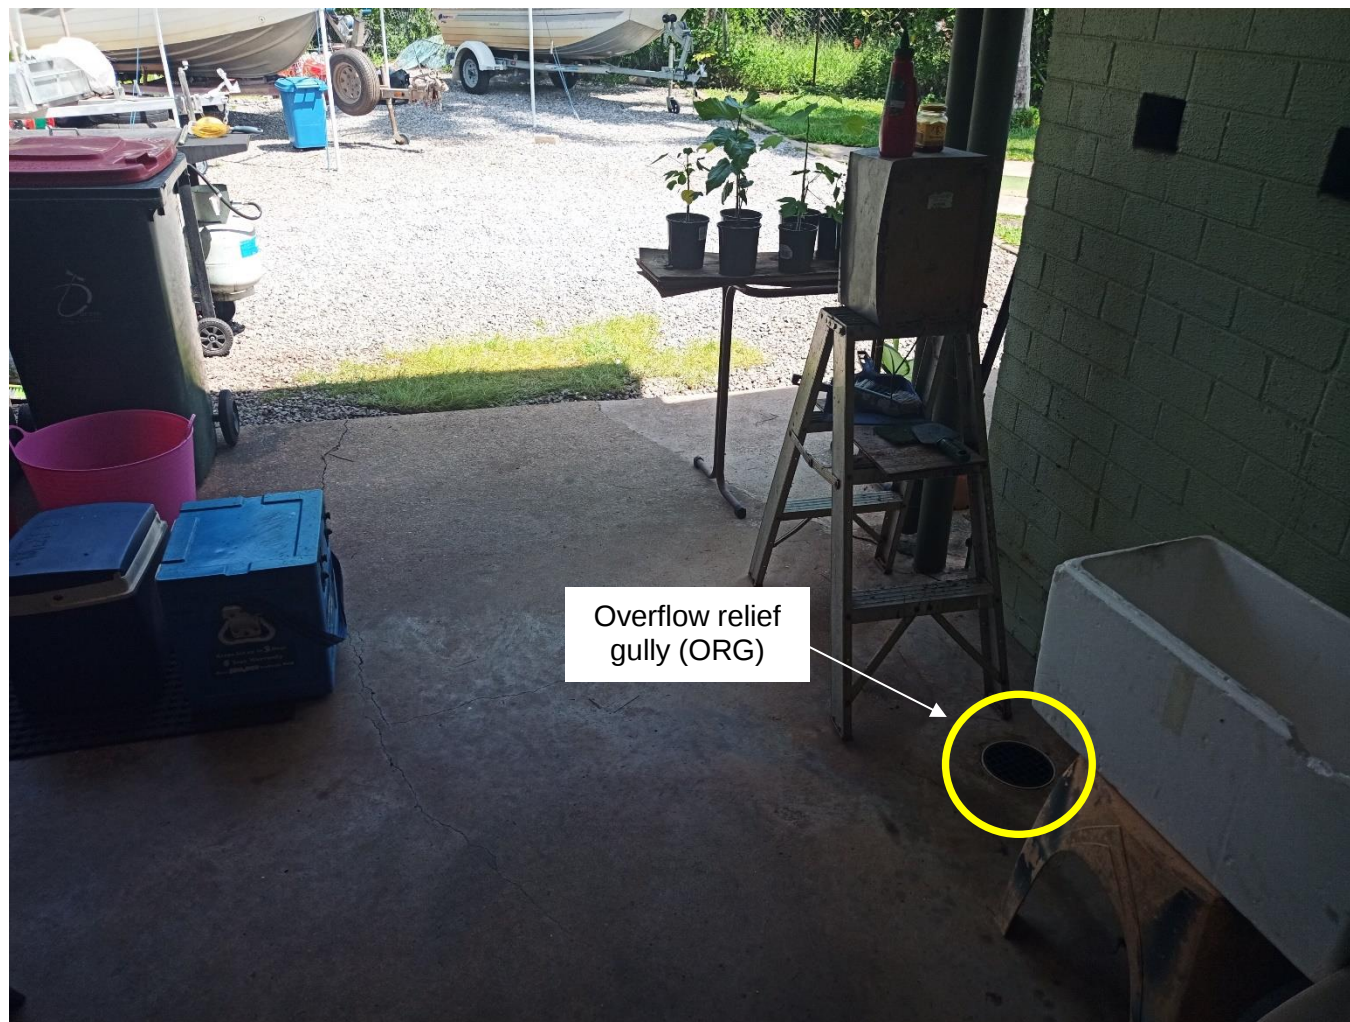
Appendix B – Photograph of the ORG post clean up and disinfection

| <b>(e) the attempts made to prevent, reduce, control, rectify or clean up the pollution or resultant environmental harm caused or threatening to be caused by the incident</b> | <p><i>i. Confirmation signage and fencing has been erected, as appropriate.</i></p> <p>No signage or fencing was erected in this instance, as the spill occurred at a fenced, private residence. All residents residing there were advised to avoid contact with the area.</p> <p><i>ii. Decontamination of the site as appropriate.</i></p> <p>Clean up consistent with Sewage Spills/Overflow Response Work Instruction as appropriate to the location, and to minimise risk to the Environment. Site inspected for any gross pollutants of which none were observed, and the surrounding surface was cleaned. Landholders advised not to enter affected areas for a minimum of 5 days after clean up.</p> |

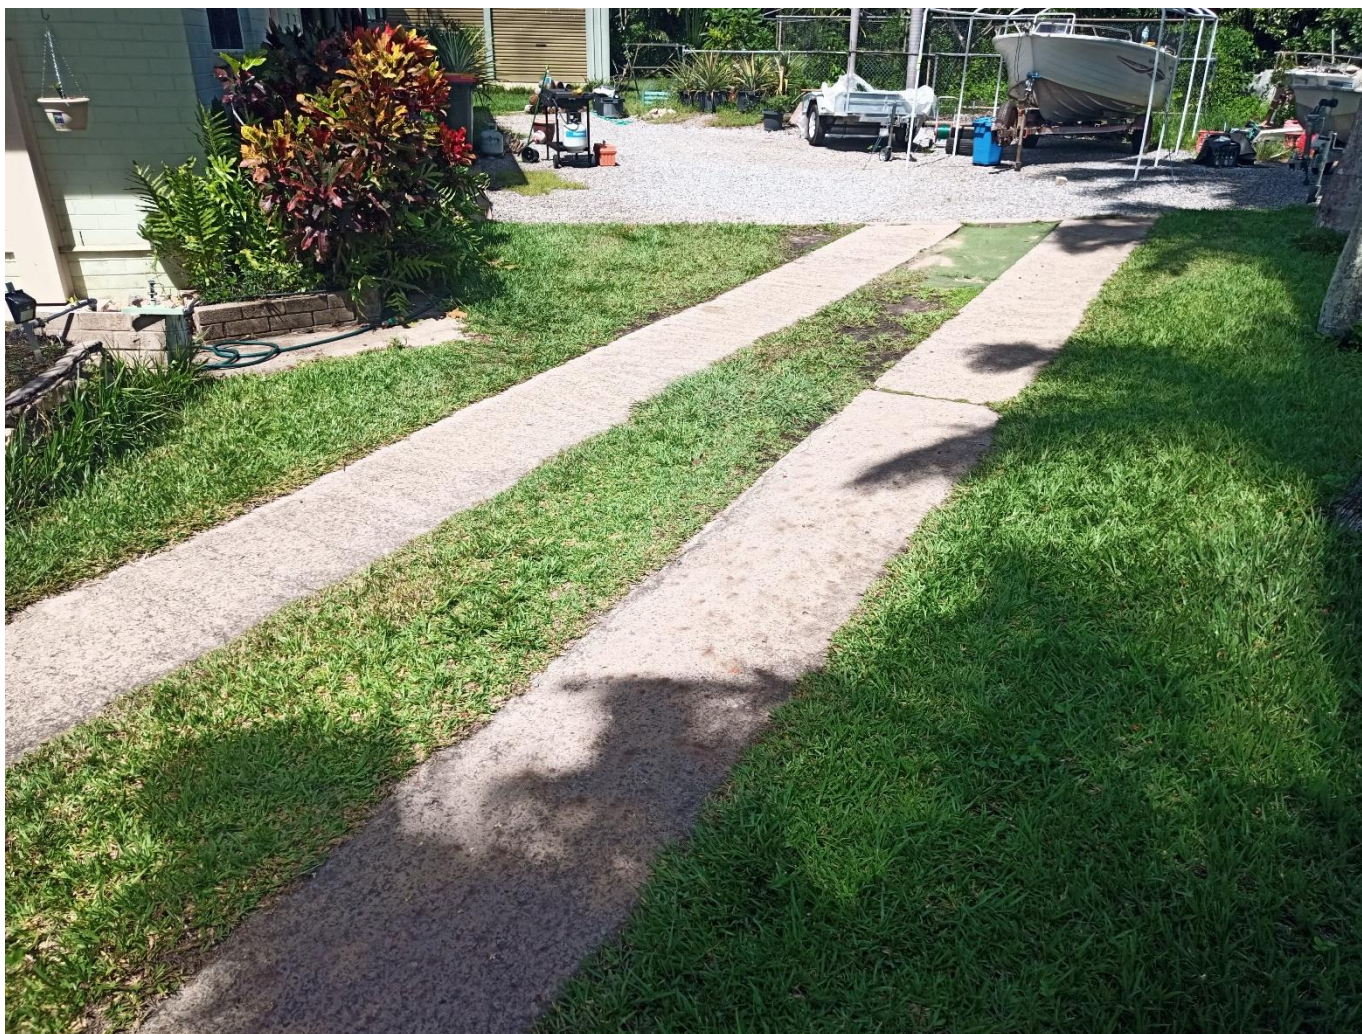
Appendix C – Photograph of the spill site post clean up and disinfection
