## SECTION 14 INCIDENT REPORT (*Waste Management and Pollution Control Act*)

| <b>Incident:</b> | Discharge of raw sewage from sewerage network |

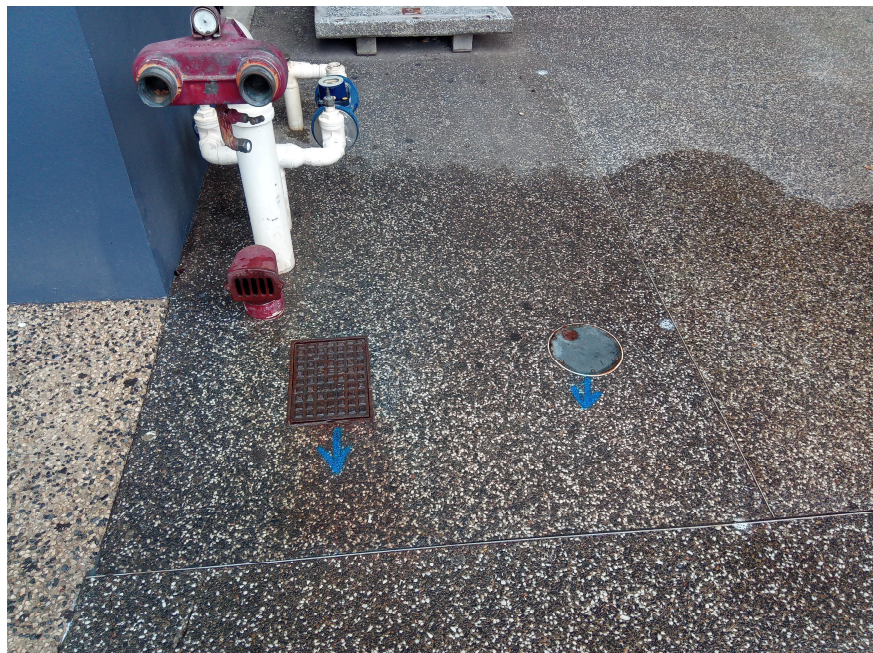
Discharge of raw sewage to the pathway and roadside occurred due to a foreign obstruction in the pipe, resulting in the overflow.

| <b>(b) the place where the incident occurred</b> | <p>80 Mitchell Street, Darwin City – from property micro-flap and inspection shaft – see photograph.</p> <p><i>i. Description of the PWC asset from which the discharge occurred.</i></p> <p>Property micro-flap and inspection shaft, located at the front of the building at 80 Mitchell Street, Darwin City. See map.</p> <p><i>ii. GPS coordinates of the discharge point from the PWC asset, and the final coordinates of the final discharge point.</i></p> <p>Overflow Point: 130.837338, -12.460682<br/>Discharge Point (road kerbside; approximate): 130.837360, -12.460736</p> <p><i>iii. Indicate any locations nearby to the discharge point where public can gain ready-access, such as public open spaces through which the discharge moves.</i></p> <p>Access by the public in this area is frequent. Upon PWC crew attending the overflow the site was cordoned off with witches hats which were supervised by PWC staff to prevent access by the public. Upon resolution of the blockage the area was cleaned comprehensively to ensure the area was safe for the public to access immediately.</p> <p>Clean up was undertaken as per Sewage Spills/Overflow Response Work Instruction. The site was disinfected and rinsed with fresh water. The fresh water was sourced from the PWC harben truck, which has a water storage tank on it. The water storage tank is filled from fire hydrants. Approximately 2,000L of water was flushed down the curb and into the stormwater, to dilute any sewerage in the stormwater system.</p> |

Property micro-flap vent and inspection shaft, from which discharge occurred.

| <b>(e) the attempts made to prevent, reduce, control, rectify or clean up the pollution or resultant environmental harm caused or threatening to be caused by the incident</b> | <p>The blockage was cleared and the overflow was stopped. Clean up undertaken as per Sewage Spills/Overflow Response Work Instruction.</p> <p><i>i. Confirmation signage and fencing has been erected, as appropriate.</i></p> <p>Upon PWC crew attending the overflow the site was cordoned off with witches hats which were supervised by PWC staff to prevent access by the public. Upon resolution of the blockage the area was cleaned comprehensively to ensure the area was safe for the public to access immediately. Due to the location temporary fencing was not appropriate. Therefore cleaning undertaken was performed to ensure access by the public immediately after resolution of the blockage was safe.</p> <p><i>ii. Decontamination of the site as appropriate.</i></p> <p>Clean up consistent with Sewage Spills/Overflow Response Work Instruction as appropriate to the location, and to minimise risk to the environment. The area was disinfected and flushed with fresh water. See photographs provided below.</p> |

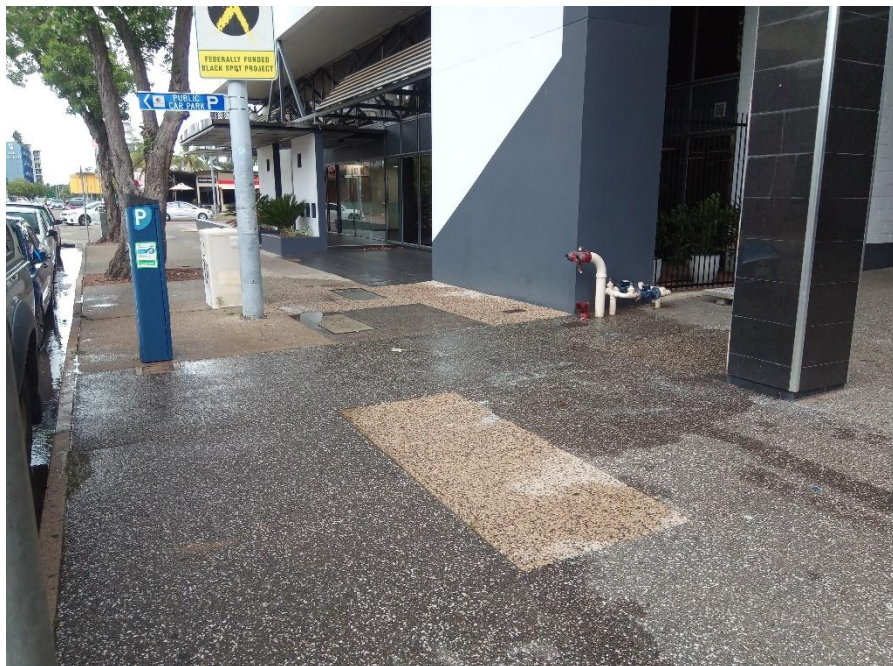
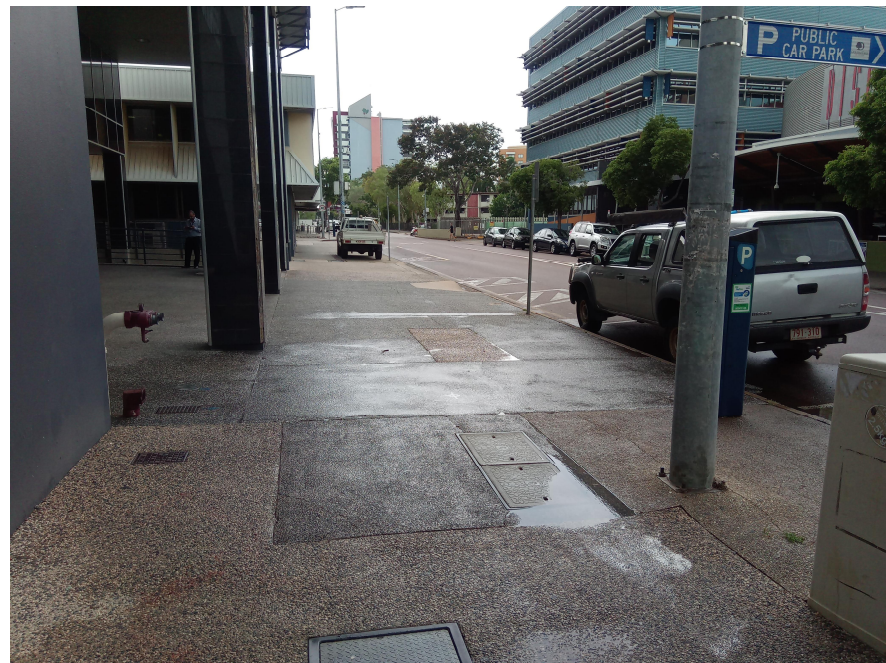
Photographs of overflow area after it has been cleaned up, disinfected and rinsed.
