## SECTION 14 INCIDENT REPORT (*Waste Management and Pollution Control Act*)

| Incident: | Discharge of raw sewage from Sewer Pump Station (SPS) 1, Amanbidji. |

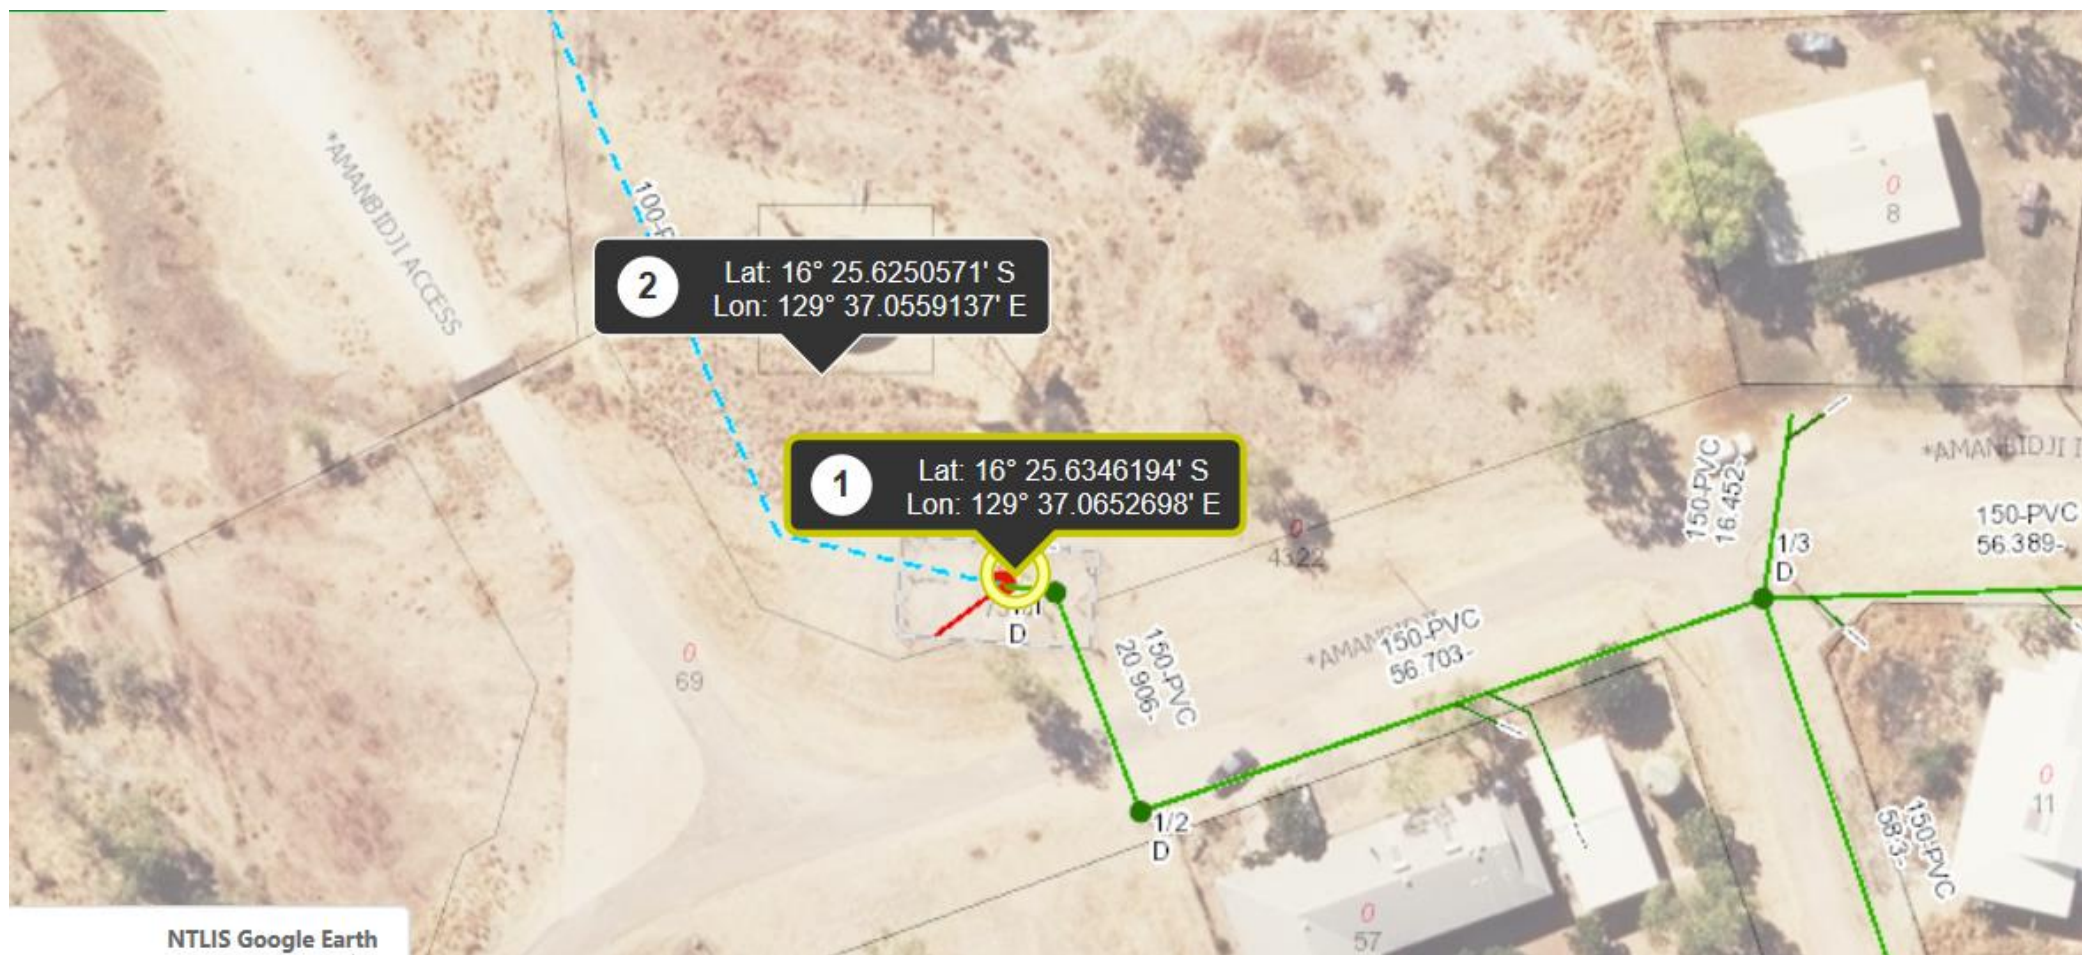
Figure 2. Discharge location (1) and Receiving Environment (2)

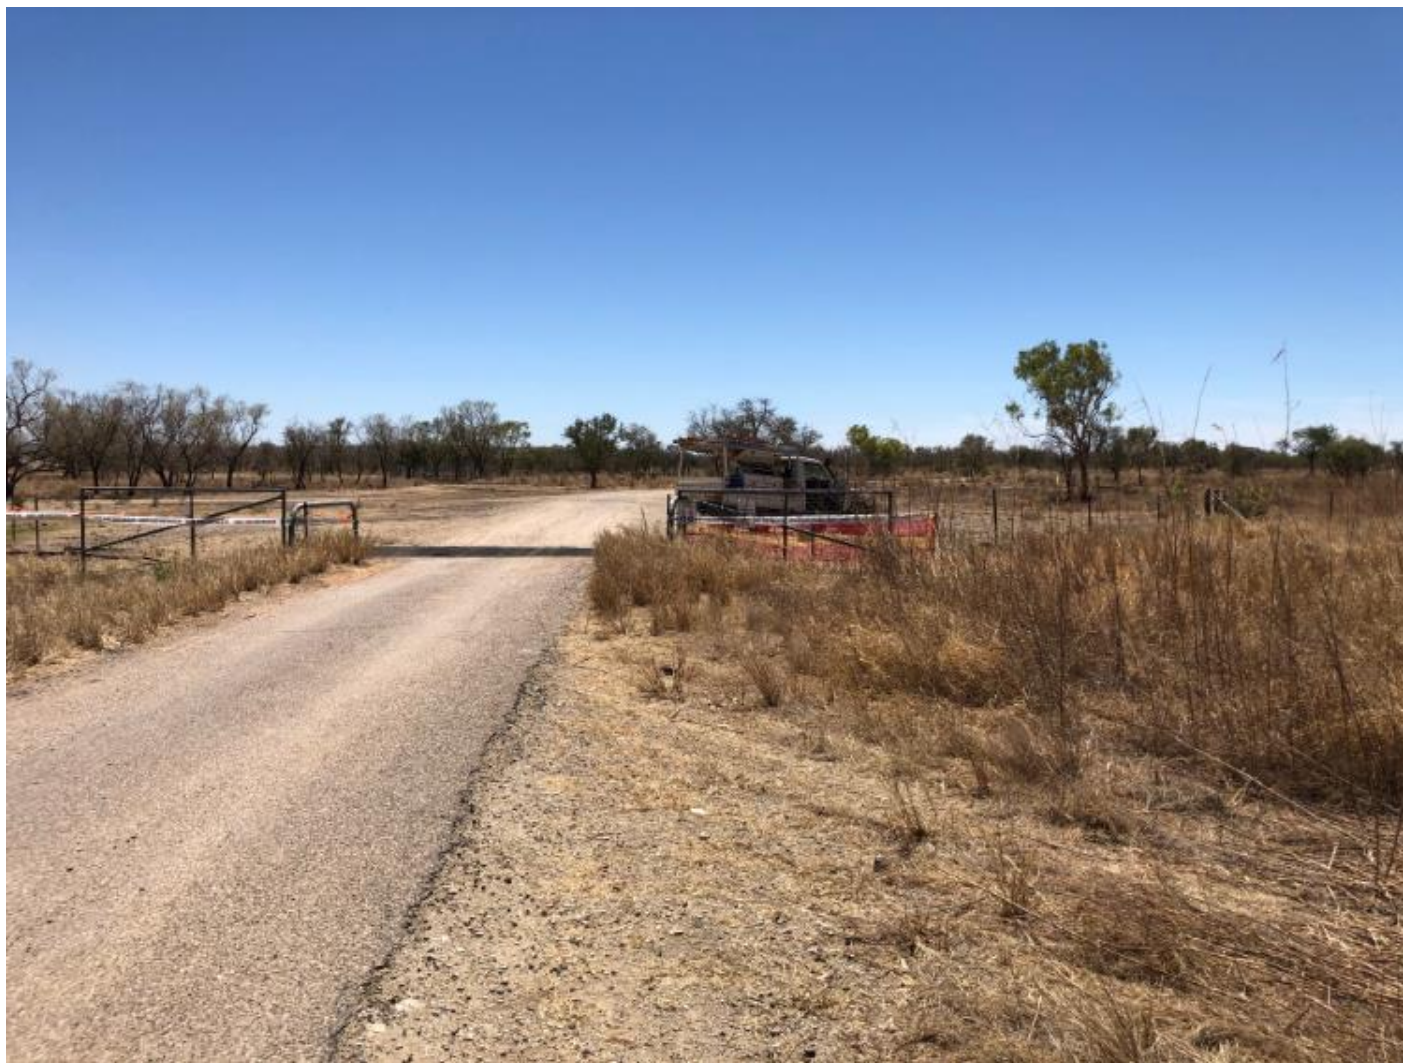
**Figure 3. Warning tape**

| <b>(e) the attempts made to prevent, reduce, control, rectify or clean up the pollution or resultant environmental harm caused or threatening to be caused by the incident</b> | <p><i>i. Confirmation signage and fencing has been erected, as appropriate.</i></p> <p>PWC has sent signs to the Timber Creek depot from Katherine, and were installed during the ESO's next visit. See attached image.</p> <p><i>ii. Decontamination of the site as appropriate.</i></p> <p>Site was inspected for gross pollutants of which none were present, By the time personnel arrived at site there was no pooling of wastewater evident and as such no lime has been applied to the area.</p> |
