## SECTION 14 INCIDENT REPORT (*Waste Management and Pollution Control Act*)

| <b>Incident:</b> | Overflow of diluted fully treated effluent |

| <b>(b) the place where the incident occurred</b> | <p><i>i. Description of the PWC asset from which the discharge occurred.</i></p> <p>Angurugu Wastewater Ponds, Angurugu – Groote Eylandt. Overflow is from infiltration basin after treatment ponds so effluent is “fully” treated.</p> <p><i>ii. GPS coordinates of the discharge point from the PWC asset, and the final coordinates of the final discharge point.</i></p> <p>Discharge Point: 136.4520024, -13.9802776<br/>Final discharge point: 136.4497657, -13.9788083</p> <p><i>iii. Indicate any locations nearby to the discharge point where public can gain ready-access, such as public open spaces through which the discharge moves.</i></p> <p>Discharge is to nearby bushland, via a purpose built drain, which is accessible to the public. Communication in place including appropriate signage along the drain to alert the public and prevent them coming in close proximity.</p> |

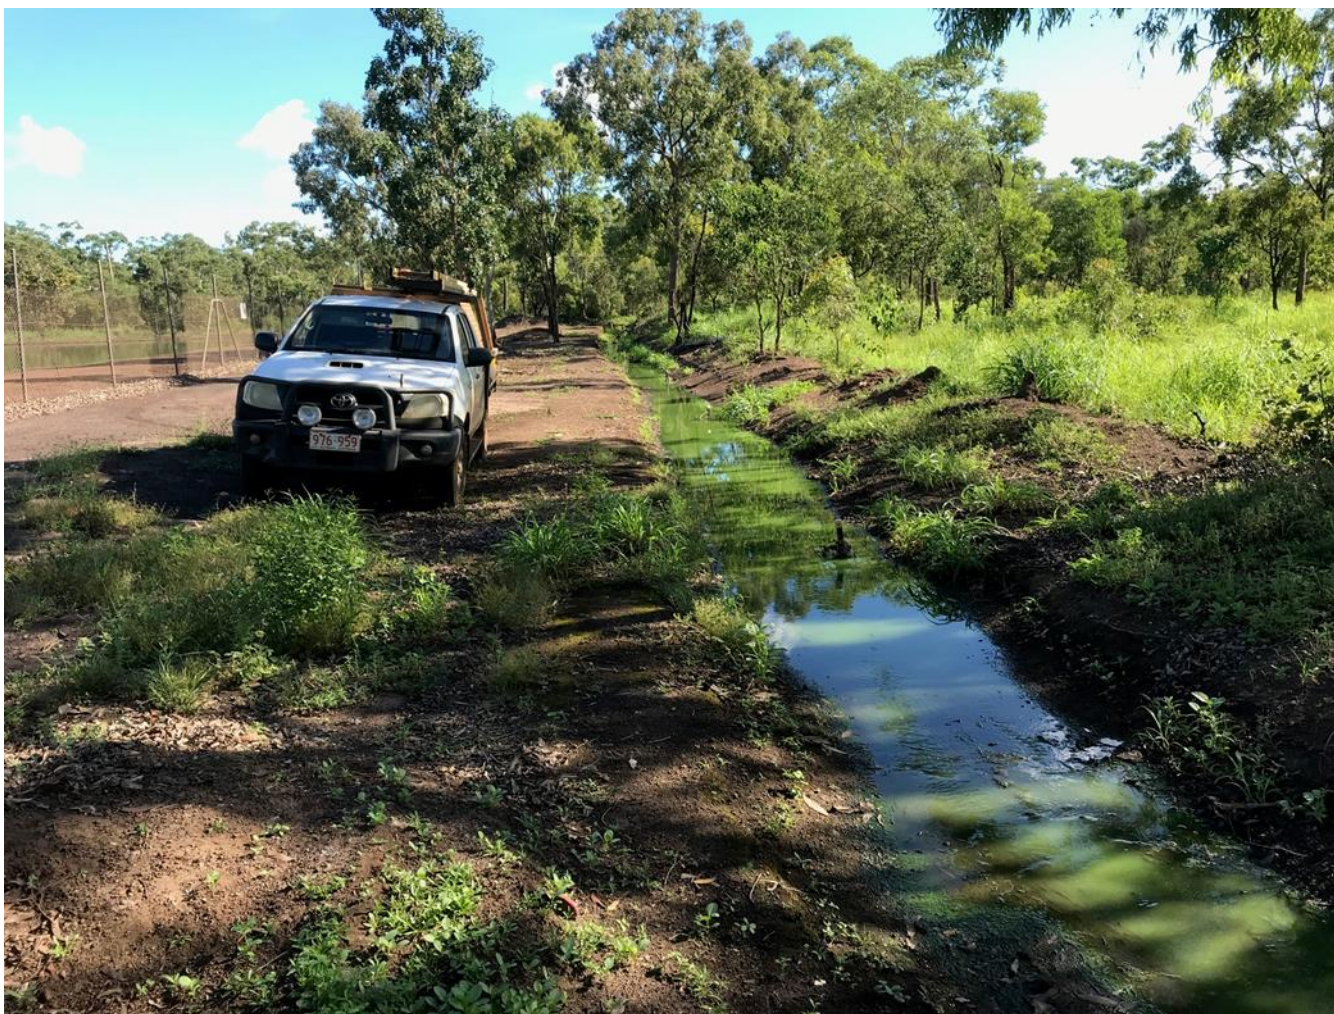
Appendix B – Photos of discharge travelling along drainage ditch

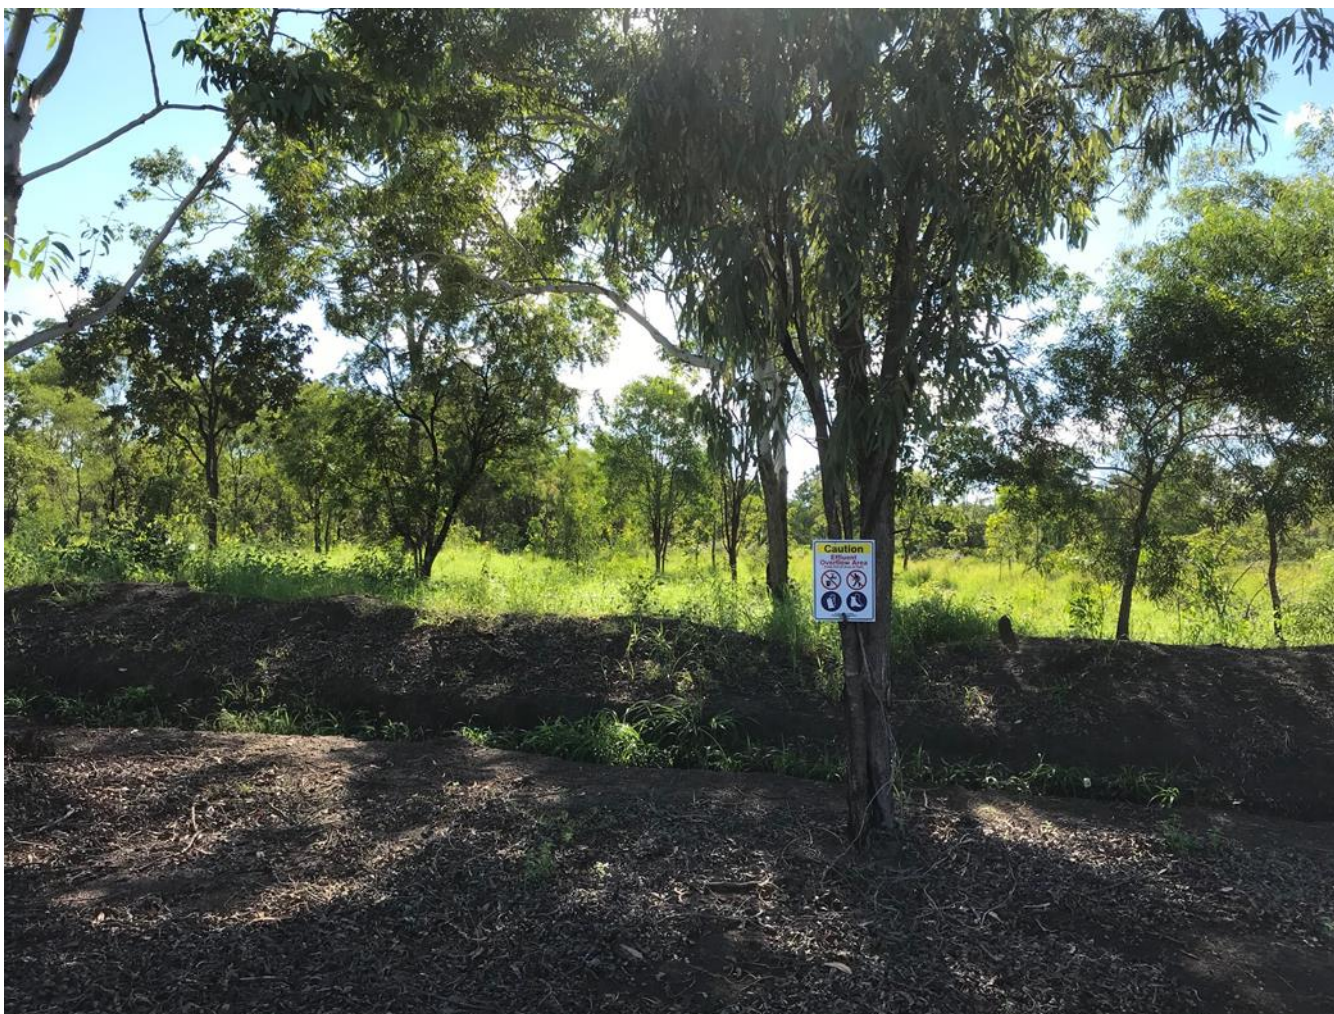
Appendix B – Photos of warning signage along drainage ditch

| <b>(e) the attempts made to prevent, reduce, control, rectify or clean up the pollution or resultant environmental harm caused or threatening to be caused by the incident</b> | <p><i>i. Confirmation signage and fencing has been erected, as appropriate.</i></p> <p>PWC prepared designs in 2013 to formalise and install an outfall pipe to the Angurugu River to allow controlled discharge of treated effluent during periods of high rainfall. Traditional owners of the land and another group of sacred site custodians could not agree on alignment of outfall pipe so a permanent solution was not able to be constructed.</p> <p>No rectification is possible as overflow is rainfall dependent. Diversion drains in place to direct the effluent from the ponds across the road and into bushland. Onsite staff monitoring situation and overflow pathway. Signage has been placed within the area to alert the public and the overflow area is located within a restricted road reducing the probability of the public coming in within close proximity.</p> <p>Fencing not appropriate in this instance, as the spill is flowing over a road and discharging into nearby bushland, with no anticipated access by the public. Warning signage has been erected.</p> <p><i>ii. Decontamination of the site as appropriate.</i></p> <p>Overflow is diluted treated effluent, sewage debris is not present. Natural processes (UV disinfection) will provide disinfection of the discharge. Mosquito larvae baiting is also being undertaken to prevent an increase in biting pests within the community.</p> |

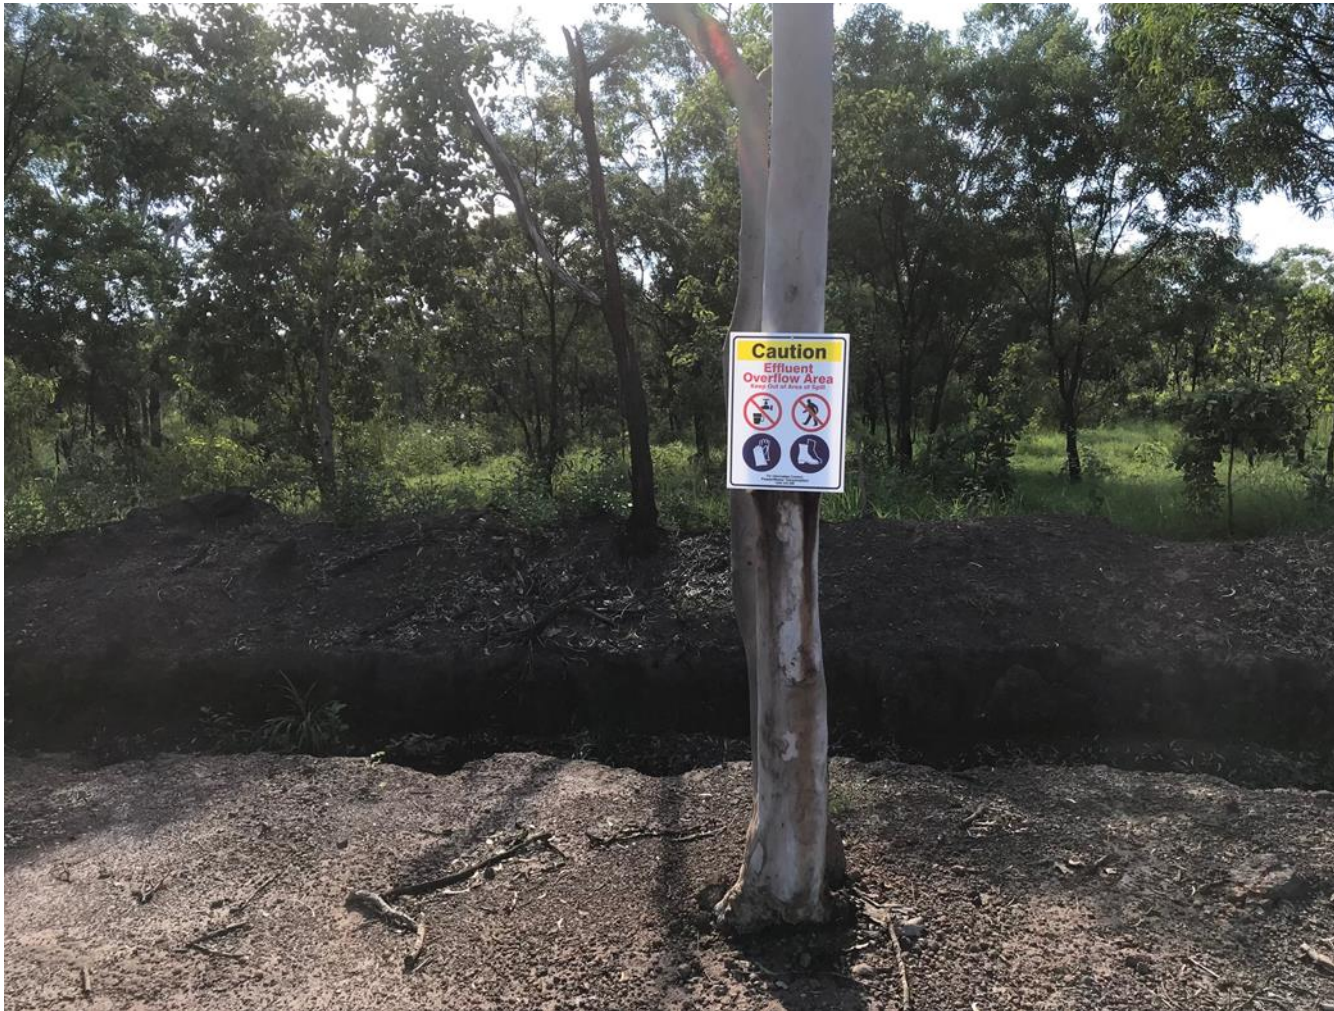
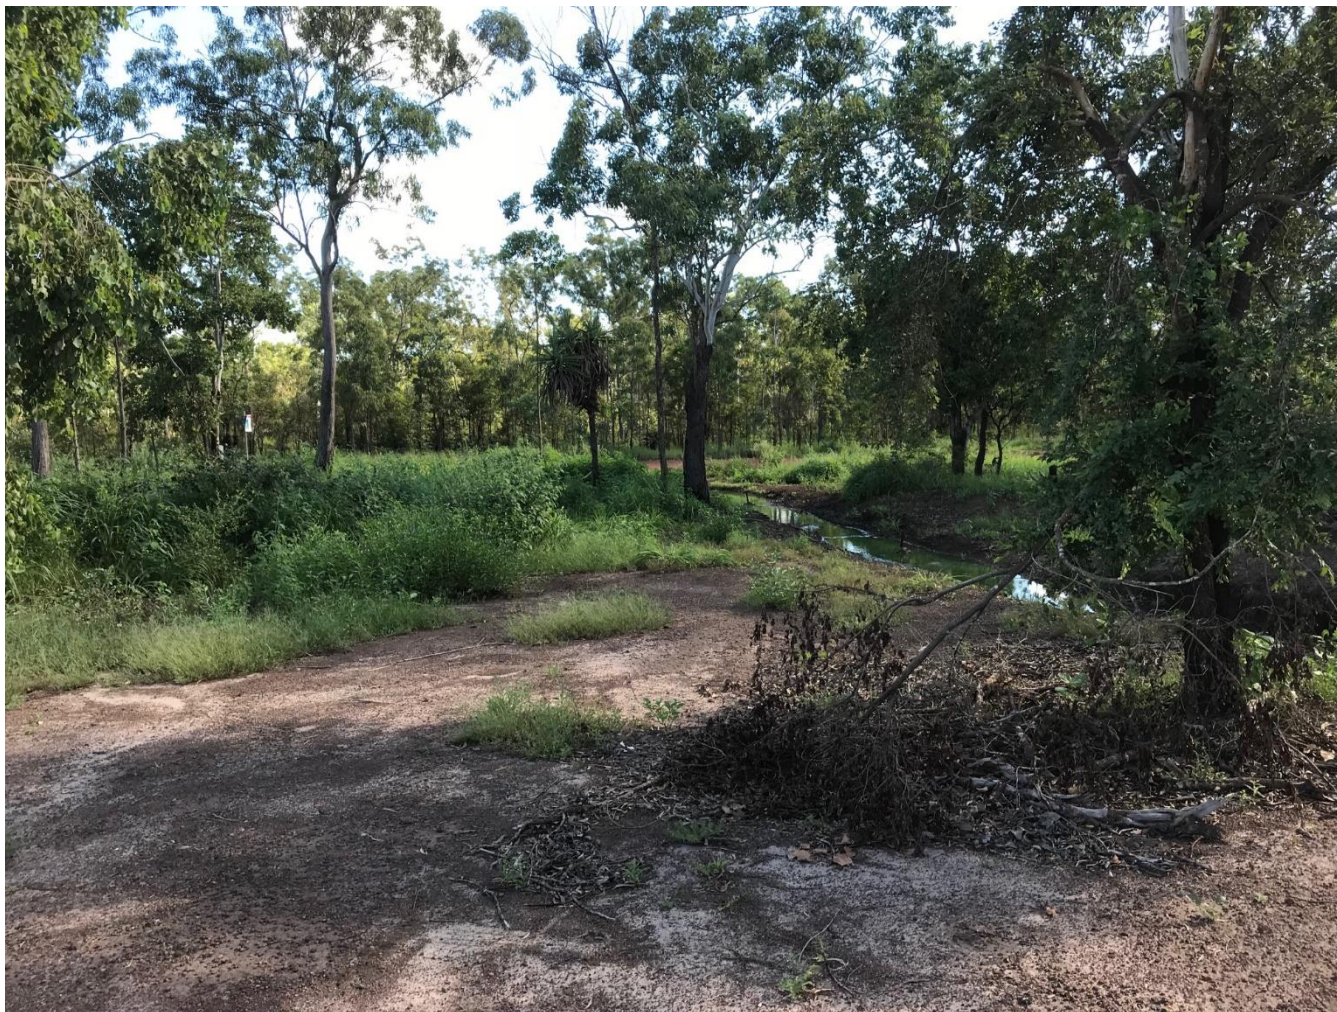
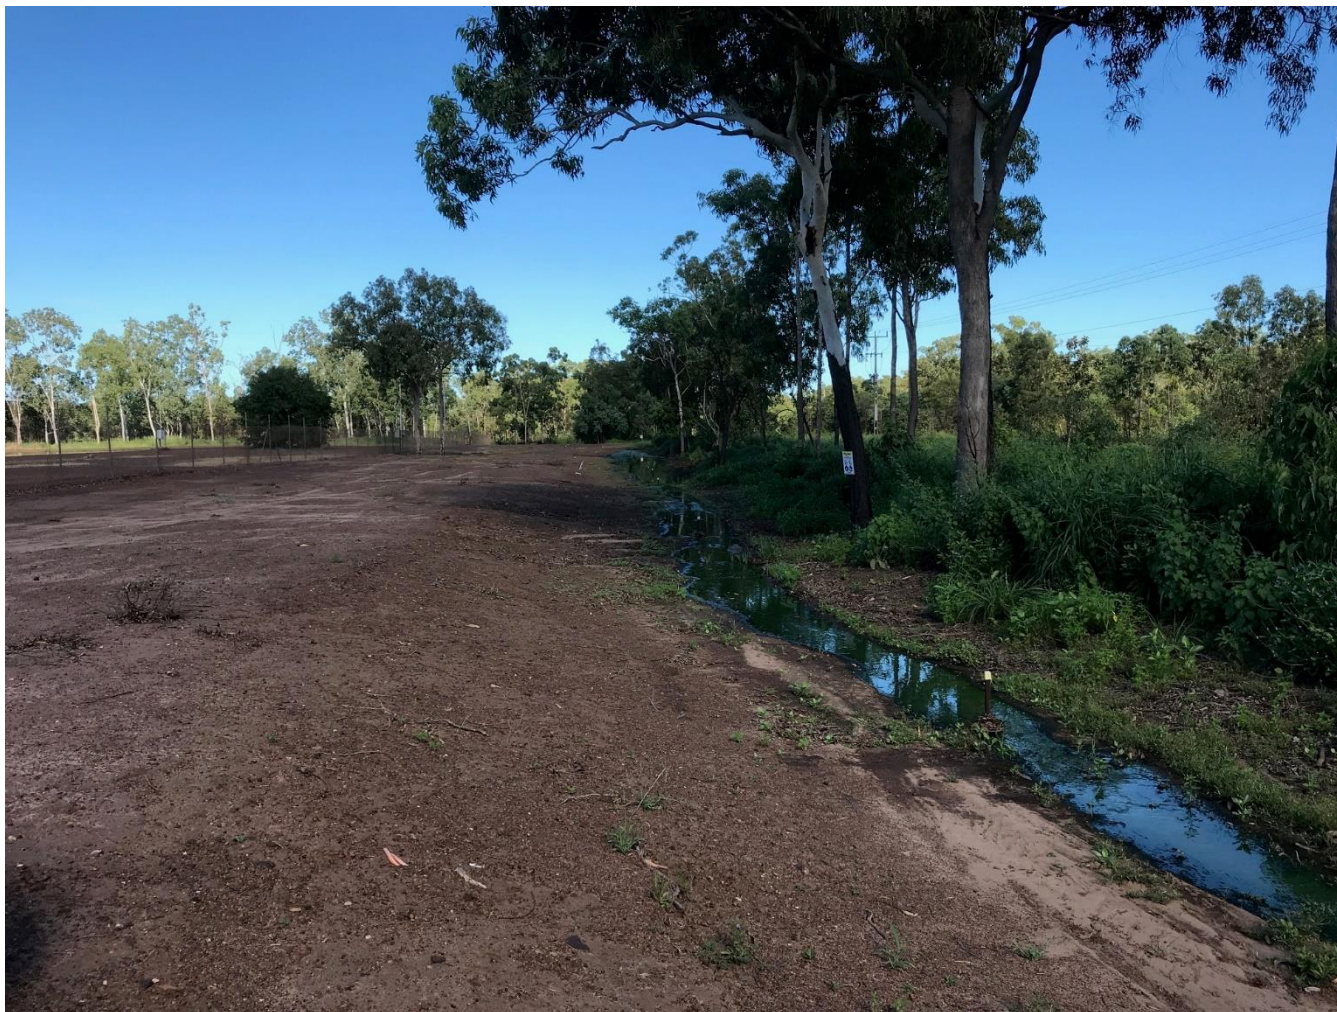
Appendix B – Photos of discharge travelling along drainage ditch
