## SECTION 14 INCIDENT REPORT (*Waste Management and Pollution Control Act*)

| Incident: | <p>Discharge of raw sewage from Sewer Pump Station (SPS) 2, Garawa.</p> <p>Power and Water is reporting this overflow on behalf of the Department of Housing. Power and Water operates the assets located within Garawa Camp, but are not the owners.</p> |

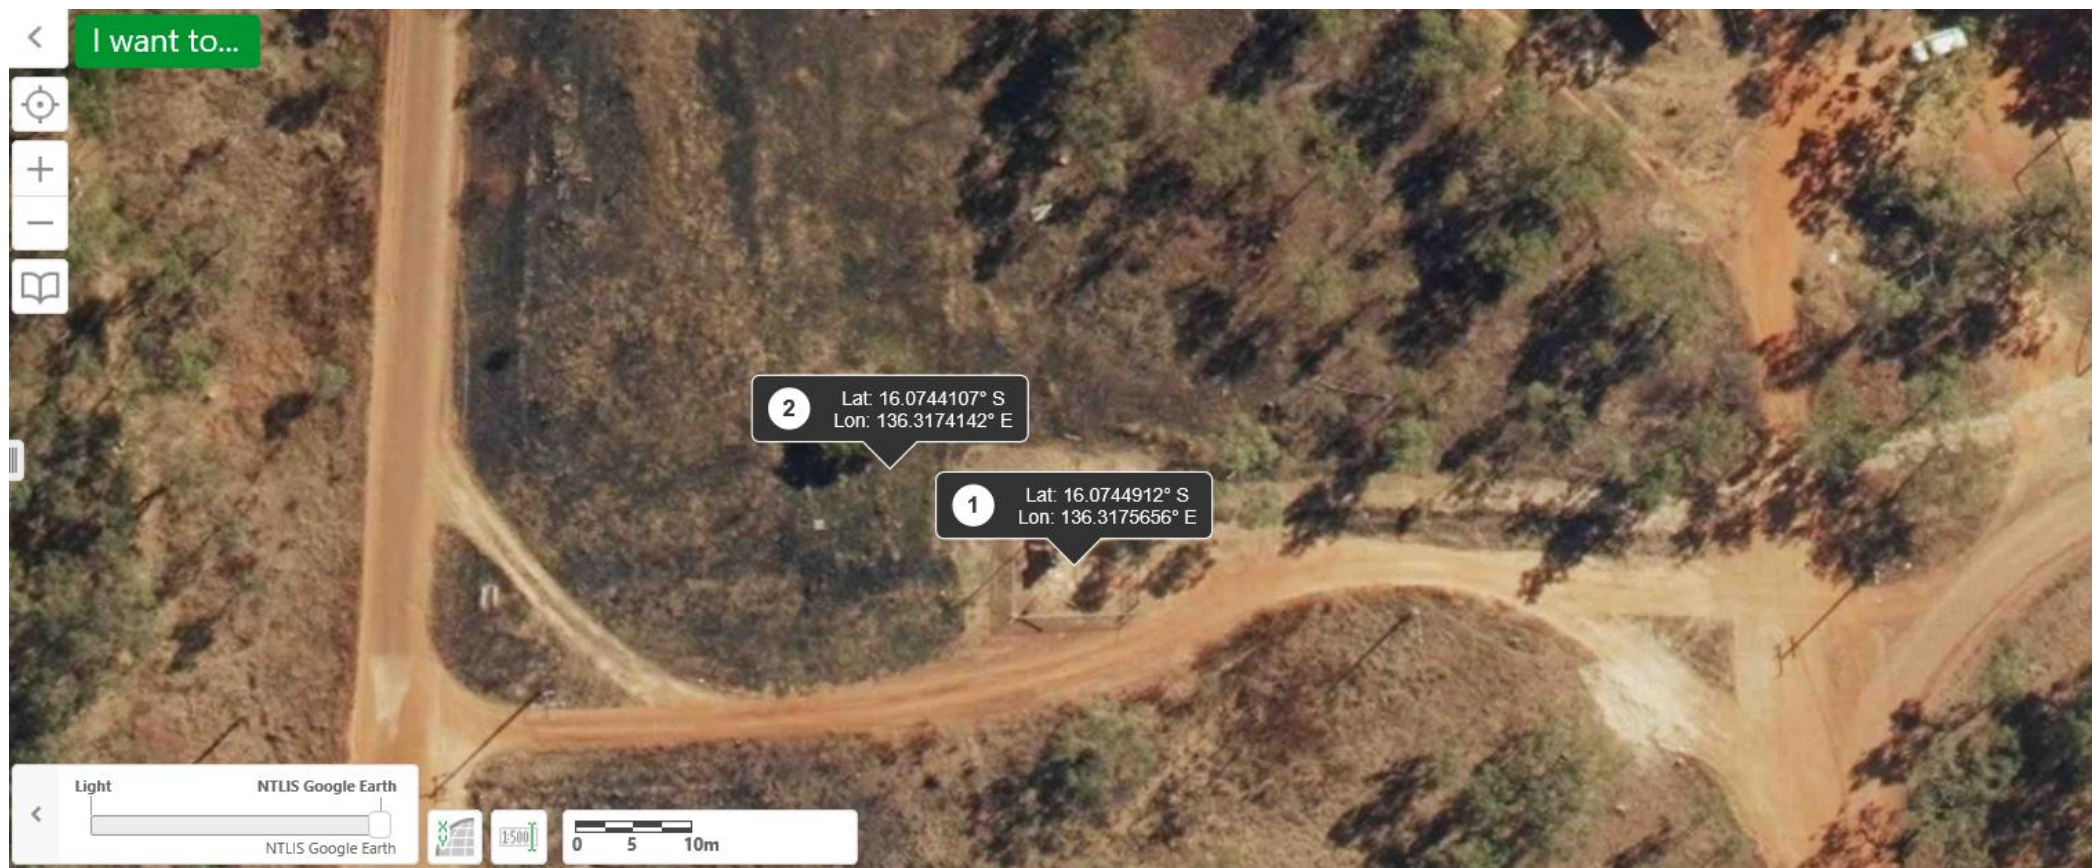
| | <p>07:00am on 5<sup>th</sup> August 2020. The overflow was stopped at approx. 07:15am on 5<sup>th</sup> August 2020.</p> <p>The discharge of raw sewage occurred from the SPS overflow point onto the surrounding land approx. 5m from the SPS boundary fence.</p> |

**Figure 3. Discharge location (1) and Receiving Environment (2)**

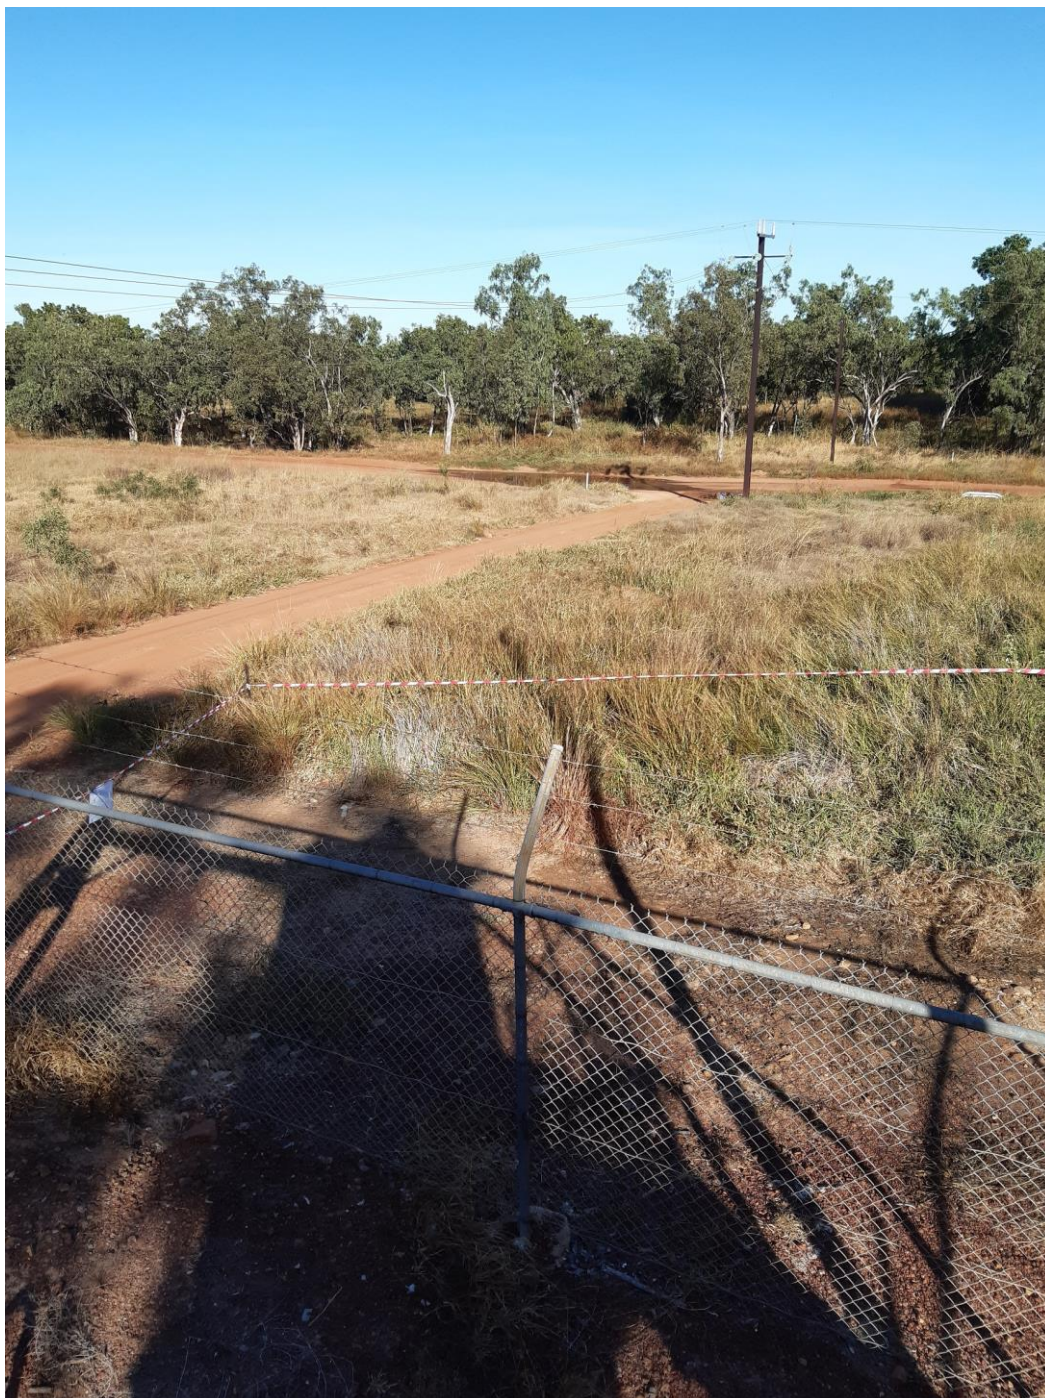
**Figure 4. Overflow site post clean-up – warning tape and signage**

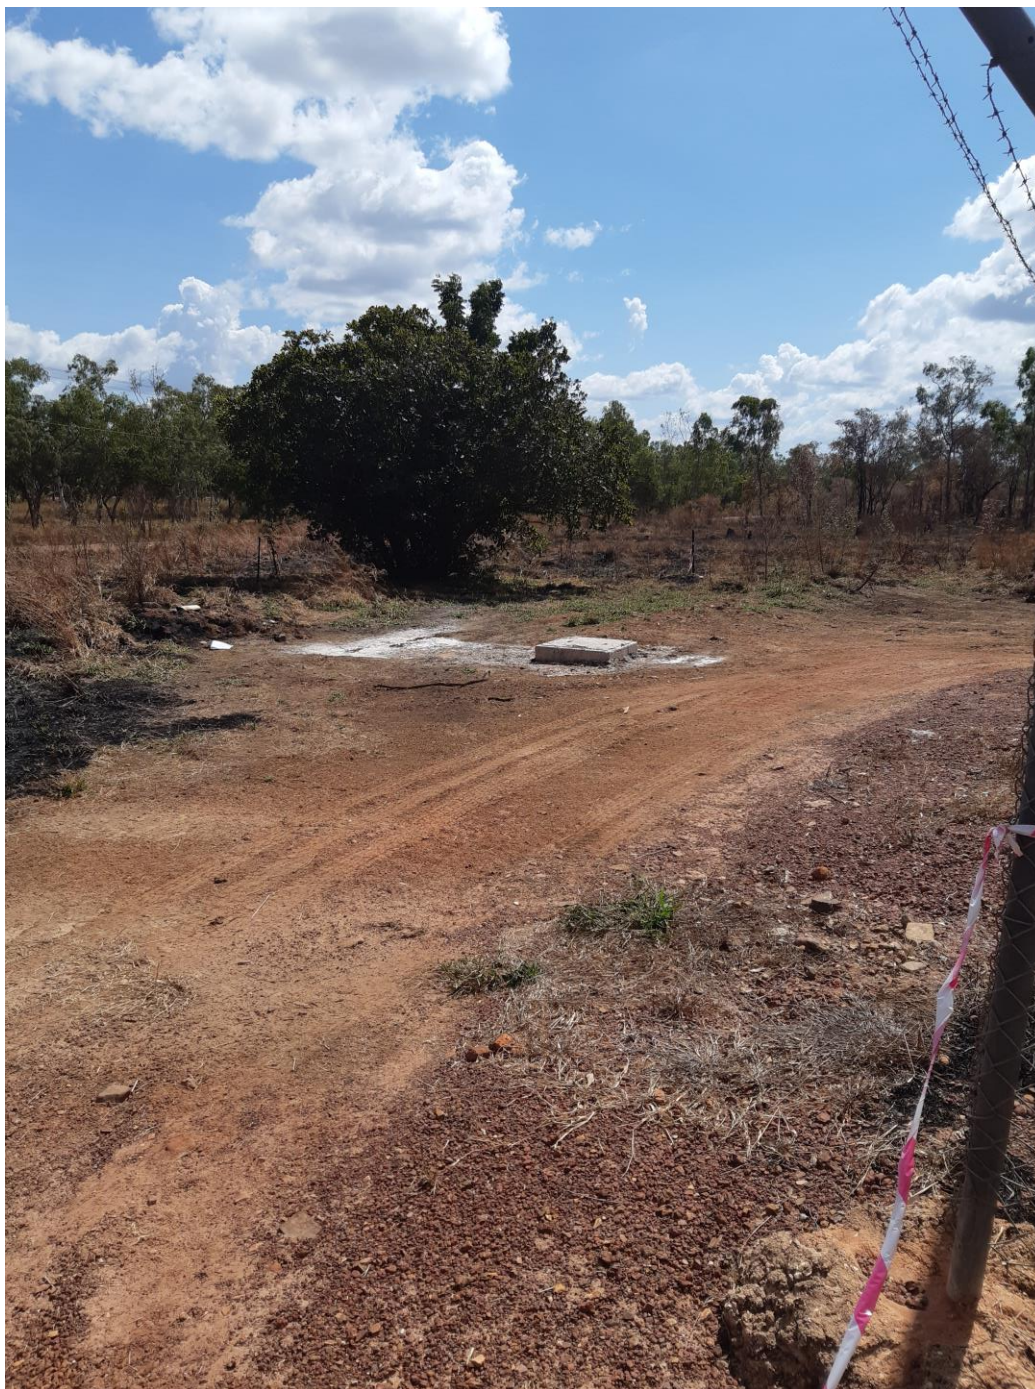
**Figure 5. Overflow site post clean-up – Warning tape and disinfectant spread over the site**
