## SECTION 14 INCIDENT REPORT (*Waste Management and Pollution Control Act*)

| <b>Incident:</b> | Discharge of raw sewage from sewerage network (no gross pollutants) |

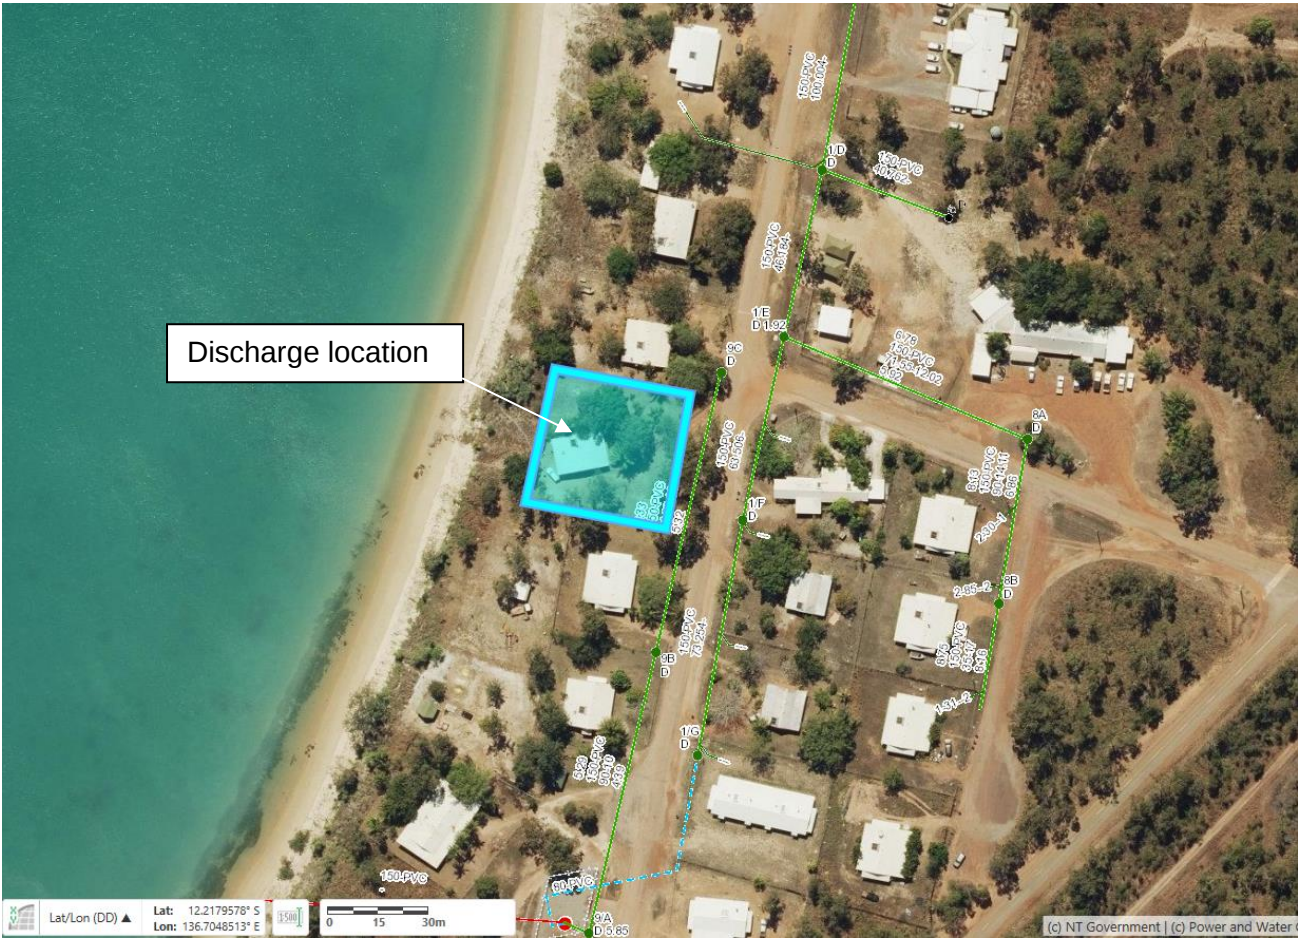
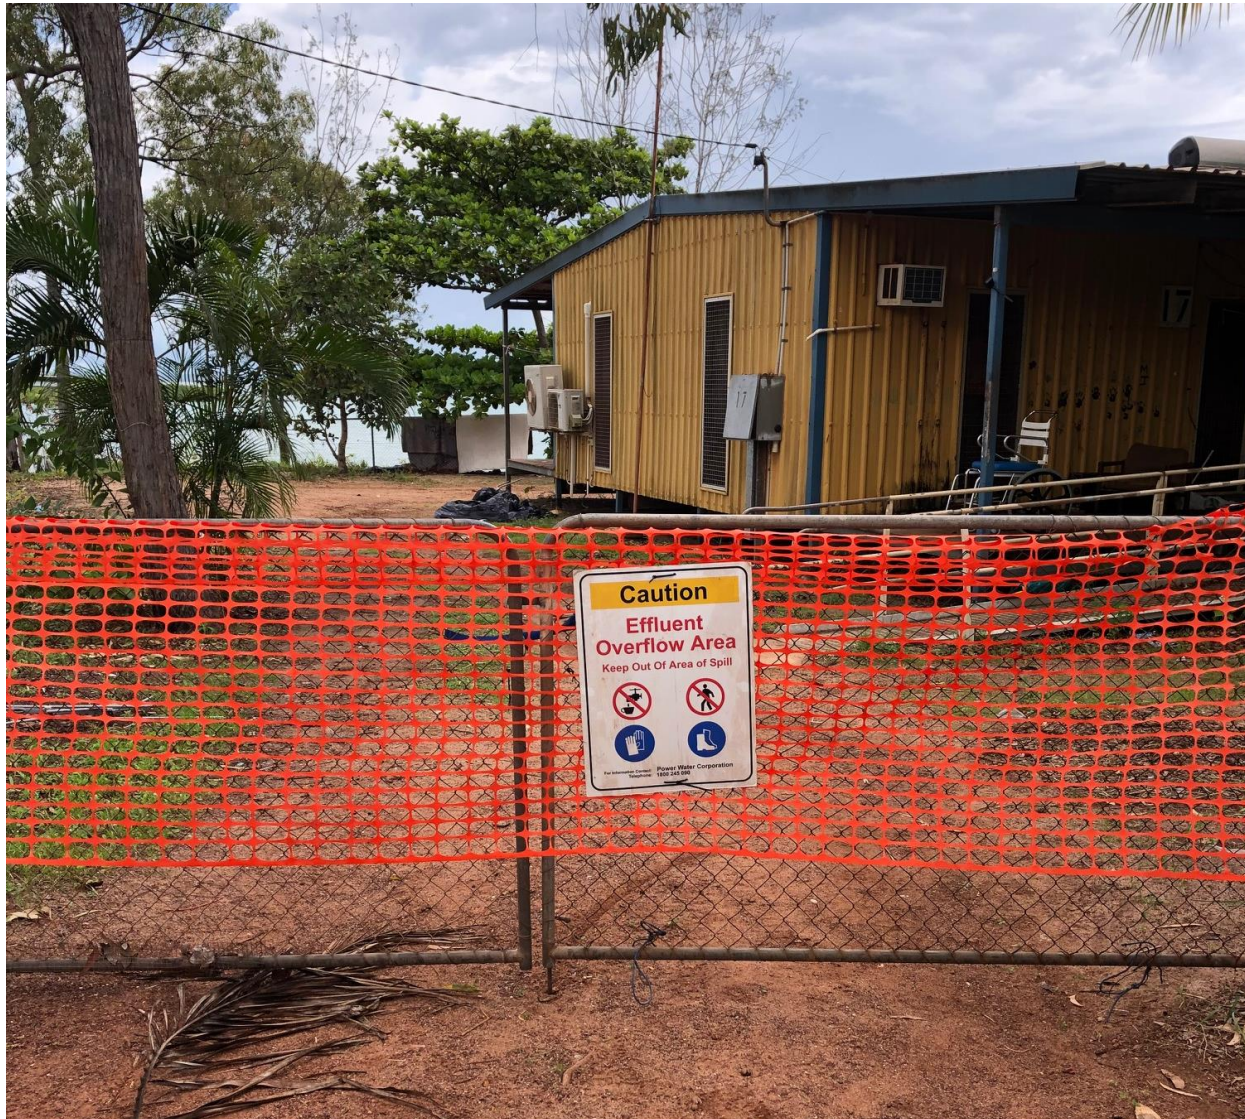
| <b>(b) the place where the incident occurred</b> | <p><i>i. Description of the PWC asset from which the discharge occurred.</i></p> <p>Overflow relief gully (ORG) from Lot 17 Gunyangara (East Arnhem Land).</p> <p><i>ii. GPS coordinates of the discharge point from the PWC asset, and the final coordinates of the final discharge point.</i></p> <p>Approximate Discharge Point: 136.7048528, -12.2179549</p> <p>Final discharge points are immediately downstream of the above co-ordinates.</p> <p><i>iii. Indicate any locations nearby to the discharge point where public can gain ready-access, such as public open spaces through which the discharge moves.</i></p> <p>Access to the public is not possible, as the ORG is within a private residential property. Residents voluntarily vacated and the yard is barricaded off to prevent access, signs warning the public of the overflow have been installed, as per the PWC Sewage Spills/Overflow Response Work Instruction. See attached picture page 4.</p> |

| <p><b>(e) the attempts made to prevent, reduce, control, rectify or clean up the pollution or resultant environmental harm caused or threatening to be caused by the incident</b></p> | <p><i>i. Confirmation signage and fencing has been erected, as appropriate.</i></p> <p>The site has had barricaded off and warning signage installed to alert the community residents, as per Sewage Spills/Overflow Response Work Instruction.</p> <p><i>ii. Decontamination of the site as appropriate.</i></p> <p>Clean up consistent with Sewage Spills/Overflow Response Work Instruction as appropriate to the location, and to minimise risk to public health and the environment.</p> |
